# POST OCCUPANCY EVALUATION REPORT

## GATEWAY BUILDING

FEBRUARY 2014

FINAL

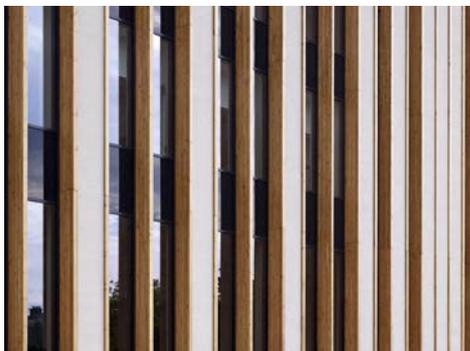
A particular feature of the building is the use of straw bales harvested from the University's farmland which form the infill to the prefabricated external wall panels. The resultant thermal insulation is impressive, achieving a low U-value of 0.135W/m<sup>2</sup> which is 60% better than that required under Part L of the Building Regulations current at the time.

The repetitive vertical elements of glazing randomly placed between the wall panels creates an interesting rhythm to the two long sides of the building while the full height glazing to the main entrance elevation forms an impressive façade frontage to the main circulation route through the campus.

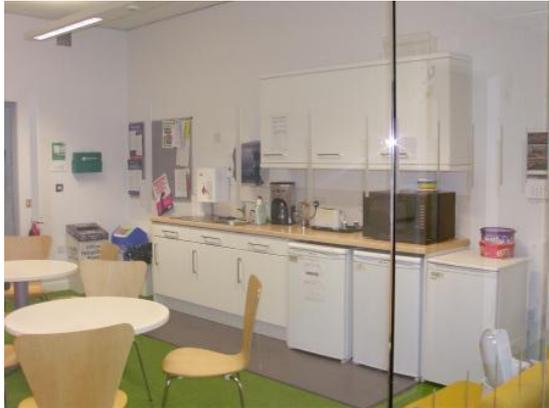
This is a good facility located on the third floor. It is well used by occupants on this floor but less so from those on the lower floors due to its location. Small kitchens or beverage points would have been useful on the lower floors although it was pointed out at the workshop that other café areas are close by on campus and when the new Amenities Building is completed this will provide an alternative venue.

◀Kitchen/Social Space on third floor

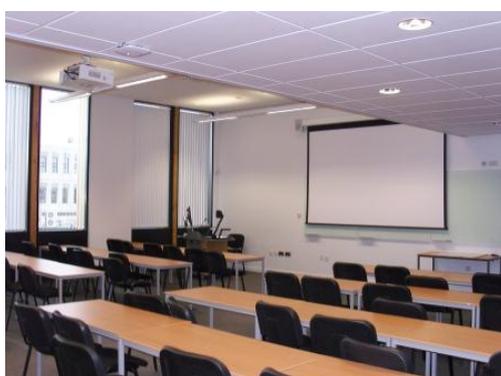
▲ Seminar Room B01

There are three central timetabled rooms within the building. Rooms B01/B02 can be subdivided but are generally used as one room. The utilisation rate is fairly good, exceeding the HE median and Russell Group median. However the computer room A07 has a very low utilisation rate and this needs to be investigated.

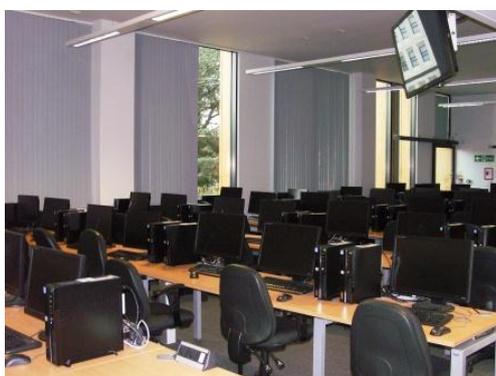
▲ Computer Room A07

- v) *v) An alternative to full height doors should be specified as these are considered not fit for purpose*
- vi) *vi) Investigate the low utilisation rate to the computer room A07*

| vi) Investigate the low utilisation rate to the computer room A07 | Development |

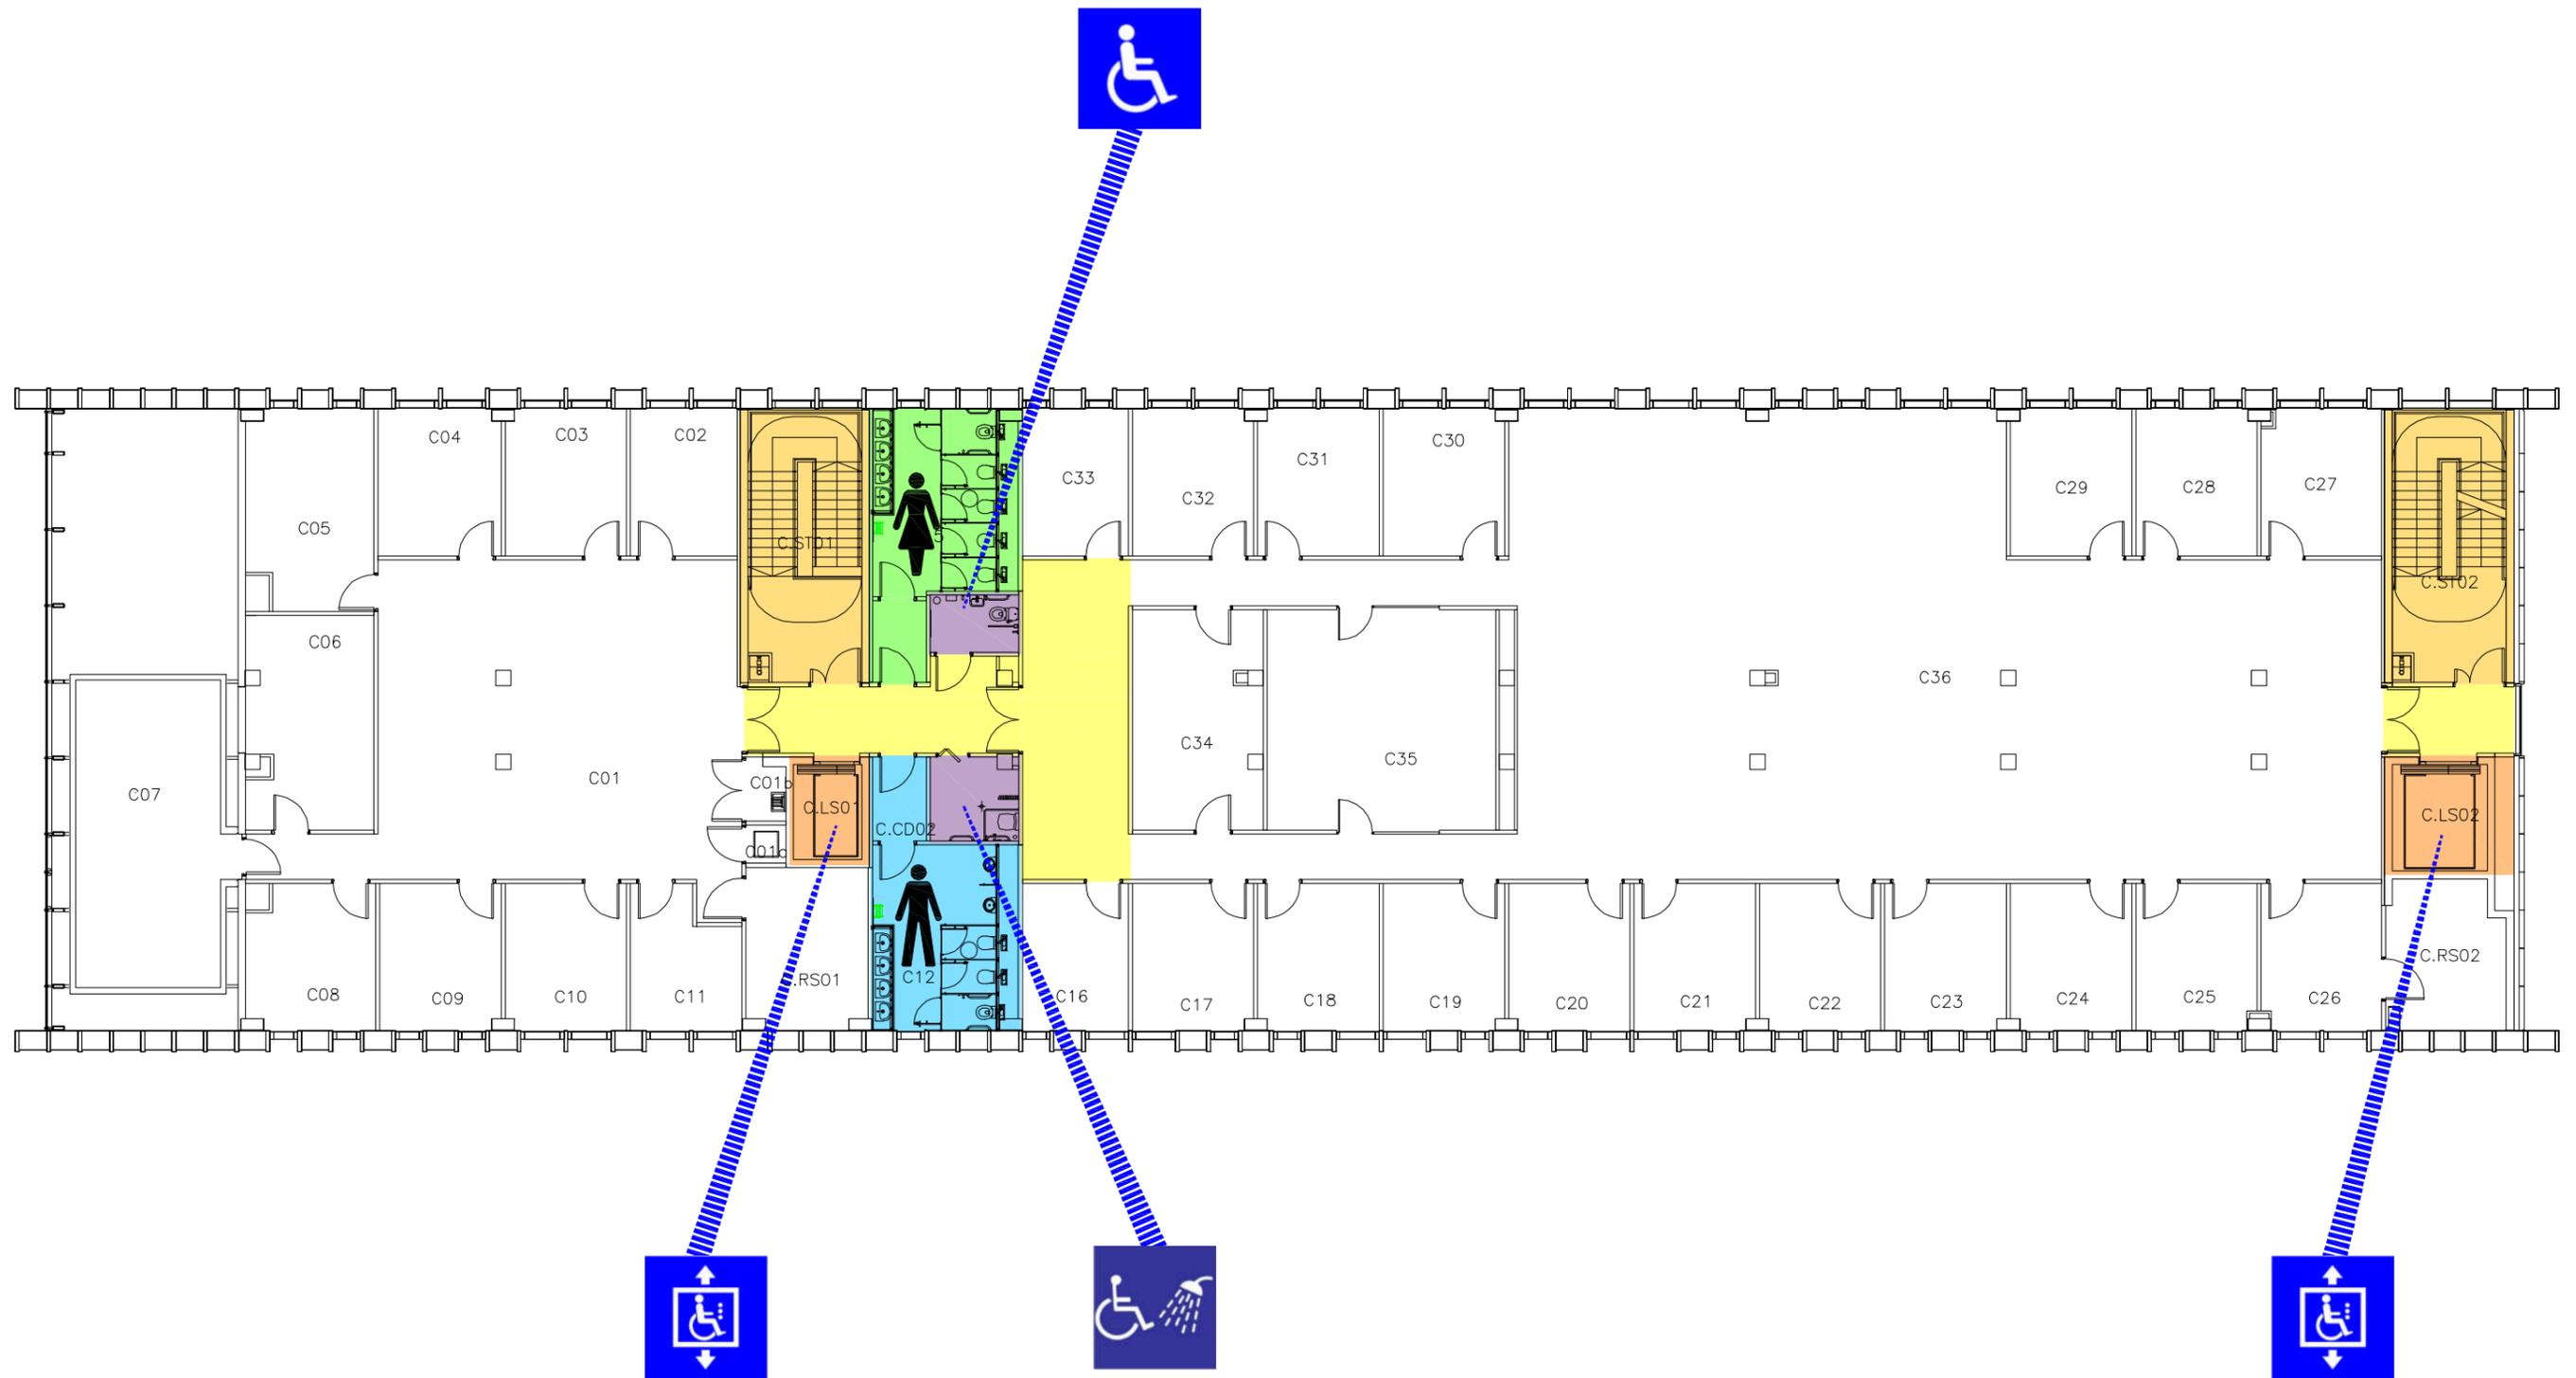
# Gateway Building - C Floor Plan

Disturbance by noise and distraction are obviously issues due to foot traffic to and from the perimeter offices and access to the break out area (C07). There is also no natural light to this office area. There was originally to be a rooflight over this space but it was omitted due to the extent of plant required on the roof. Removal of partitions to the office overlooking the full height atrium would help in providing some borrowed natural light.

- ii) *ii) Internal offices with no natural light that allow foot traffic through a working space result in poor working conditions. In the case of room C01, this could be improved through the introduction of borrowed light from the atrium. Removal of an office to facilitate this might be an option*

| ii) Natural lighting and the general environment in room C01 could be improved through the introduction of borrowed light from the atrium. Removal of an office to facilitate this might be an option | Estate Office/SMC |
