# POST OCCUPANCY EVALUATION REPORT

## MATHEMATICAL SCIENCES BUILDING

JUNE 2013

FINAL

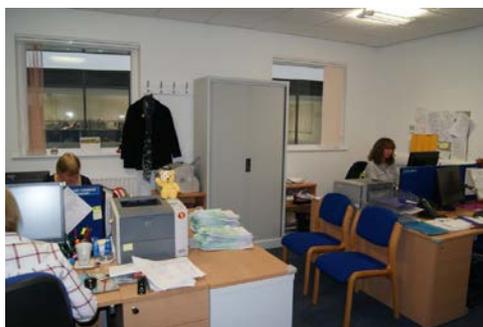
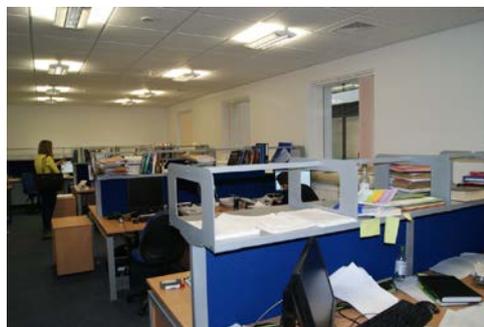
A major extension to the existing building on a very tight site inevitably meant that some perimeter offices in the existing building would lose some natural light. Although this has been replaced by borrowed light from the central atrium, this is not considered ideal. The occupants' comfort conditions are also affected by the ventilation system which provides the air quality needed to these internal spaces. Comments have been made regarding the effectiveness of the ventilation system and it is recommended that this is checked and adjustments made if necessary.

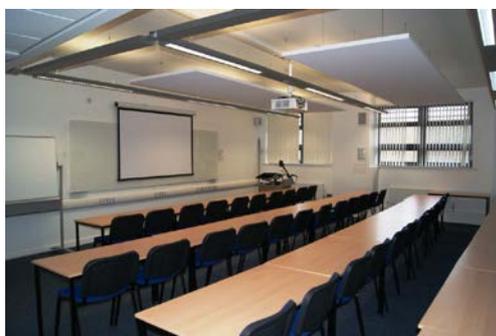
Seminar Room A17

Users would like more meeting rooms and more use of seminar room (A17) which is a central timetabled room. B35 which is currently used as a meeting room is in the existing building but has no natural light even though it has a window. It is accepted that a rooflight should have been incorporated into the design of the adjacent void which would have given this room some borrowed light.

There is one central timetabled room within the main building (A17). This is well used as can be seen from the audit that was carried out in October 2012 (Table 2). A utilisation rate of just under 42% is a respectable figure and above the current median for the HE sector as a whole.

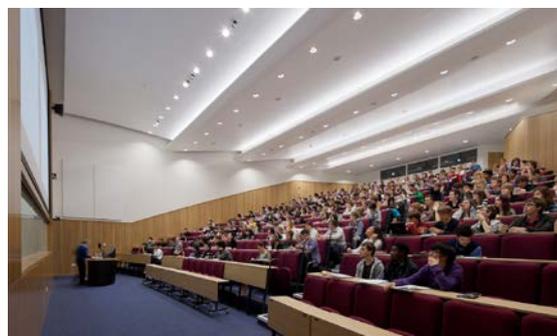
Keighton Auditorium

The adjacent Keighton Auditorium, a centrally timetabled space, is an excellent facility with good levels of utilisation. It is well used not just for teaching but also for University wide events and open days.

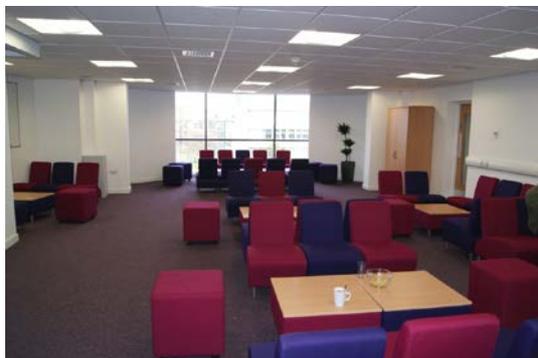
Common Room

The provision of a staff common room in the building is a facility welcomed by staff and enables the School to achieve its aim of promoting staff collaboration and interaction at all levels. This is a very positive aspect of the building's design and fitness for purpose.

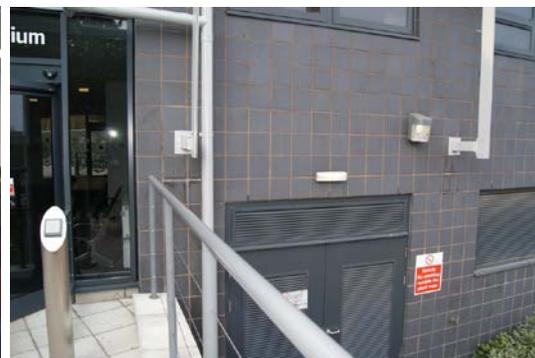
It has been reported that smokers who stand outside the entrance to the Auditorium are fairly close to the ventilation intake and plant room doors. This is causing smoke smells to enter the building via the ventilation system which some users find unpleasant.

Entrance to auditorium adjacent to vent grilles

Management of smokers external to the building is an operational issue and therefore not part of this review. However, it might be useful to bear this in mind on future projects and locate air intakes well away from potential smoker locations.
