POST OCCUPANCY EVALUATION REPORT

VAUGHAN PARRY WILLIAMS PAVILION

APRIL 2012

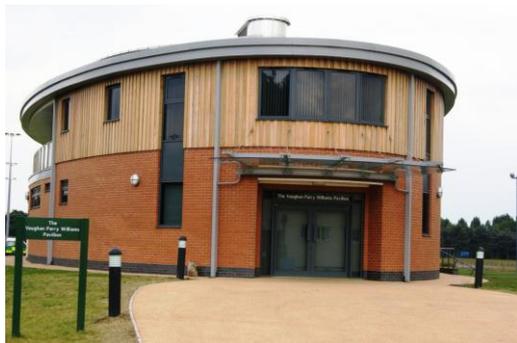
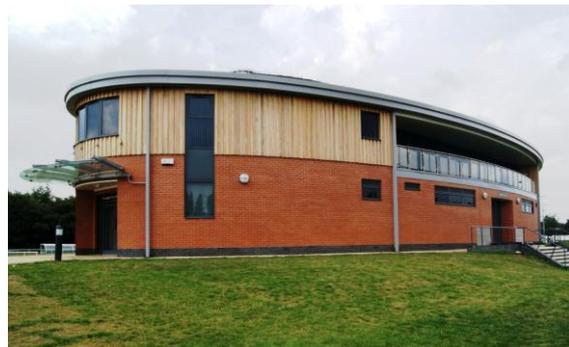
The building presents a unique and innovative design solution being elliptical in shape and on two storeys. Changing rooms are arranged on the ground floor with entrances/exits for the pitches on the north west and south east elevations. A separate main entrance to the pavilion is also provided. On the first floor is an extensive flexible meeting/viewing area with kitchen facilities. Two meeting rooms are also provided at this level.

Externally, the building is constructed of face brickwork at ground level and cedar boarding at first floor level. Metal sheet material forms the roof covering and fascias. The building is well sited in relation to the pitches both of which take account of the proposed route for the new tram link down University Boulevard.

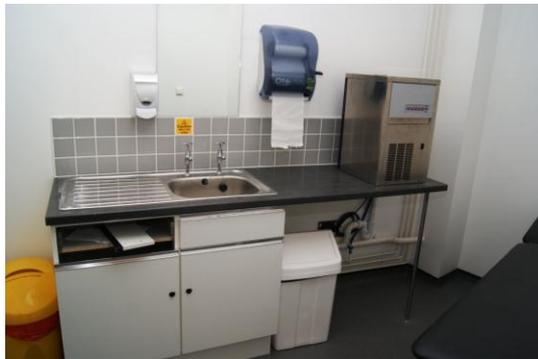
Base unit in First Aid Room

- Paint finish to changing room walls: a more durable paint finish would have been preferred that allowed the walls to be washed down. Also the white colour shows marks easily
- The shape of the training room makes it difficult to optimise space when setting out furniture
- The chairs in the first floor tea room may not be considered sufficiently robust – where seat backs are subject to abuse rather than normal wear and tear
- The showers to the changing rooms are temperature controlled and the user cannot manually turn them colder
- The carpet to the main entrance is difficult to keep clean due to spectators bringing in mud on their shoes
- The base unit in the First Aid Room has not withstood general wear and tear

- iii) Check the condition of the chairs to the tea room and change the specification on future similar projects if necessary
- iv) Provide one shower within each of the team changing rooms which can be manually operated to allow cooler temperature if required
- v) Review carpets to entrances where muddy conditions are present and consider a more easily cleanable flooring material
- vi) Ensure fitted furniture is of the right quality to withstand general wear and tear

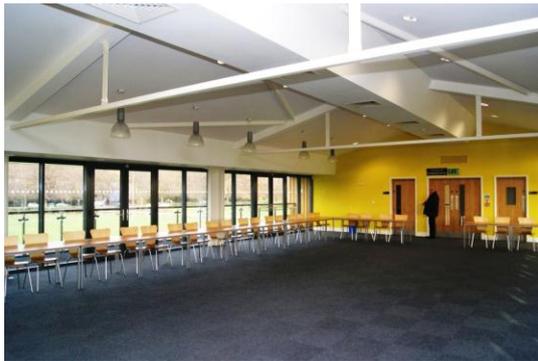
View of Tea Room/Viewing Area

The design has provided good first floor space with the provision of a training room as a bonus as this was not required in the original brief. The tea room which is more of a flexible space for multipurpose use is a good asset but it is not well used. It is noted that this facility is beginning to be used more for University Departmental use. It has the benefit of being an off-site venue and lends itself to conference and training events.

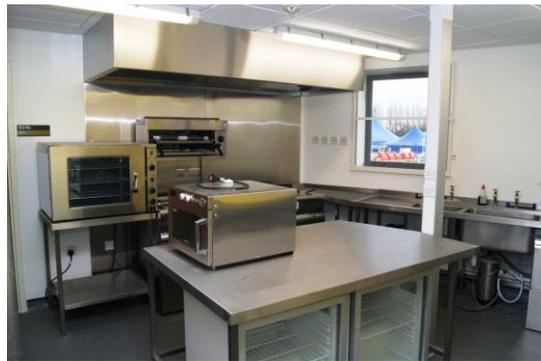
Kitchen

The tea room is served by a fully equipped kitchen but is not large enough to cater for events such as weddings. At early design stage it was difficult to obtain a user brief and eventually the consultant Project Manager approached a kitchen fit-out company to develop a brief.

At present the kitchen generally remains unused with catering often provided through outside caterers.

- i) On future projects, design briefs need to be more clearly established and defined for facilities such as kitchens and University Catering should be consulted where appropriate*
- ii) Lines of communication and points of contact with end user representatives need to be established at the start of the project to ensure appropriate consultation takes place with those who understand the needs of the pavilion*
