POST OCCUPANCY EVALUATION REPORT

ROMAX TECHNOLOGY CENTRE

DECEMBER 2015

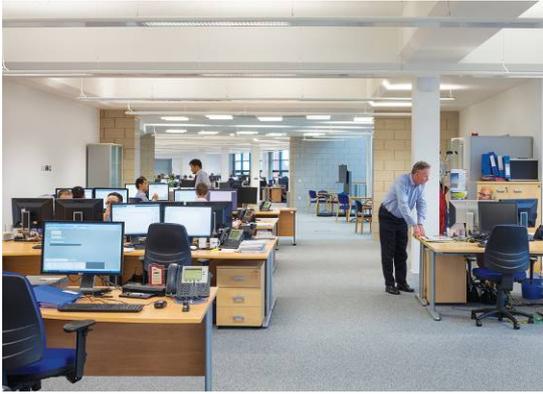
General office area

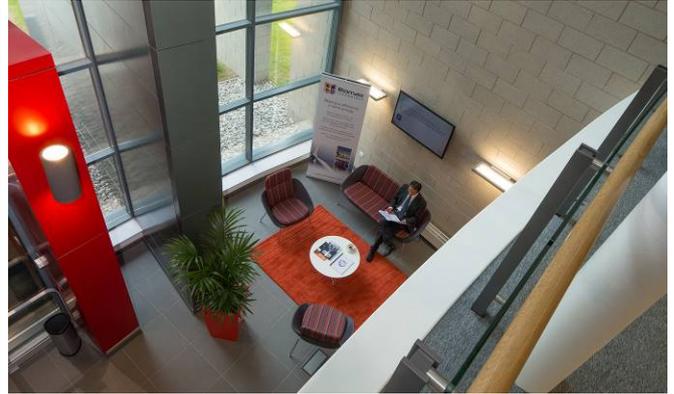
Central area open to main entrance below

The atrium provides an impressive central space but occupants of the central office area on the first floor, which is open to the atrium, suffer from noise disturbance from the floor below. In hindsight it would have been better to enclose this space from the atrium. This has been done on the floor above for fire protection purposes. A proposal is now in hand to incorporate a demountable partition in front of the balustrade to the atrium.

- i) Complete the work to improve sound insulation at first floor level*
- ii) Investigate the heating to the ground floor entrance and improve performance of the warm air curtain if possible*

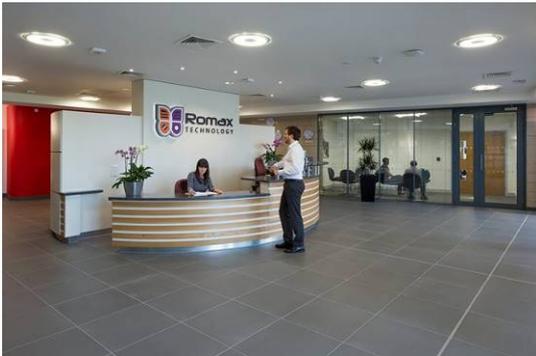
Staff who work at the reception desk in the ground floor main entrance have complained of feeling cold in winter despite the provision of a warm air curtain above the main entrance doors. This is considered to provide insufficient heat and further investigation is needed.

Main reception desk
