POST OCCUPANCY EVALUATION REPORT

AEROSPACE TECHNOLOGY CENTRE

MARCH 2015

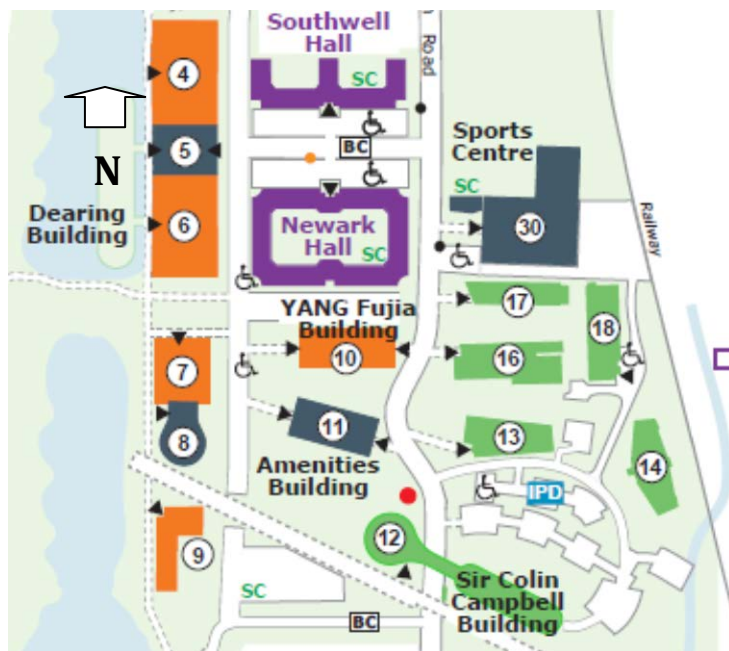
The building (18) has been aligned on a north-south axis and forms a closure to the open space between the Energy Technologies Building (16) and Institute of Mental Health Building (17).

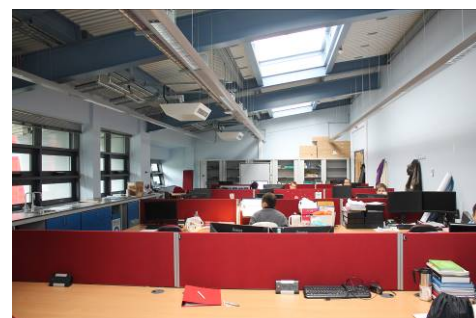
Room B13

The PGR/Post Doc Office space attracts the most dissatisfaction. It should be noted that this room (B13) was originally intended to be used as a laboratory. As a shared office it has attracted some comments due to temperature conditions and natural lighting. Despite this, 58% of respondents found the working space to be satisfactory.

Comments from users concerning the lighting relate to the automatic movement/daylight sensors and further adjustment may be needed. In the PGR/Post Doc office B13, it was noted at the workshop that as this was originally designed as a laboratory space, the lighting sensors may be incorrectly located for an office environment. This needs further investigation.
