# POST OCCUPANCY EVALUATION REPORT

## HIGHFIELD HOUSE

**JUNE 2014**

**FINAL**

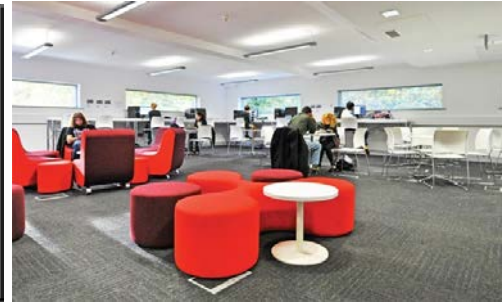
The new build elements of the project incorporate three small meeting rooms together with the inner courtyard which has been glazed over and refurbished to create an informal social and meeting space. 84% of respondents rate these spaces as good to excellent. The only adverse comments relate to the size of furniture selected for the small meeting rooms (A10 and A12). This has compromised the functionality of the rooms.

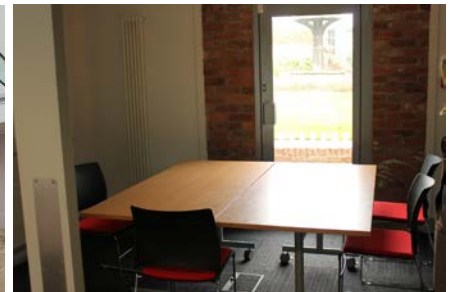
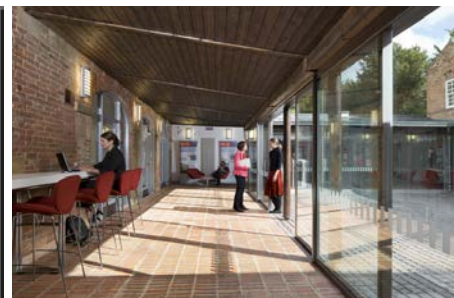
The Cloister area successfully links the existing house with the former outbuildings and new build element and provides a useful forum for staff interaction and use for social gatherings, private study/work. The natural light from this area supplements the top-lighting to the internal meeting rooms which form one side of the cloister. Overall this space was rated 84% good to excellent by respondents to the survey.

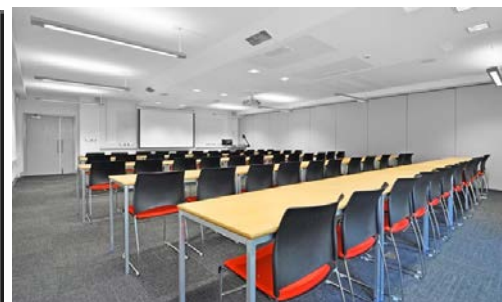
There are five seminar/teaching rooms on the ground floor which are centrally timetabled. Two of the rooms are reserved for postgraduate use only. The rooms provide very good facilities which is reflected in the 95% good to excellent rating given by respondents to the survey.

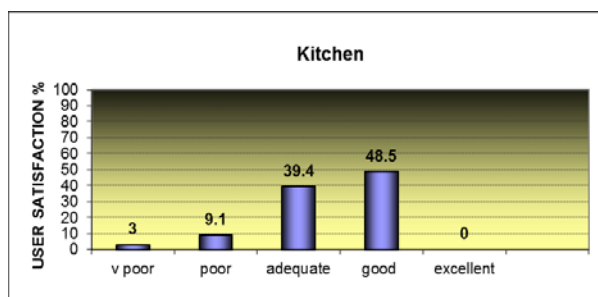
Regarding kitchen facilities, the Graduate Centre has its own kitchen area. The main kitchen for the building is centrally located on the ground floor. This is a well-used area and comments from the users relate to the amount of worktop space which is considered inadequate. Wall space is limited but it is possible to add a short return of worktop to increase the working area. Research and Graduate Services should pursue this via a works request to the Estate Office.

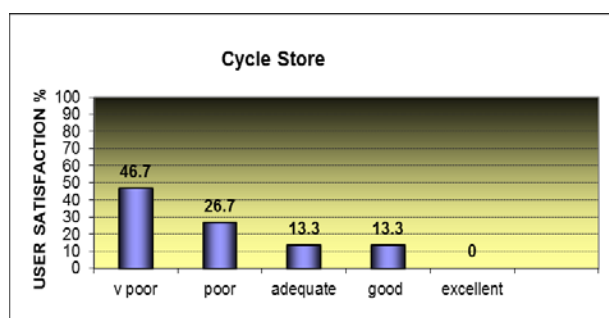
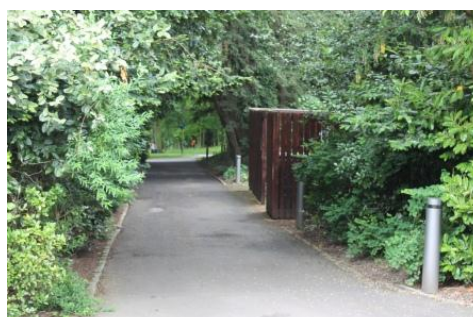
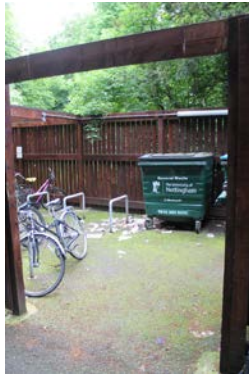
The project included the provision of an external cycle store which is located a short distance from the main building and incorporates bin storage. The store has generated a number of comments in response to the satisfaction survey which shows that 73% of respondents are dissatisfied with this facility. These relate mainly to safety and security both in terms of safe access to the store and the high incidence of cycle theft.

At present there are no plans to improve security to this area. Discussion at the workshop concluded that the store should be restricted to bin storage only and that an alternative location should be sought for cycles or another cycle store used elsewhere.

A proposal should be put to Estates Directorate to implement this change for the start of the new term.

Due to the number of cycle thefts and that staff don't feel safe accessing the store during hours of darkness, the store should be restricted to bin storage only and an alternative location should be sought for cycles or another cycle store used elsewhere. It is noted that Security and Sustainability support this view.

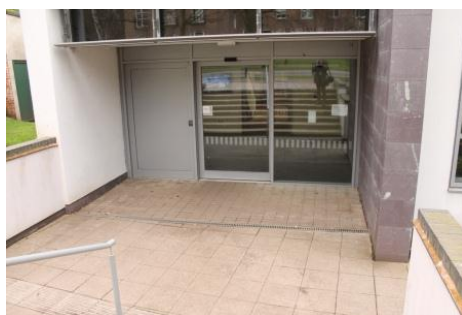
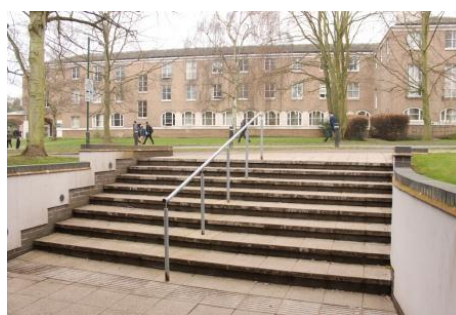
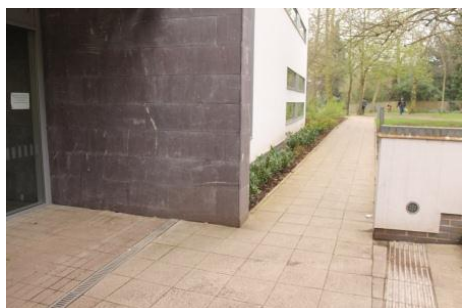
### External steps and main entrance

The design of the main entrance steps and adjacent paths allows surface water to fall towards the main entrance to the building. Water is prevented from entering the building by use of a drainage channel across the full length of the entrance.

Users have experienced flooding of the lobby area in heavy downpours of rain due to blockage of the drainage channel. A larger channel section together with an additional drainage channel across the adjacent path would have been a better solution.

Due to a number of large trees adjacent to the building, it is important that the drainage channel is kept clear of debris.

- i) Consider installing an additional ACO drainage channel to the footpath running parallel with the building*
- ii) On future projects where possible ensure main steps and paths leading to main entrances fall away from the entrance.*
- iii) A regular maintenance regime should be adopted where drainage channels are used and there is a high density of trees close to the building*
