# POST OCCUPANCY EVALUATION REPORT

## SI YUAN CENTRE OF CONTEMPORARY CHINESE STUDIES

**JUNE 2014**

**FINAL**

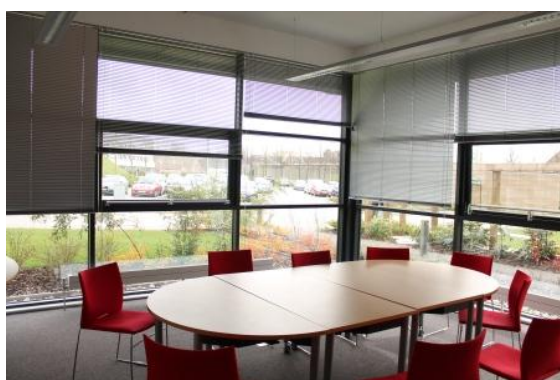
Private Dining Room

Both the private Dining Room and Video Conference Room provide excellent meeting room facilities. This is reflected in the level of satisfaction shown for users of these areas. The rooms are located on the ground floor and the full height glazing gives excellent light and adds to the quality of these spaces for small group meetings.

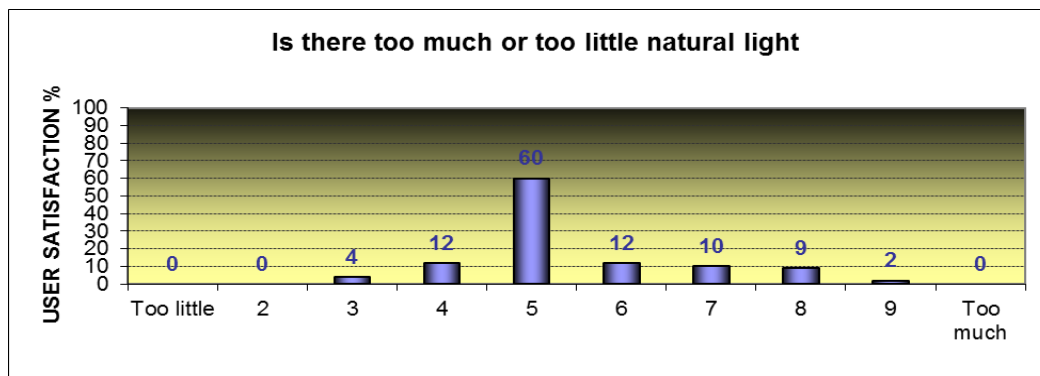
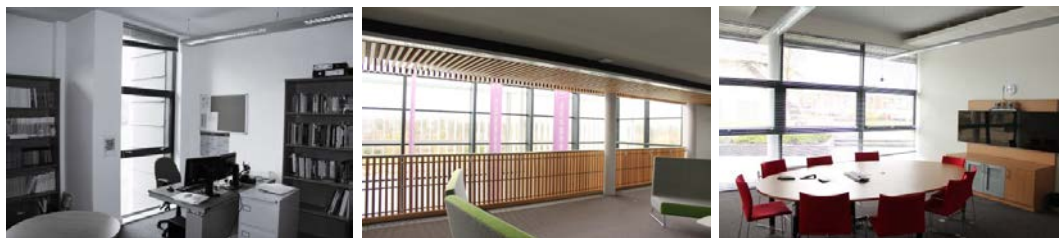
Regarding light both natural and artificial, respondents to the survey were very positive about this aspect of the building. Natural light has been maximised through the use of full height glazing in some areas and the top-lighting is particularly effective at 2<sup>nd</sup> floor level.

Examples of use of good natural light in different parts of the building

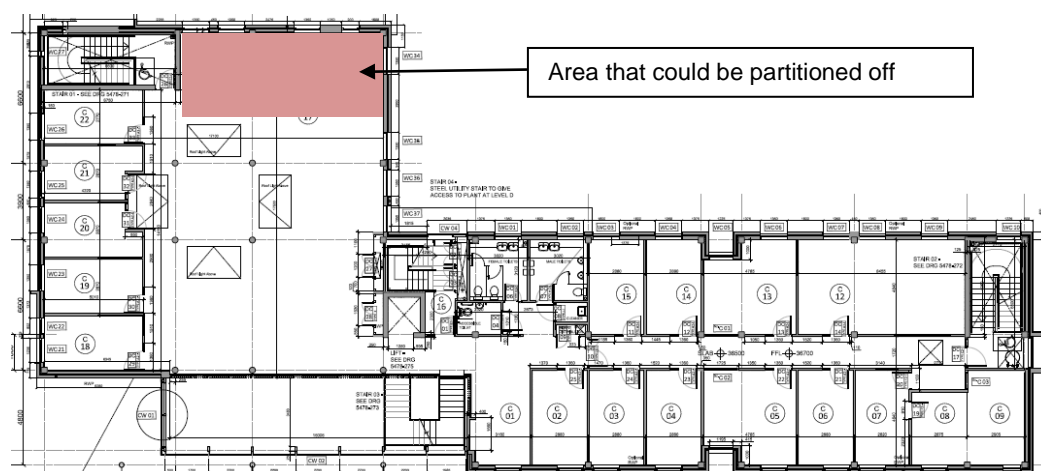
### PGR/Visiting Scholars' Open Plan Office Area

Users of this space have commented on the disturbance to working caused by noise emanating from other floors and the adjacent atrium.

A possible solution to alleviate the problem would be to partition off some of the area at the back of the space to create offices and/or introduce more office screens to subdivide the space. A case could be presented by the School management to Space Management Committee (SMC) or funded directly.

- i) School to consider changes to the PGR/Visiting Scholars' space to reduce noise disturbance through submission of a case to SMC or by direct funding*
- ii) Investigate the heating in Room B22 (raise job ticket)*
- iii) Consider adjusting the heating programme/schedule to help mitigate the temperature changes/drop*
