**University of  
Nottingham**

# Post-Occupation Evaluation Study Report

Project: S-Lab: Chemistry Building, University Park

Date: May 2017

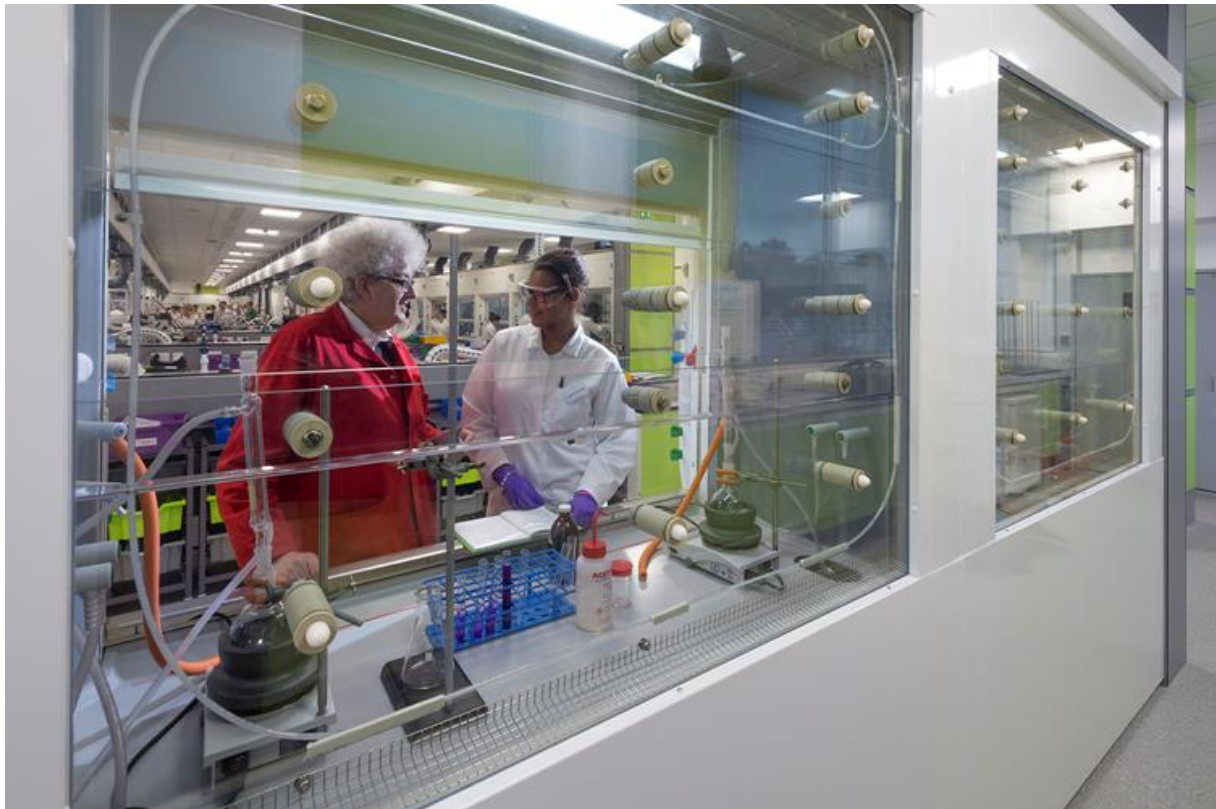
The delivery of services through the booms has made the lab tidier and the glass-backed fume cabinets contribute to the light and open feel of the space. The cabinets also facilitate the teaching of students, allowing people to observe from all sides of the cabinet.

**“The space has an audio system in so that we can communicate directly with students and both the technicians and the academics can access the audio system through the lapel microphone. It has completely changed how we deliver things.”**

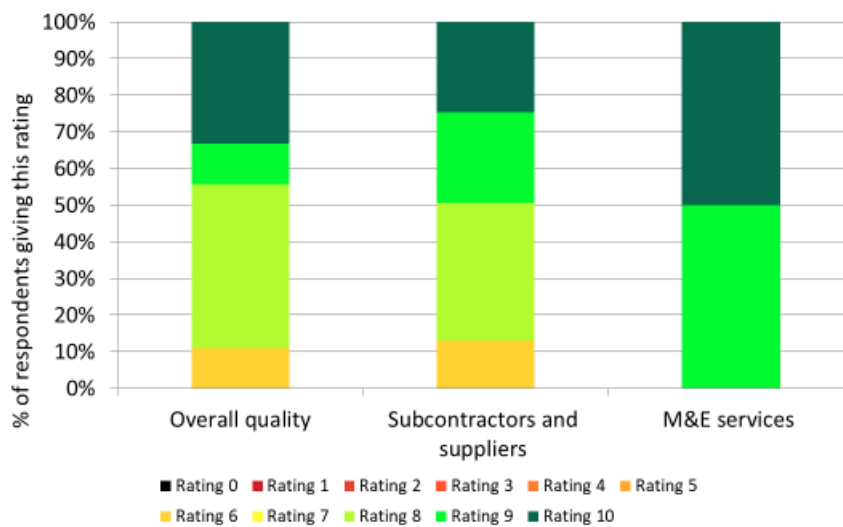
### 4.0 Satisfaction with the quality of S-Lab and the team involved in the programme

The lowest ratings were received in response to the question regarding the overall quality of S-Lab. Dissatisfaction with the experience of dealing with the supplier of the vacuum system is reflected in responses to the question concerning satisfaction with subcontractors and suppliers. For both of these questions, 50% of ratings were of 'eight' or below.
