# POST OCCUPANCY EVALUATION REPORT

## ENERGY TECHNOLOGIES BUILDING

DECEMBER 2014

FINAL

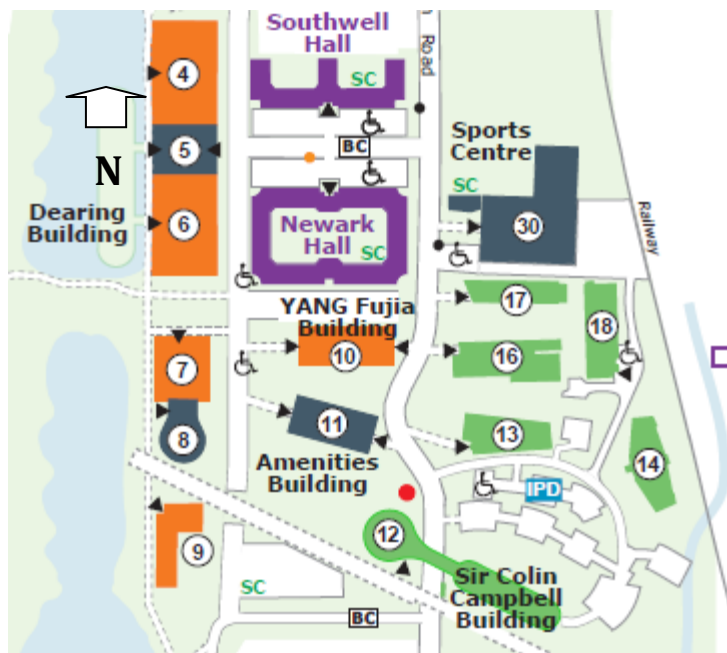
The building which comprises three main elements of a front facade block and two 3 storey rectilinear blocks, sits comfortably on the site (16). It is bordered to the west by Triumph Road on which the building's frontage gives a predominantly glazed and open aspect, to the north by the Institute of Mental Health Building (17), to the south by the Nottingham Geospatial Building (13) and to the east by the Aerospace Technology Centre (18).

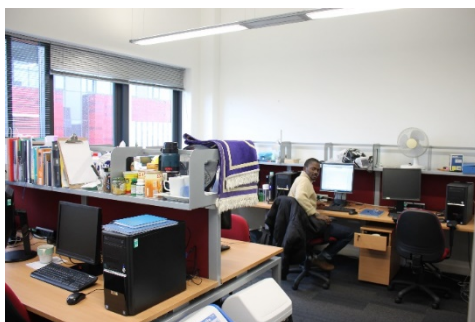
Shared office C04

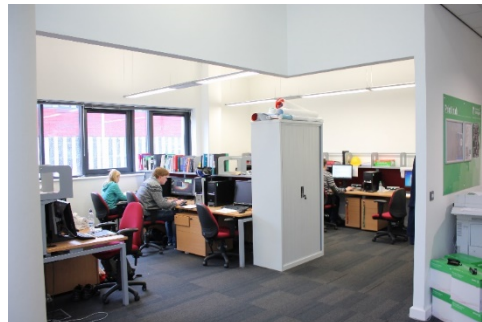
Shared Office C08 which is open to the corridor

A number of comments have been made regarding noise disturbance experienced by occupants of office C08. This office has an open side directly onto the corridor and adjacent kitchenette. Noise is generated from the activities around the kitchenette where groups tend to congregate.

A solution to this would be to construct a partition to screen off the office completely from the corridor. This has been done to office A09 with some success.

- iv) The operation of the fire vents should be investigated to ensure closure is activated as soon as possible following a fire alarm activation*
- v) Consider partitioning C08 off from the corridor to reduce noise disturbance. An option would be for the Faculty to refer this to SMC for their consideration*

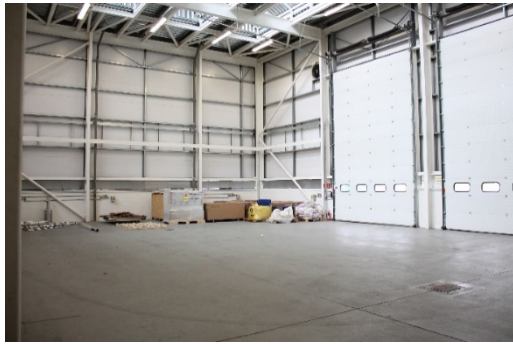
The large prototyping hall, a light industrial type space, was originally intended as an area for construction and testing full-scale prototypes of building facades and materials with an adjacent external test area.

The take-up on the use of this facility has not been good and other research uses for energy technologies are now being considered by the University.

Prototyping Hall

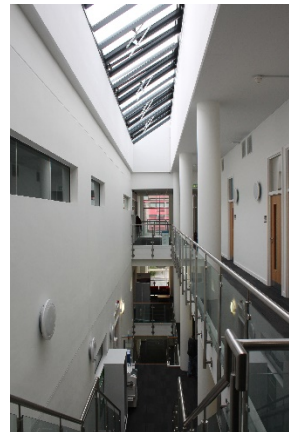
The fire strategy for this building incorporates roof vents over the main corridor spine and staircase which open when the fire alarm is activated. The issue for users is that the vents seem to remain open for a long period once the alarm has been de-activated and people are allowed back into the building. On rainy days this results in the photocopier getting wet as well as the main staircase which may be a safety hazard.

The operation of the fire vents should therefore be investigated.

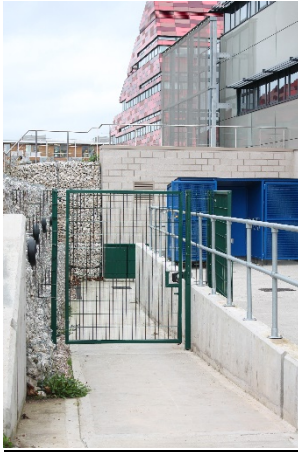
### Ramped Rear Access

The building has a ramped service access to the rear of the electrical lab. Users have commented that the ramp is far too narrow for goods vehicles to reverse close to the access doors for off-loading. This was discussed at the workshop and the design intent, which was endorsed by PMG, was that forklift trucks would be used to transport equipment/plant the short distance to the access doors.
