The University of
Nottingham

POST OCCUPANCY EVALUATION REPORT

INSTITUTE OF MENTAL HEALTH BUILDING

OCTOBER 2014

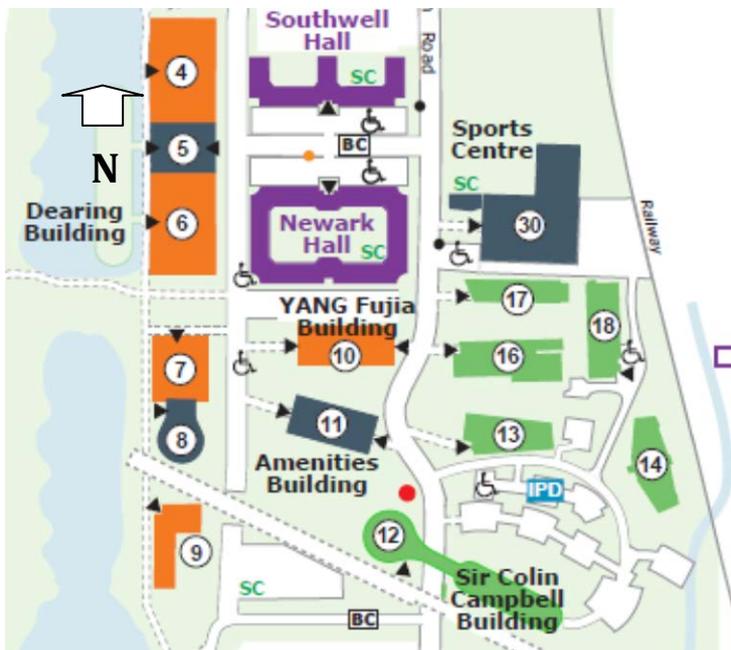
The proportions of the site have dictated a shallow plan design with two distinct volumes of accommodation linked by an eyebrow roof projection. The site (17) is bordered to the west by Triumph Road, to the north by the existing Sports Centre, to the south by the Energy Technologies Building (16) and to the east by the Aerospace Technology Centre (18).

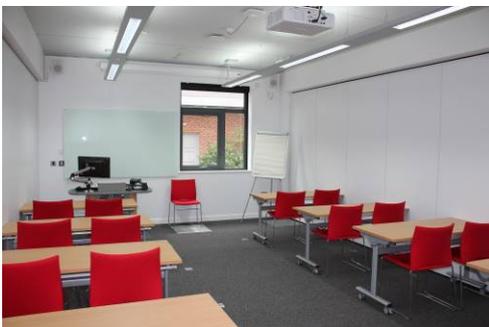
The building provides very good seminar rooms on the ground floor with adjacent breakout space. The rooms vary in capacity but are made flexible through the use of folding partitions. The booking of these rooms is managed by IMH. Overall, 72% of respondents rated these facilities good to excellent.

One of the seminar rooms

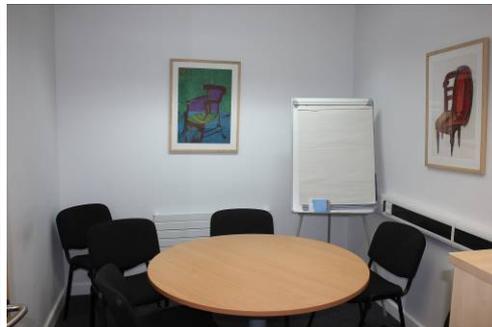
Small meeting room

On the meeting rooms there was less satisfaction. Room B27 is considered a reasonable size and has natural light. However the other six meeting rooms are quite small and are internal which is reflected in the level of satisfaction with these rooms (52% good to excellent)

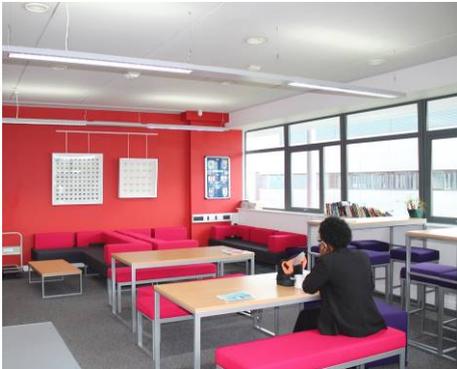
A staff relax area is provided on C Floor which comprises a good sized, well lit room with lounge furniture and tables and chairs. Kitchen facilities are provided down one wall with a range of units, worktop and sink. Users of the building rate this space very highly with 80% of respondents rating it good to excellent.

Staff Relax Area

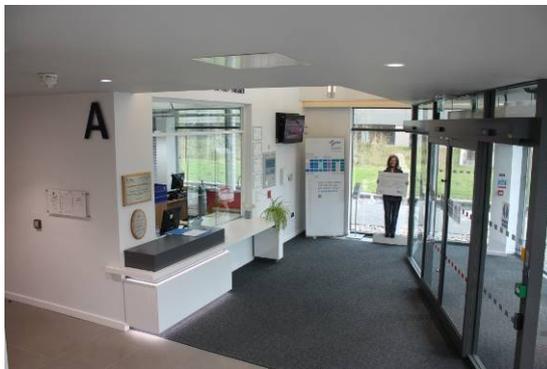
Main Entrance/Reception

The building layout incorporates a main entrance area and reception desk and office to the rear. The open aspect of the staircase extends to the first floor with ample landing space for breakout purposes or for other social activity. The building has a well-defined entrance and the presence of a reception is considered an asset in welcoming visitors and other users. 84% of respondents rate this space either good or excellent.

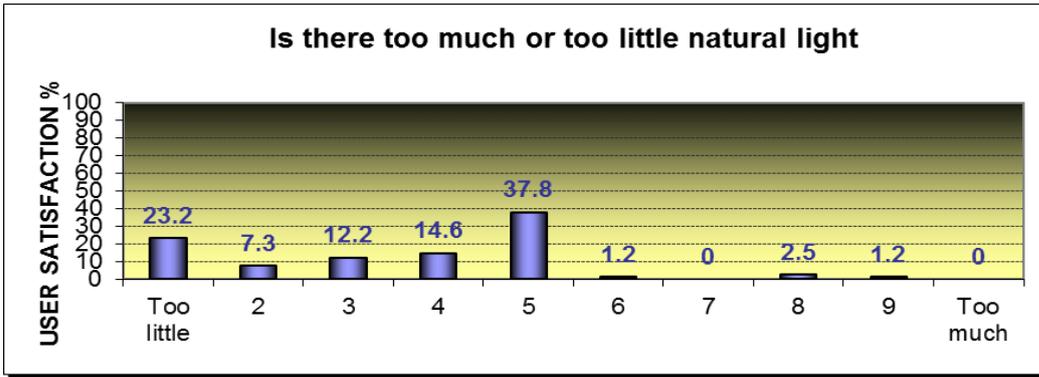
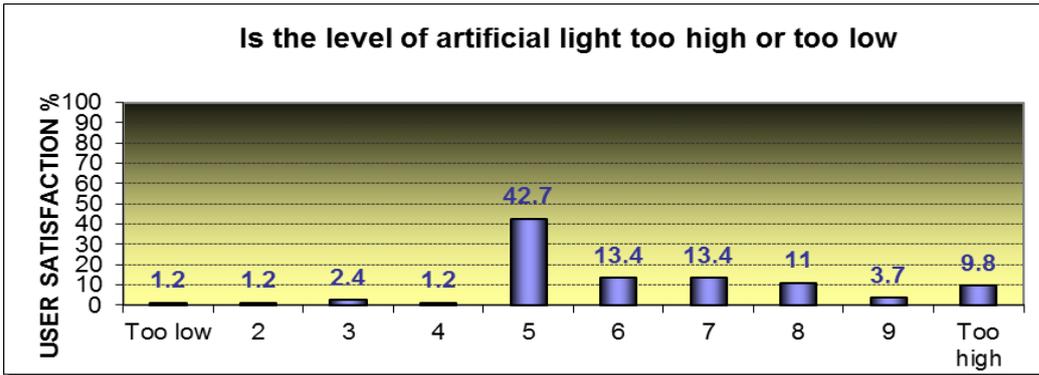
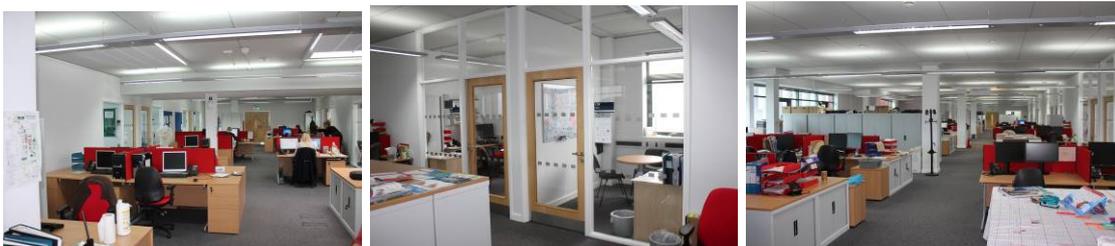
Regarding light both natural and artificial, respondents to the survey were concerned at the lack of natural light to the open plan areas and the consequent reliance on artificial light. The D Floor open plan area has the benefit of top lighting although this is very often blacked out to reduce solar gain. The other open plan areas on B and C Floors rely heavily on borrowed light made worse by the inclusion of additional perimeter single offices.

Examples of offices with varying degrees of natural light

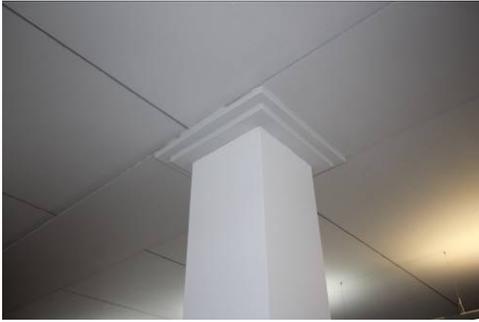
The quality of the finishes both internally and externally are good and to a standard expected by the University. One exception is the column and Delta beam junctions which have necessitated the fitting of timber strips to cover the joints. Having exposed concrete slab soffits with no suspended ceiling requires careful detailing at column and beam junctions to avoid having to conceal unsightly gaps.

View of column junction with ceiling

This is an example where design co-ordination needs to be improved and detailed drawings need to be carefully reviewed prior to construction on site.

- i) Ensure detailed drawings are adequately reviewed and critical junctions fully detailed prior to construction on site*
- ii) Ensure adequate time is given to the commissioning period particularly when shared services are delivered by other building contracts*
