POST OCCUPANCY EVALUATION REPORT

BIOENERGY & BREWING SCIENCE BUILDING

FEBRUARY 2014

FINAL

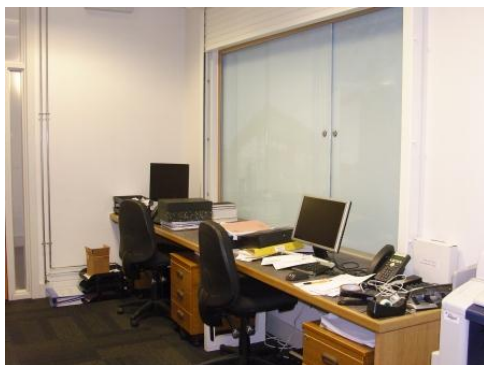
The reception area was designed on the basis that greeting of external business representatives would be an important part of the building's function and therefore a reception was considered an important design element at the time. However this external engagement with businesses has not happened in the way it was originally intended and the reception has become unnecessary. This space is now used as an office.

◀ The reception which has now become an office

Schools/Departments' use of receptions is difficult to predict at project design stage. The design brief on reception areas therefore needs to be made clear at the earliest opportunity and some flexibility built into their design.

Ensure that the design brief on reception areas is made clear at the earliest opportunity and some flexibility built into their design

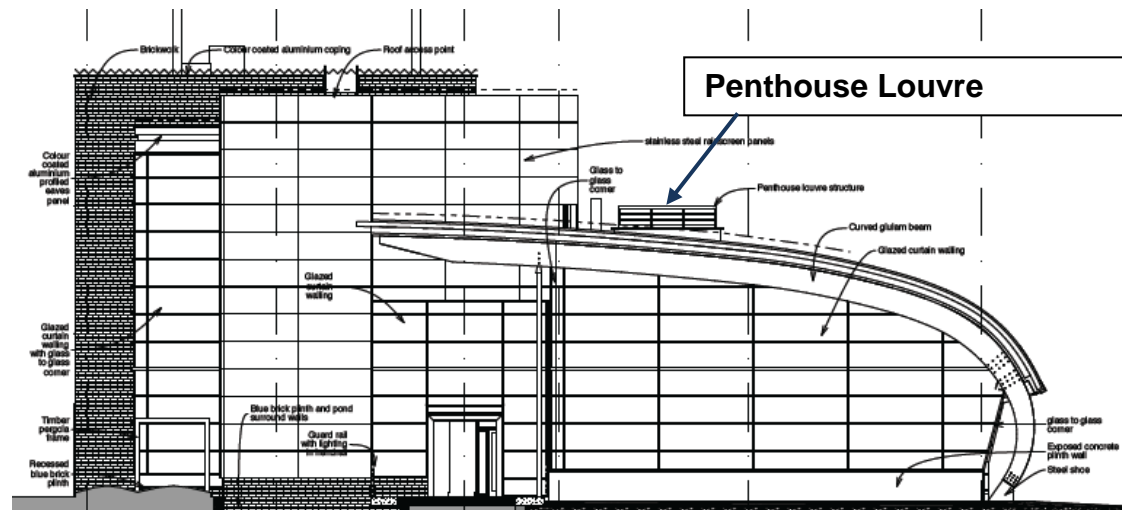
The penthouse louvre installation was a late design change which required an amendment to the planning approval. This came about due to inadequate ceiling void space to accommodate the mechanical services once full design specifications and layouts had been produced by the main contractor's mechanical subcontractor.

The Design and Build contract allows for the contractor and his team to complete the design post tender. It is the contractor's responsibility to appoint the M & E subcontractors at an early stage and co-ordinate and conclude the design. This did not happen on this project resulting in some co-ordination issues and additional design work.

To improve design co-ordination and timely completion of the M & E design, emphasise to the contractor the need to appoint subcontractors as soon as possible
