POST OCCUPANCY REVIEW REPORT
CENTRE FOR BIOMOLECULAR SCIENCES

Post Occupancy Evaluation of the Centre for Biomolecular Sciences For the University of Nottingham

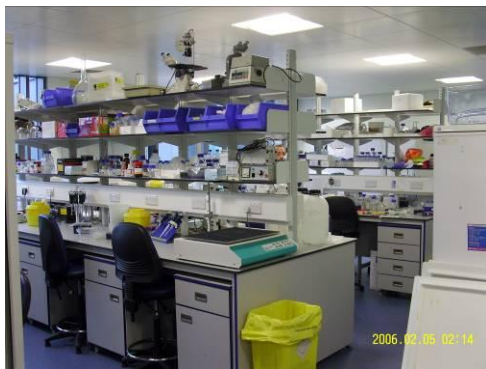
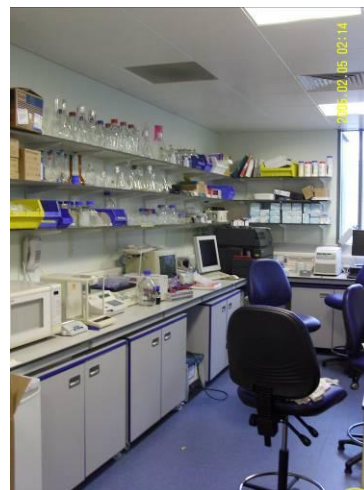
Comments from the user client have shown that they would have liked a more imaginative and innovative approach to the design of the laboratory spaces and that the architectural team might have benefitted by using a specialist laboratory designer.

It is not clear on what was specified in the original design brief but as the user groups were not known in the very early stages it may have been difficult to identify specific user requirements. A more modular approach to the laboratory design and construction might

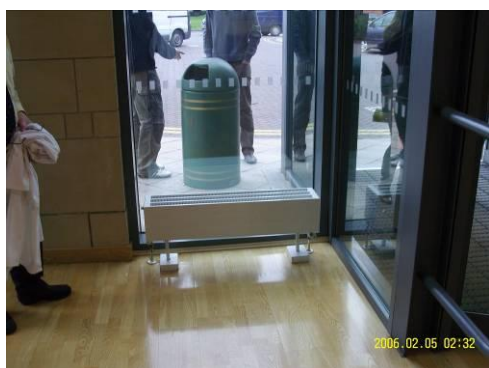
There have been comments that the temperature in the Atrium is below satisfactory comfort levels. Modifications had to be made to the reception counter shortly after handover as no screen had been provided and the receptionist had complained of being too cold due to draughts from the entrance doors.

There is no mechanical means of providing warm air to this large atrium space, the only means of heat being provided by small radiators. Using the space for ad hoc meetings may have been an afterthought but clearly the space has only been designed for background heating.

*Orientation and location of internal spaces should be carefully assessed in relation to solar gain on future building projects.
Consider providing larger LPHW radiators in the atrium area.*
