POST OCCUPANCY EVALUATION REPORT

ENGINEERING AND SCIENCE LEARNING CENTRE

JULY 2013

FINAL

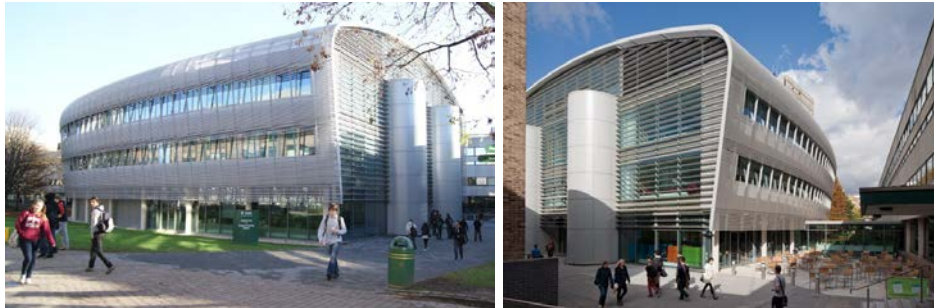
Externally, the building presents an interesting shape and design solution. An external curved screen of extruded aluminium horizontal tubes wraps itself on three sides around a basic rainscreen clad concrete framed structure punctuated with horizontal bands of glazing. The flat gable end facing the Pope Building is clad in horizontal aluminium louvres balanced by two vertical drum staircase elements also rainscreen clad.

The roof materials comprise a central double skinned ETFE roof with perimeter sloping areas finished in a single ply membrane.

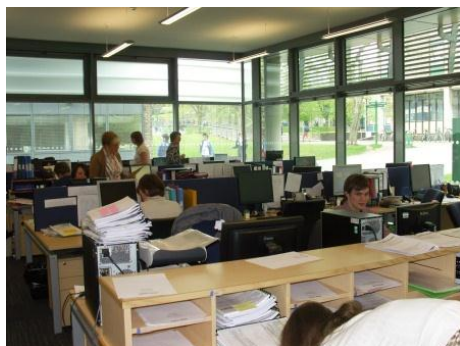
As shown earlier, the user satisfaction for this area is very low primarily due to the number of staff accommodated in the working area provided (21 staff originally, now increased to 24 by the Faculty of Engineering). A calculation of the floor area (excluding the reception counter area) shows that at 21 staff, this equates to 4.1m² per person which is around the minimum level of the University's space guidelines.

View of shared office space

It was suggested at the workshop that some form of screen might help between the office area and rear of the reception counter.

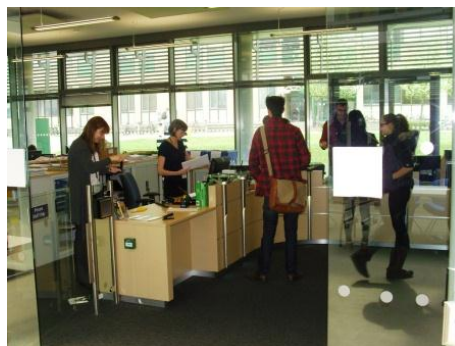
View of reception desk area

The layout of the reception counter has improved since its re-design but the main issue for the occupants is the working conditions.

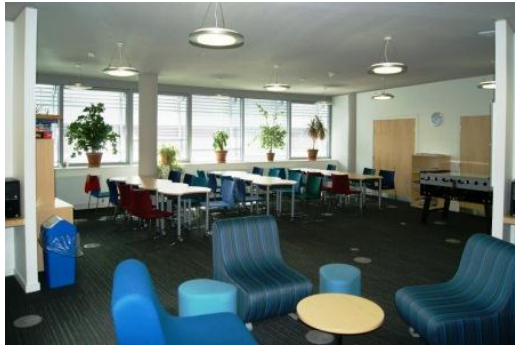
Despite some negative comments made by PG students, the Centre remains an excellent venue which is well used. It provides a positive experience for users and the Graduate Centre Manager is very satisfied with the facility.

Graduate Centre Social/Study space

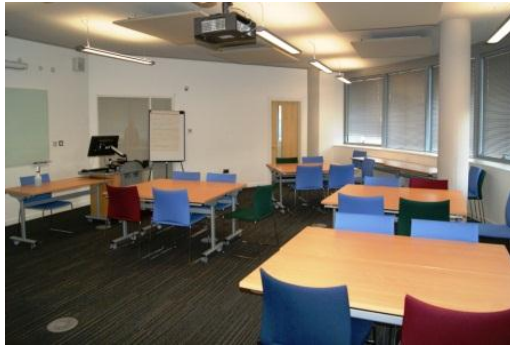
Graduate Centre Seminar Room

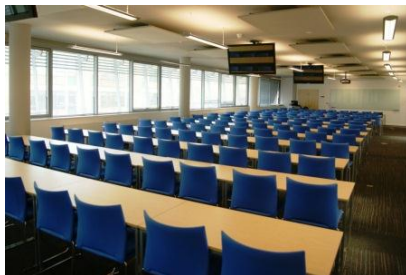
Seminar Room C01

A large capacity seminar room such as C01 is a much needed facility of this size. However comments have been made concerning the proportion of this room which makes it appear to have a low ceiling and requires repeater screens due to its length.

The disadvantages of this room shape for formal seminar use was raised at design stage but PMG agreed to retain this space on the basis that it would also be used for informal layouts and studio type working. It is understood that plans have now been drawn up to subdivide this space.

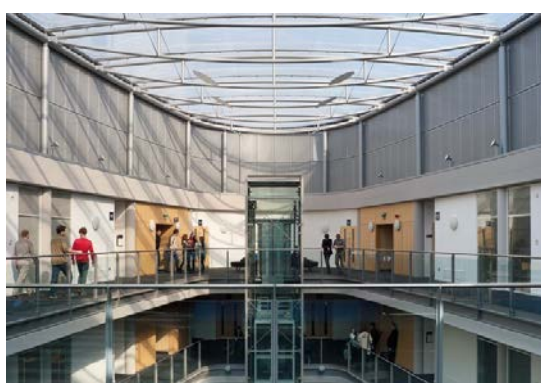
The central roof covering to the atrium is formed from a double skinned inflatable structure of ETFE material. It provides a cost effective lightweight structure and allows a high level of natural light into this central area.

Some comments have been made that noise is generated from this roof in heavy rain. This has only recently been raised by the Engineering Office and the Conference Office, who are the main users of this space, who have not raised this as an issue. However the manufacturers offer an option of a mesh covering which reduces the noise level. This may be something to consider if the noise becomes unacceptable and budgets allow.

At the workshop there were comments from the maintenance team regarding the structural integrity of the roof should it deflate for any reason. It was confirmed that a standby generator has been provided and the systems/pumps are monitored through the Building Management System.
