POST OCCUPANCY EVALUATION REPORT

HUMANITIES BUILDING

MAY 2013

FINAL Rev 1

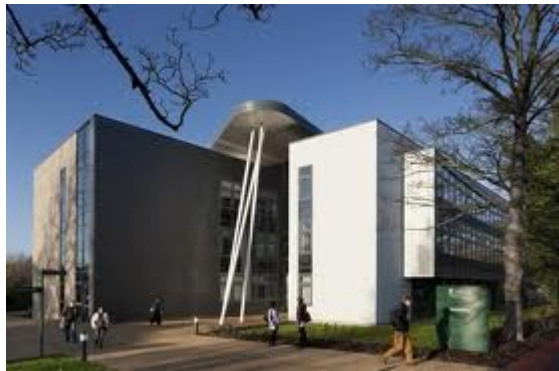
The two main elements of the building

The building plan form consists of two elements. The south facing element contains the smaller cellular offices over three storeys. The north facing element contains the larger teaching and specialist areas on the ground floor and open plan PGR space and some cellular offices on the upper two floors.

These two elements are separated by a three storey atrium (forum) space creating a focal point for the building and a direct entrance from the external landscaped area. A wealth of natural light is brought into the building via the atrium space.

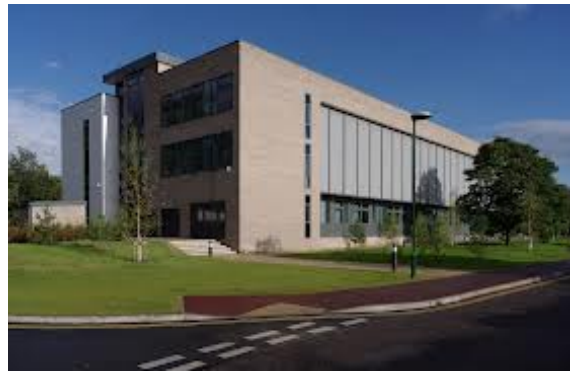
Elevation facing Cavendish Hall

A simple palette of materials has been used for the two elements with pre-patinated zinc standing seam cladding, light coloured rendered panels and glazed curtain wall system to the elevation facing Beeston Lane. The elevation facing Cavendish Hall consists of buff facing brickwork which frames the glazed curtain walling set back behind solar shading panels.

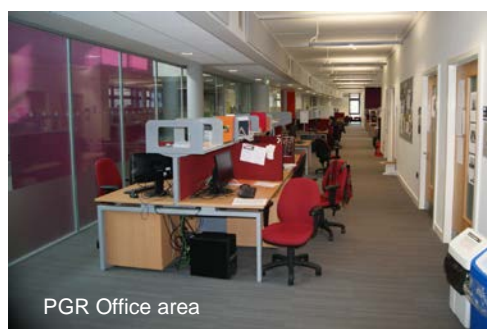
The feedback from the satisfaction survey shows that over 40% rated this space as poor or very poor. Criticisms focus on the space being more of a "corridor" rather than an area for quiet study. Cross circulation is caused by the location of academic offices on the far side of the PGR space and notices on the entrance doors to the space have been posted to deter use by UG students. The photocopy area is also included in this space.

The design of this space has not fully worked and on future projects where PGR space is required, the Design Team should work with users to understand individual requirements on the basis that different Schools'/Faculties' PGR's have diverse needs.

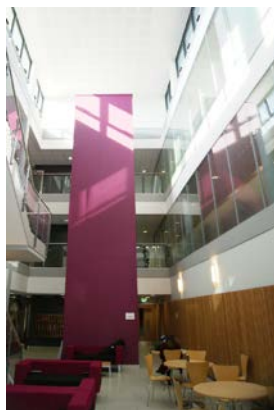
Atrium space

A main feature of the building's design was the central atrium. This space was felt by all to work well as a focal point, providing a naturally lit three storey space incorporating social areas, private study and access to offices.

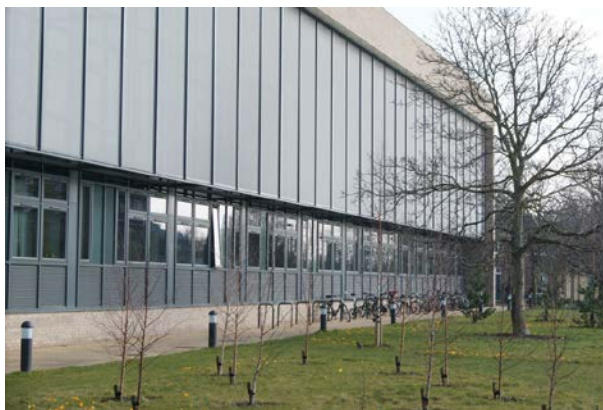
Solar shading to southwest elevation

In order to reduce solar gain and glare on the southwest side of the building, this elevation is shielded by a mesh screen. Although this screen works as intended, occupants of the offices have complained that their rooms are dark and at times have to be supplemented by artificial light. It is understood that a number of materials were considered and samples presented to PMG for comment.

Discussion at the workshop resolved that the density of weave may have been too great and a wider, more open weave might have been more appropriate. This needs to be borne in mind on future projects whilst taking account of BREEAM thermal requirements.
