## **POST OCCUPANCY REVIEW REPORT**

### **JUBILEE CAMPUS SPORTS CENTRE**

**JUNE 2009**

# Post Occupancy Evaluation of the Jubilee Campus Sports Centre for the University of Nottingham

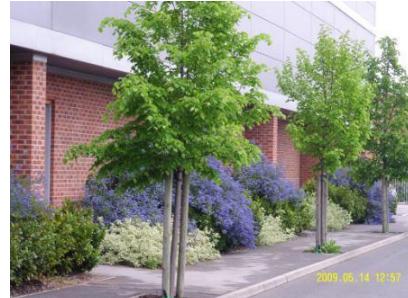
The building itself sits back from the main road fronted by a car park. The building is tight on the northern boundary but on the south side the opportunity has been taken to introduce some attractive landscaping.

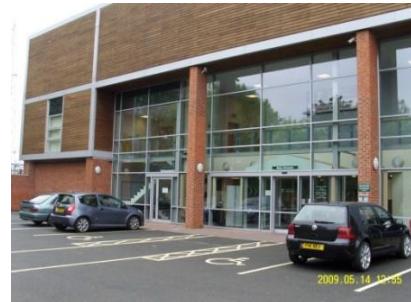
The building stands 11.9m high [with a shallow pitched roof](#) and comprises Ibstock Westbrick red facing brickwork to the ground floor up to 3.3m. Exposed brick piers help to model the elevations at this height and allow flush walls internally to the Sports Hall. At first floor level and above the building is clad with grey Kingspan aluminium cladding panels with stained western red cedar boarding to the main entrance elevation. Two brick piers frame the recessed aluminium curtain walling to this elevation.

There are also two windows on this elevation giving natural light to the first floor office and one of the practice rooms.

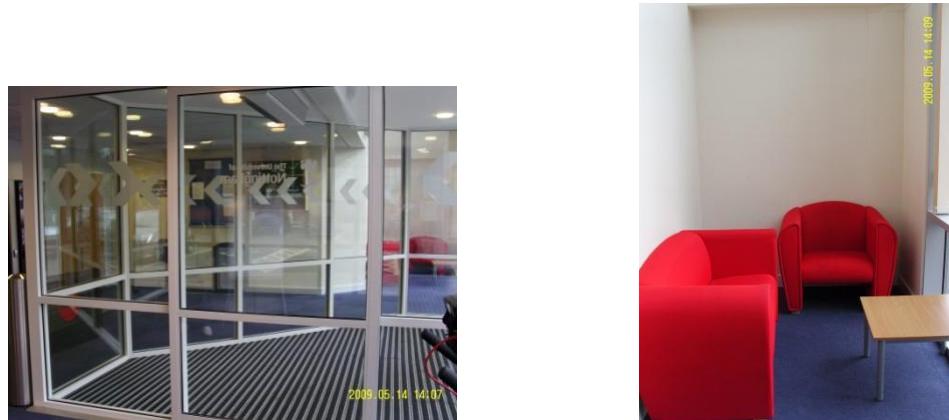
The roof to the draught lobby as viewed from the first floor makes this element appear as an afterthought. The draught lobby provides ample manoeuvring space but has created cross circulation at the reception desk and areas of unusable space.

Although there is a staircase at the main entrance which is visible externally it is not the main staircase for users to access the first floor. This is via a second staircase approached by a circuitous route from the reception area.

*Circulation routes should be clearly defined and access routes to the reception point and beyond should be logical and avoid cross circulation.*

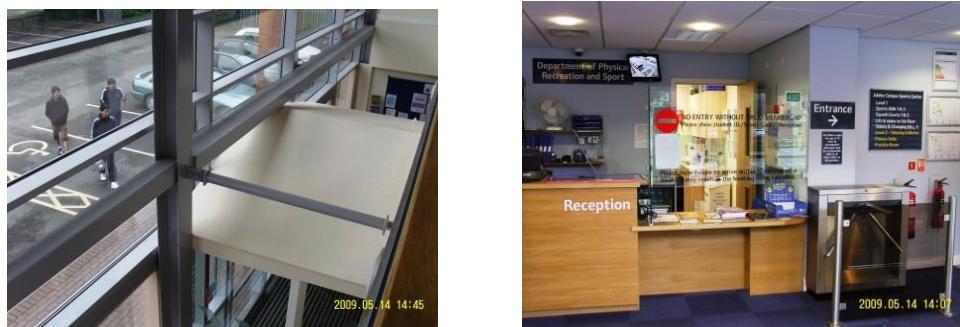
A balcony at first floor level looks down through a narrow void onto the roof of the draught lobby. It is not clear why this balcony has been set back from the curtain wall glazing since there is no apparent benefit in doing so.

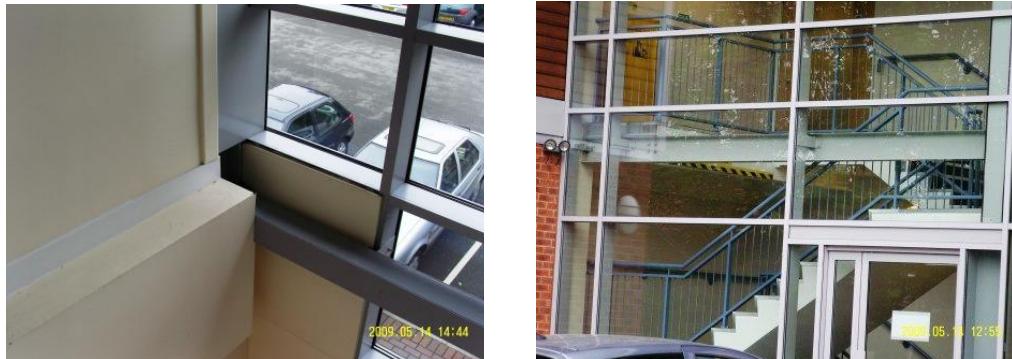
There is evidence of lack of attention to detail in the building design particularly at certain junctions of steelwork/wall panels and the misalignment of the horizontal steel beam with the entrance curtain wall glazing transome is unfortunate.

*Architects appointed should be mindful of the need for attention to detail during the design process and ensure there is adequate co-ordination of design and construction elements e.g. steelwork*

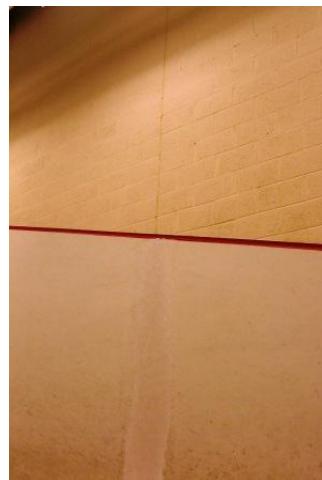
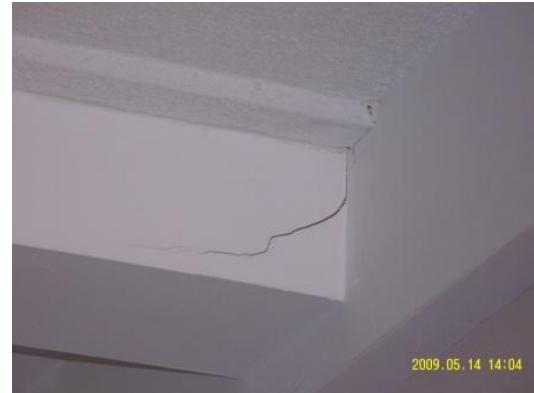
The blockwork side walls to the squash courts have a vertical expansion joint running the full height of the plastered wall. This results in cracks appearing in the plaster finish due to movement along the expansion joint which have required remedial work.

There was evidence of cracking due to some settlement/shrinkage shortly after handover of the building. Remedial work was carried out including redecoration. It was observed during a recent tour of the building that movement is still occurring with evidence of cracks in masonry and plaster in a number of areas.

*The settlement/shrinkage cracks should be investigated further and regular monitoring carried out. Further remedial work is necessary.*

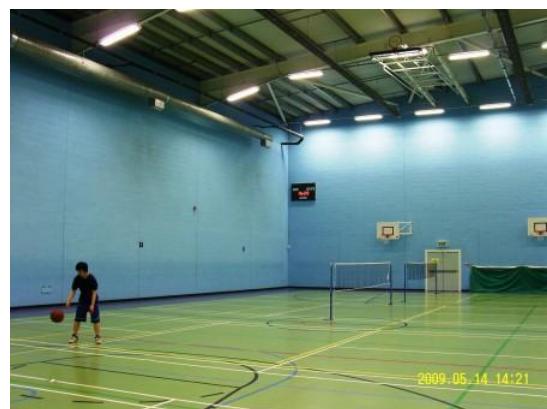
Problems have occurred with the level of noise generated by the ventilation plant serving the Sports Hall which has caused some distraction to sports users. Also the design of ventilation fans down one side of the sports hall has caused some difficulties for county and national badminton standards.

*On future projects consideration needs to be given at the design stage to the maintenance of mechanical services and their impact on the building operations.*

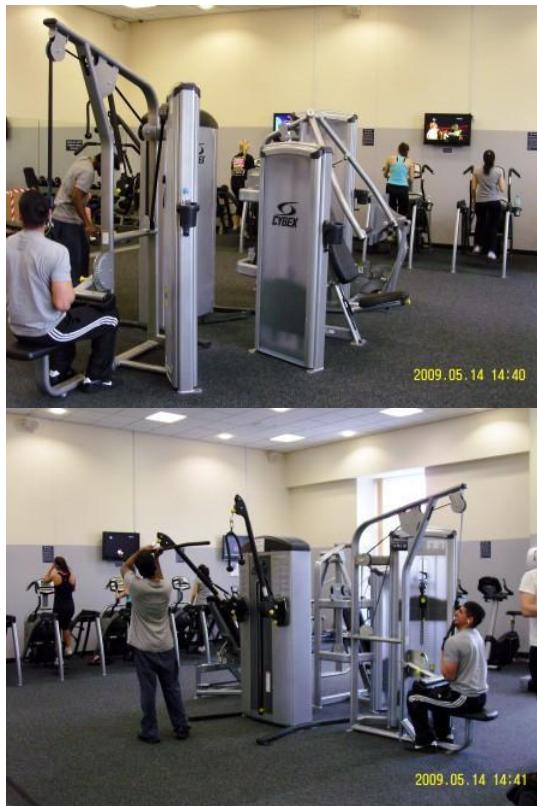
The original brief did not incorporate a fitness suite **since-as this facility was to be provided elsewhere on the campus (which has not yet materialised)**. This has now been addressed by the Sports Centre management and one of the practice rooms has been converted for this purpose. This was done in September 2008 and incorporates over 30 items of training and fitness equipment.
