POST OCCUPANCY EVALUATION REPORT

NOTTINGHAM GEOSPATIAL BUILDING

MARCH 2012

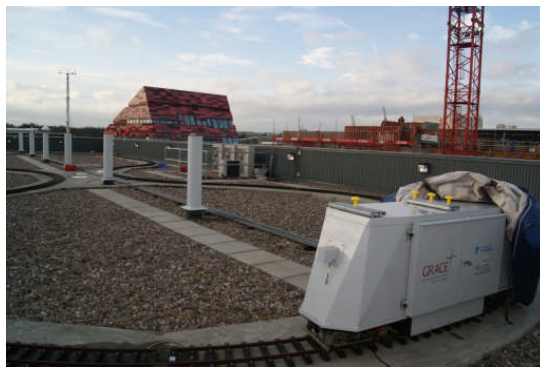
Test Track area on roof

A track was designed as a permanent facility on which testing could take place. A series of pillars or 'monuments' were also incorporated to act as receivers and were built from foundation level through the building to terminate at roof level. It is understood the pillars work very well as part of the Institute's research activities. The clear view of the sky was a fundamental requirement and this was achieved although the reflective properties of the insulation to the roof mounted ventilation ductwork caused some initial problems.

- i) On future projects consideration should be given to whether kitchen facilities should be provided in a separate room in order to maximise flexibility of space*
- ii) Where possible, details of specialist installations should be set out at an earlier stage as possible*

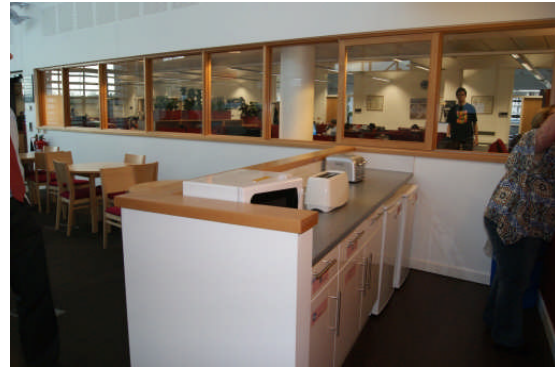
Due to increased occupation (Horizon moved in following completion of the building), the staff room is now used as a seminar/meeting room. Consequently, the beverage point off the first floor landing has been extended behind a dado height fixed partition. This has reduced the amount of seating space at this level.

Extended kitchen area

On future projects where staff rooms are provided as part of University policy, consideration should be given to whether kitchen facilities should be provided in a separate room in order to maximise flexibility of space.

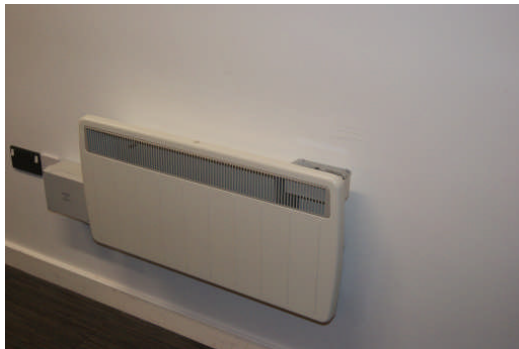
A number of building users commented that the building is cold in winter and has never been completely effective. Reference has been made to the fourteen electric convector heaters which were fitted later to some of the rooms. It is acknowledged when calculating the heat loads, Termodeck made an error in not including heat losses through the end glazed walls. The Services Engineer challenged these calculations at the time and the additional heaters were intended to solve the problem.

In addition, an imbalance in the heating system caused low temperatures in the cellular offices on the north side of the building. It was reported at the workshop that meetings with Termodeck have recently taken place to resolve the low temperatures. Adjustments now need to be monitored to ensure these adjustments/balancing have been effective

Wall mounted convector heaters

- i) Commissioning procedures should be improved to simulate winter heating conditions where possible. It is noted that this is now required under the revised BREEAM assessment criteria*
- ii) Where Termodeck systems are used there should be improved co-ordination with the main contractor's mechanical subcontractor*
- iii) Improved checks should be introduced to ensure heat loss calculations are validated*

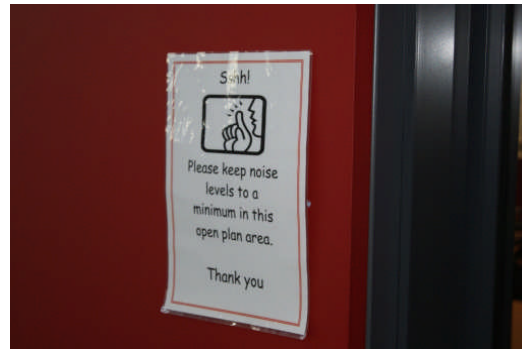
Notice regarding noise levels

The results of the satisfaction survey showed a relatively low score for noise disturbance. Comments were predominantly from those staff occupying the open plan areas who complained that noise from activities in the atrium filter into their workspace. In fact signs have been posted at first floor landing level requesting that noise levels are kept to a minimum in this area.

Measures have been taken post occupation to lessen the noise impact by introducing fixed glazed screens to part of the open side of the first floor office space and carpeting the first floor landing around the kitchen and seating area.

However noise is still regarded as a problem and consideration could be given to introducing some form of acoustic treatment such as acoustic panels within the atrium.
