POST OCCUPANCY EVALUATION REPORT
SUTTON BONINGTON SPORTS CENTRE

MAY 2010

Post Occupancy Evaluation: Sutton Bonington Sports Centre For the University of Nottingham

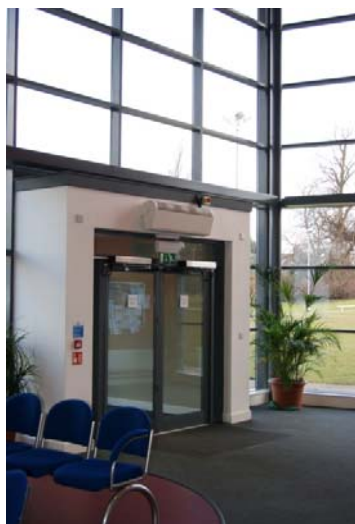
Entrance Foyer

The entrance is spacious and attractive which gives a good first impression when approaching the reception desk. This theme is followed through into the circulation areas which are generous and there is a clear and logical layout of the facilities and their approach.

Continue to monitor the main entrance foyer for further water ingress and take remedial action if this re occurs.

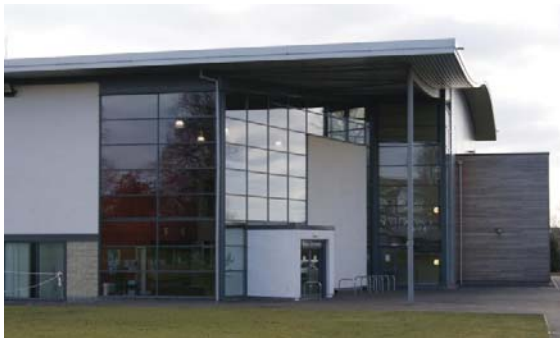
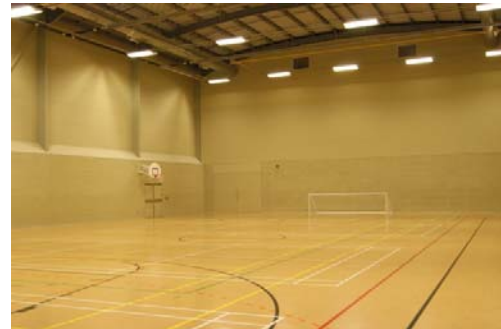
The external appearance of the building emphasises the main entrance through use of extensive full height glazing beneath a projecting main roof canopy. Materials used for the other elevations are a mix of rendered and stained cedar timber panels, face blockwork and colour coated metal cladding. Mill finished aluminium is used for the curved roof.

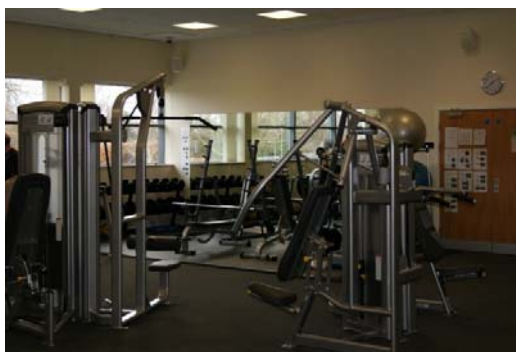
The reception area had the highest level of satisfaction with 73% of respondents rating this area as excellent. The Fitness Room also had a good level of satisfaction with the average score being good to excellent. Generally the lower scores for this room reflected some user comments relating to the lack of air conditioning within the room and no opening windows; 13% of respondents commented on this.

Mechanical ventilation is provided to the Fitness Room and Dance Studio but no cooling. As a result, portable fans are used to improve environmental conditions at certain times of the year.

Consider installation of cooling at least to the fitness room at some future date

Consider installing cooling to the fitness room and dance studio at some future date.

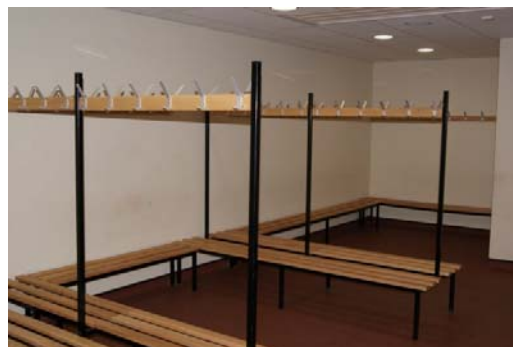
Changing Rooms

The area where least satisfaction occurred was in the changing rooms. The University has adopted a policy of no locker provision, even for valuables, but 37% of respondents made reference for the need for lockers within the changing rooms.

The paint finish to the internal walls is a standard emulsion which cannot withstand any washing or cleaning down. A more durable eggshell paint finish would have been more appropriate in some areas particularly the changing rooms.

The user client has commented that drain smells have been detected in the changing rooms. It has been confirmed that there are no problems with the drainage installation and the cause is probably due to some of the drainage traps drying out. Regular checks need to be made to ensure the traps are full and location of floor drains should be carefully considered on future projects.

Consider installation of lockers in the changing rooms at some future date

Ensure internal wall finishes are carefully selected and can be cleaned and washed down where appropriate.

Location of floor drains should be designed to eliminate drying out of traps to gullies where possible.
