# Materials and Trackbed Design for Heavy Haul Freight Routes : Case Study

By Dr Matthew Brough

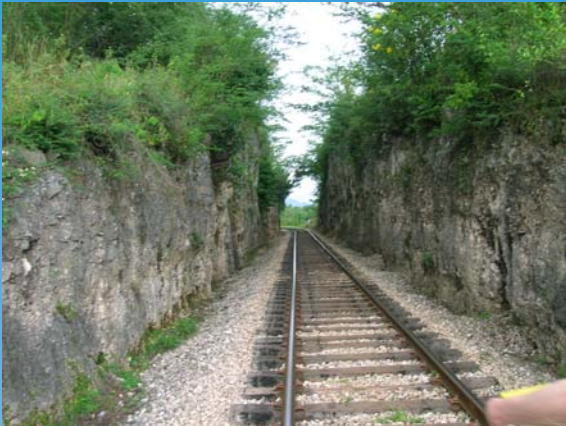
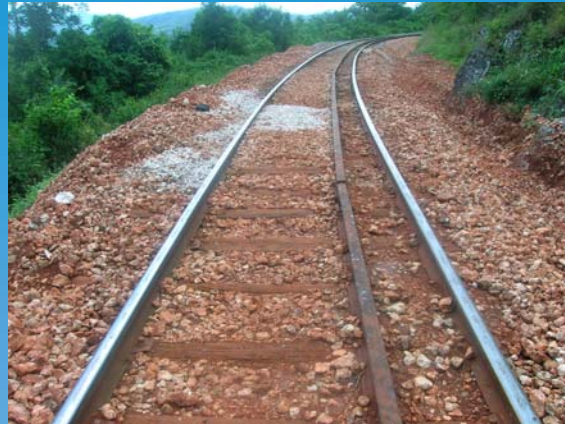
- Topography – Rock cutting, steep embankments and sidelong ground

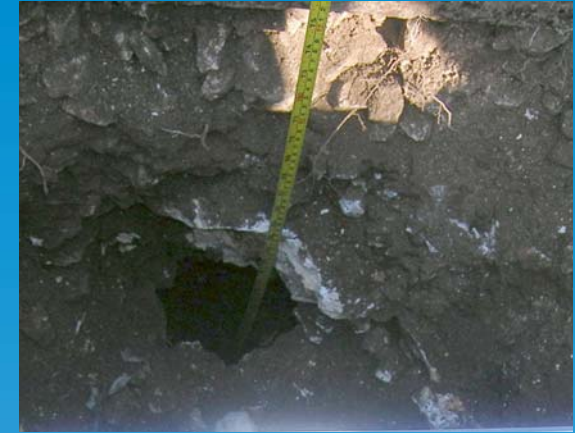
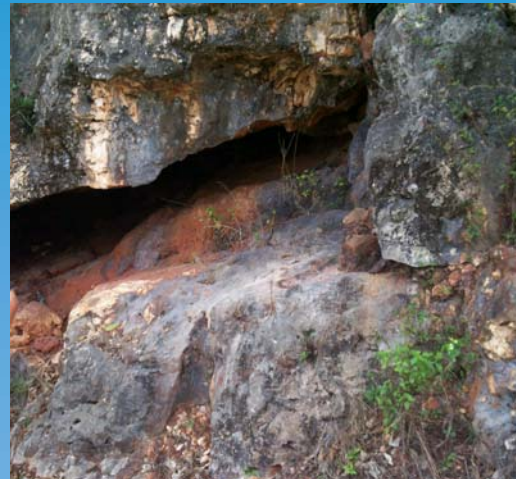
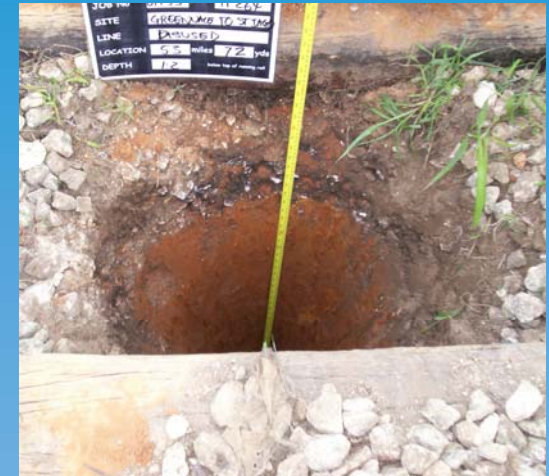
- Newport Limestone Formation
- Highly voided due to chemical dissolution (Karstification)
- Variable bedrock profile with characteristic Sinkholes, subterranean caves, open joints and solution cavities

- Terra Rossa Soils
- Extremely high plasticity red/brown gravelly clay (PI > 70)
- Occurs as an incomplete and variable soil cover and as solution cavity infilling within the limestone

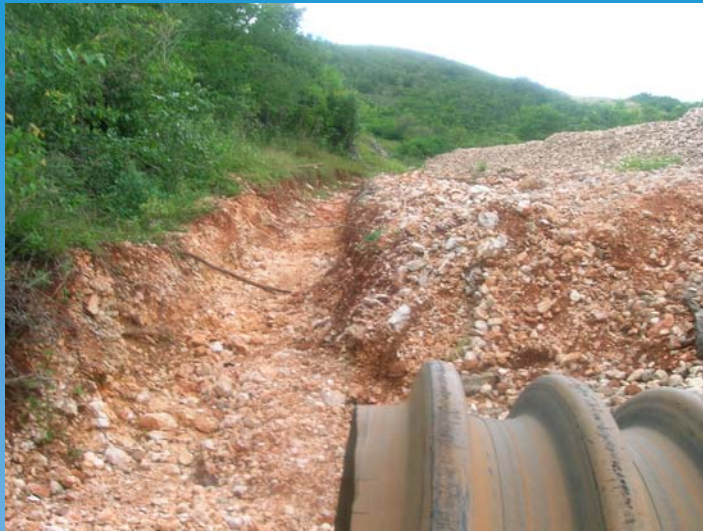
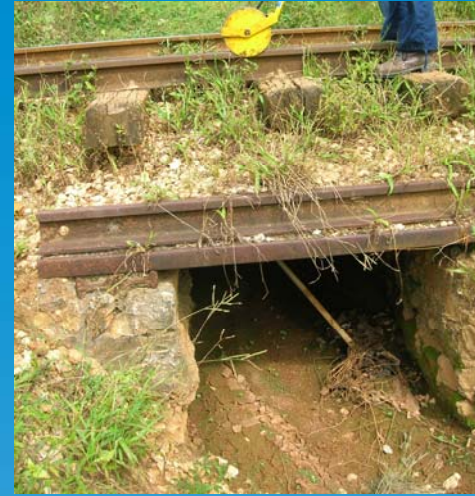
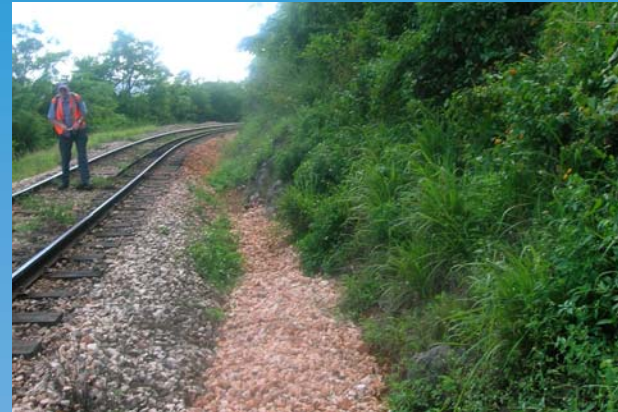
- Drainage generally absent or inadequate where present comprising cess trenches and undertrack box culverts

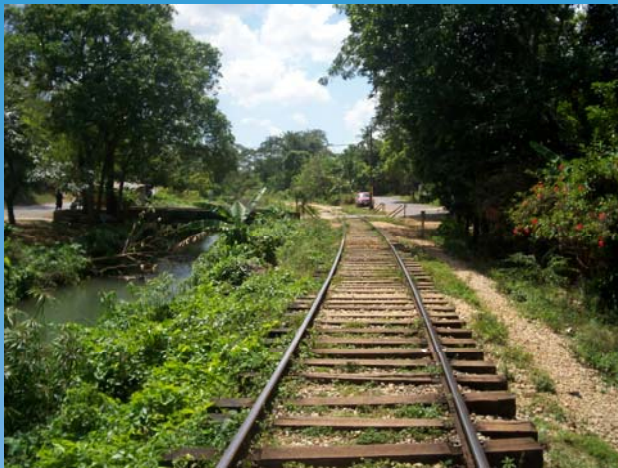
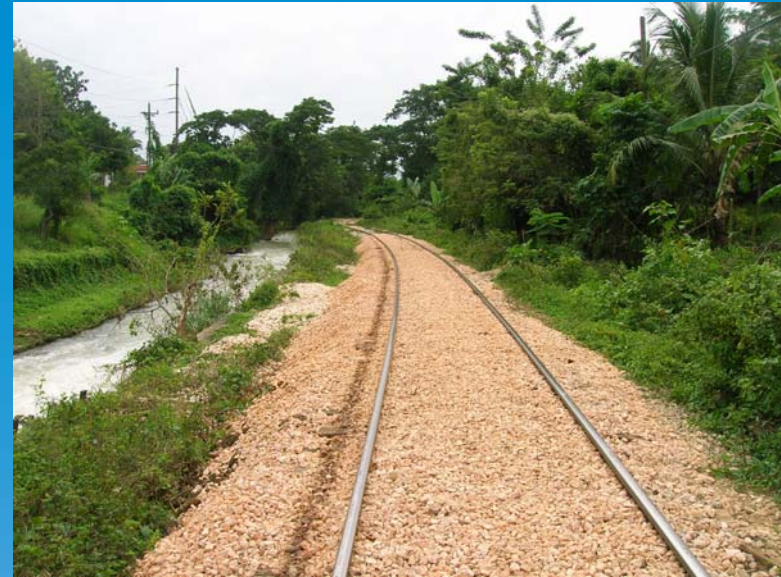
- Major flooding events and significant washout of ballast affect the area of track in the river valley on an annual basis.

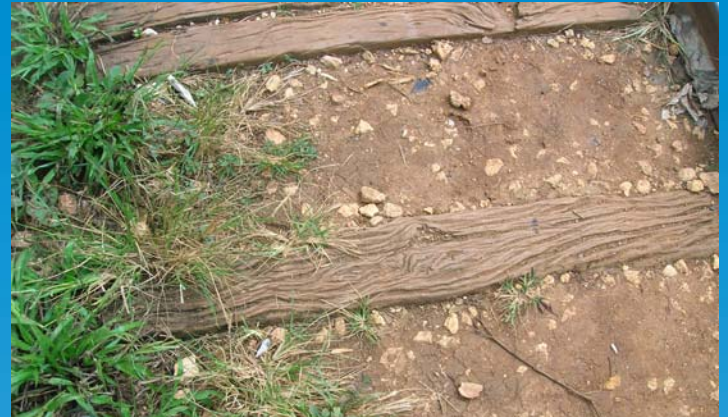
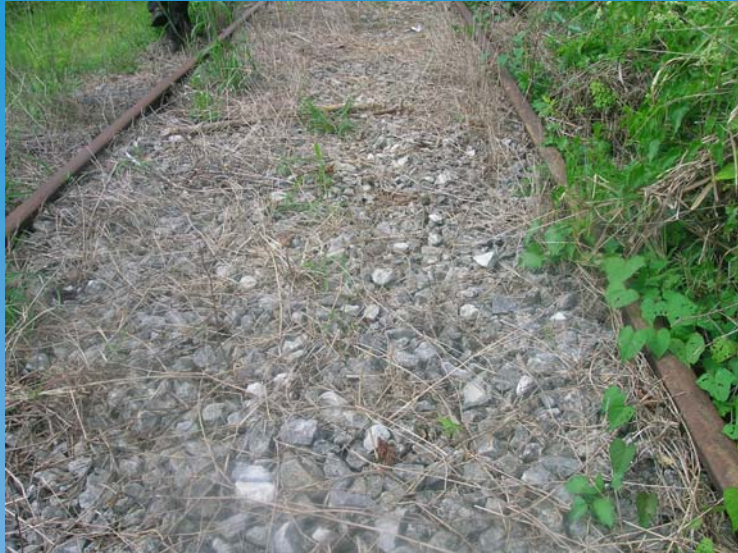
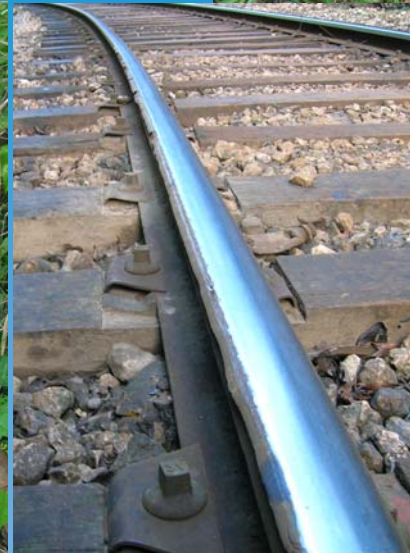
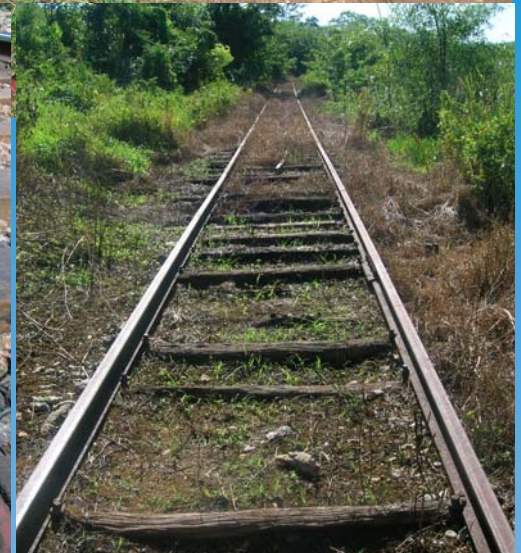
- The majority of the trackbed and components are at the end of their design life

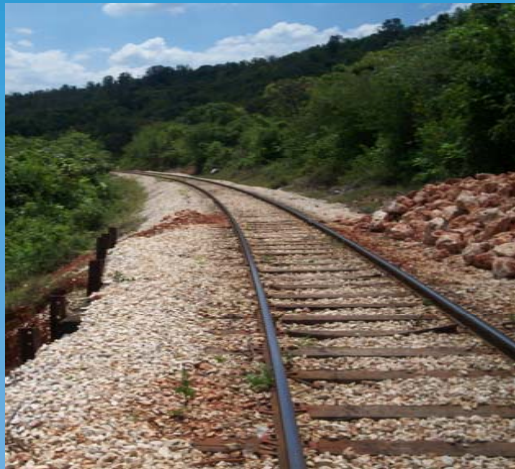
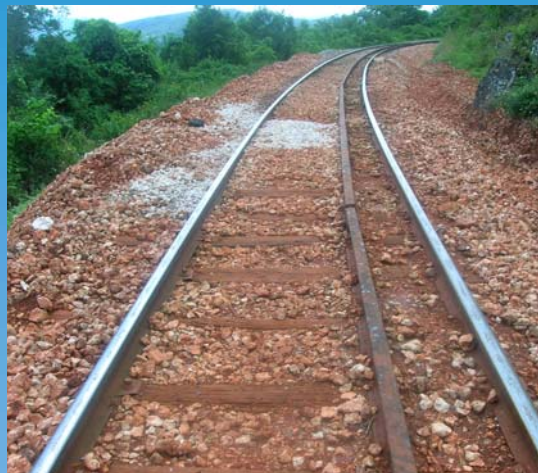
- Maintenance and spot renewal occur on a reactive rather than a proactive basis, generally at the end of the wet season where washouts occur.

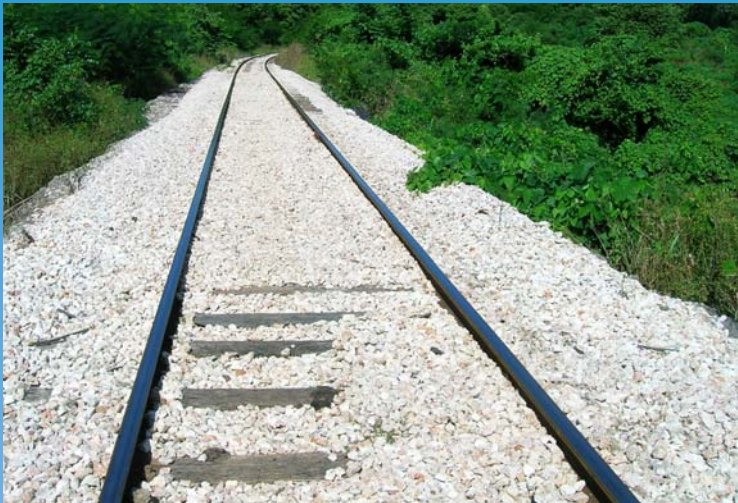
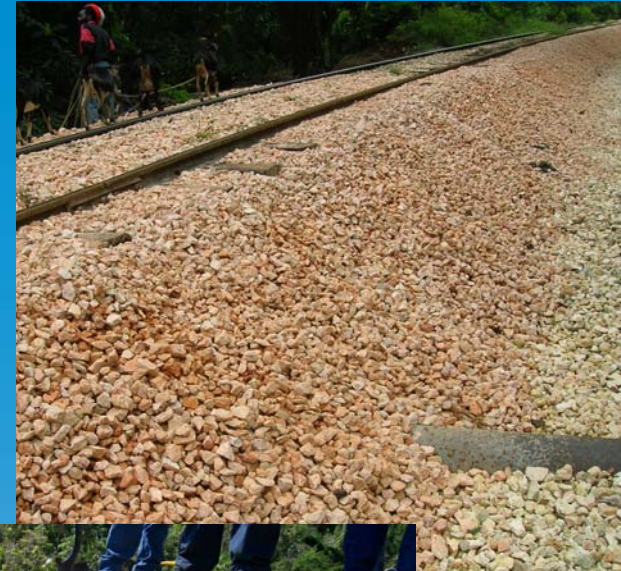
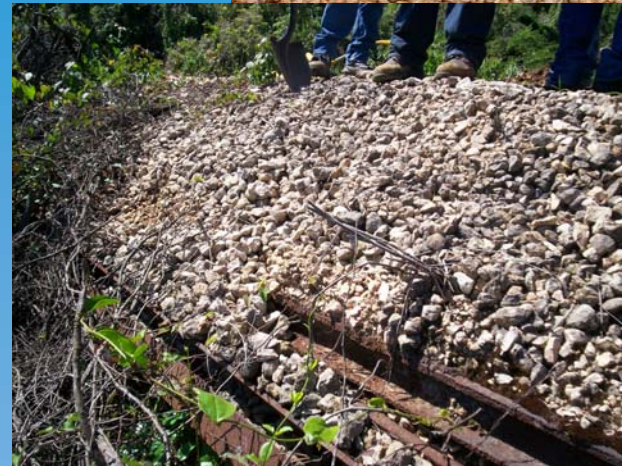
- Reballasting and 'topping up' ballast levels where problems occur has resulted in significant raising of the track and excessive ballast depth.
