Ensuring the quality of components produced by  
metal additive manufacturing using laser  
generated ultrasound

Thesis submitted to University of Nottingham  
for the degree of Doctor of Engineering

October 2017

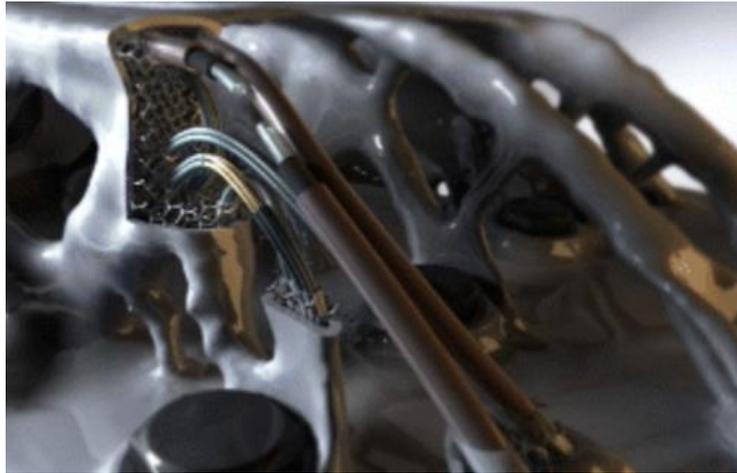
Figure 2-6 - Example of lattice structures utilised for lightweight component design [53].

Additionally, engine performance could be improved further by utilising lattice structures to save weight (Figure 2-6). Softwares are being developed to biomimetically optimise components based on their strength requirements during operation. An added benefit of designing lattice structures is the cost savings made by reducing material waste.

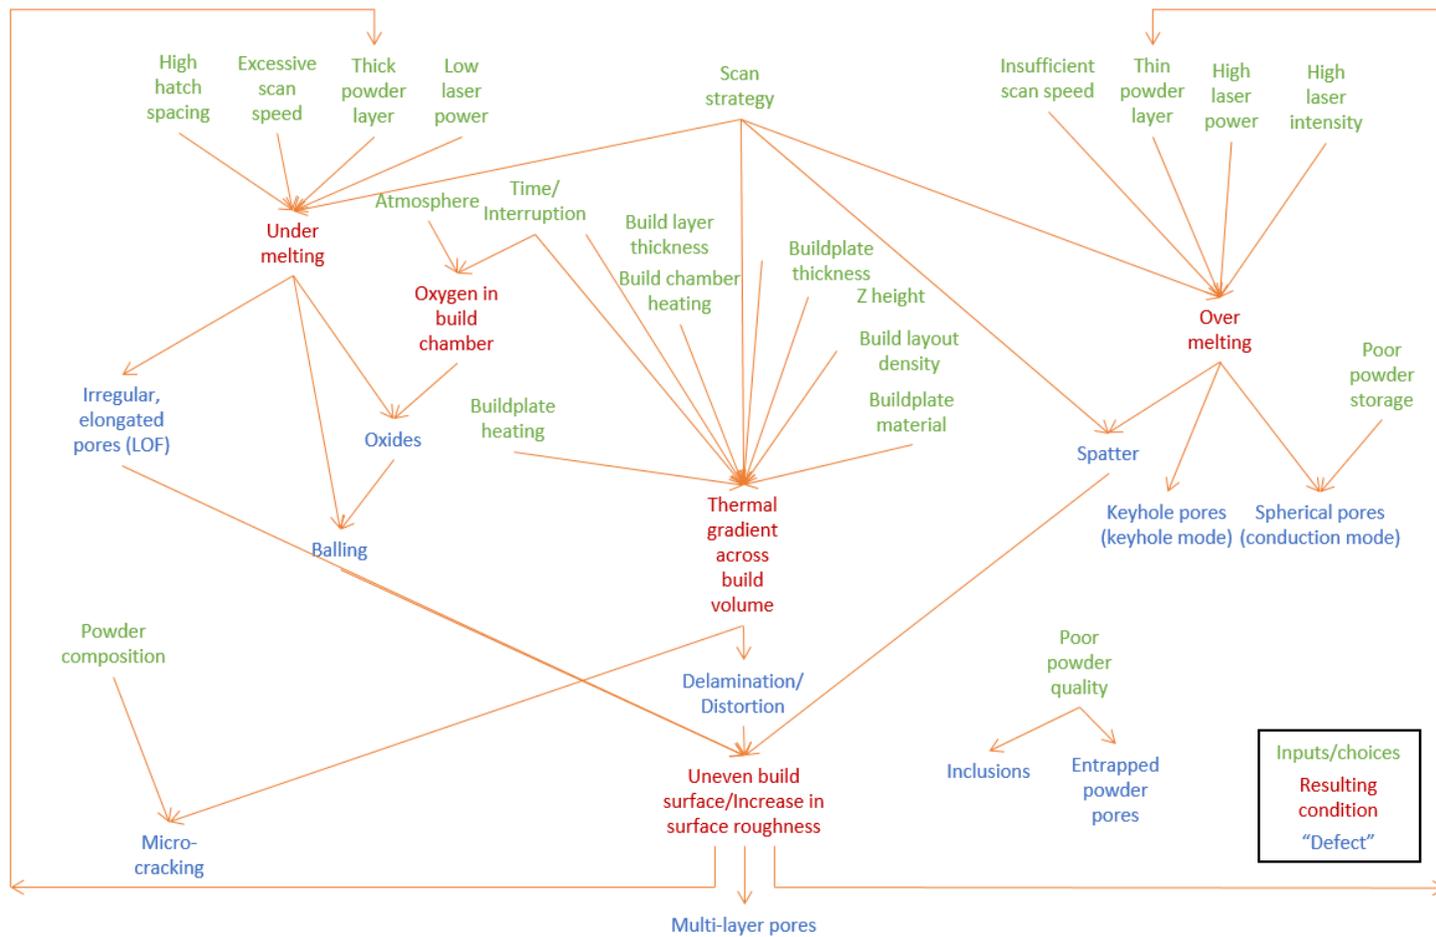
Figure 2-7- Flowchart showing laser PBF inputs (green), processing conditions (red) and resulting "defects" (blue).

The flowchart displayed in Figure 2-7 summarises the links found in literature between inputs that have been selected incorrectly or errors made when setting up a build (green), the ensuing processing condition (red) and the material discontinuity which results (blue). The orange arrows are used where a link has been found. Importantly, the generation of one “defect” type can result in a processing condition which generates a second and so on.

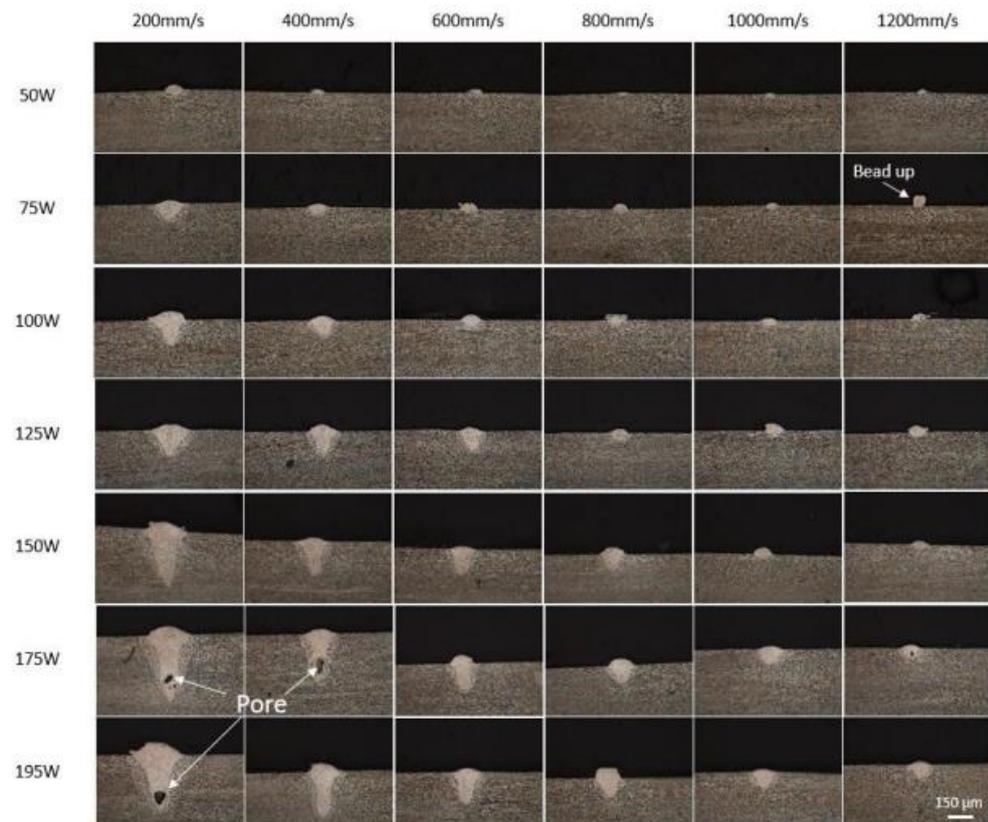
Figure 2-10 - Cross-sections showing series of melt pool depths with transition from conduction to keyhole mode melting [12].

melt pool cross sections for the transition from over-melting conditions (bottom left) to under-melting (top right) [12]. The transition from “conduction” to “keyhole” mode melting for an alloy can be expressed in terms of a normalised enthalpy, but is dependent on the powder thickness and powder size distribution [13].

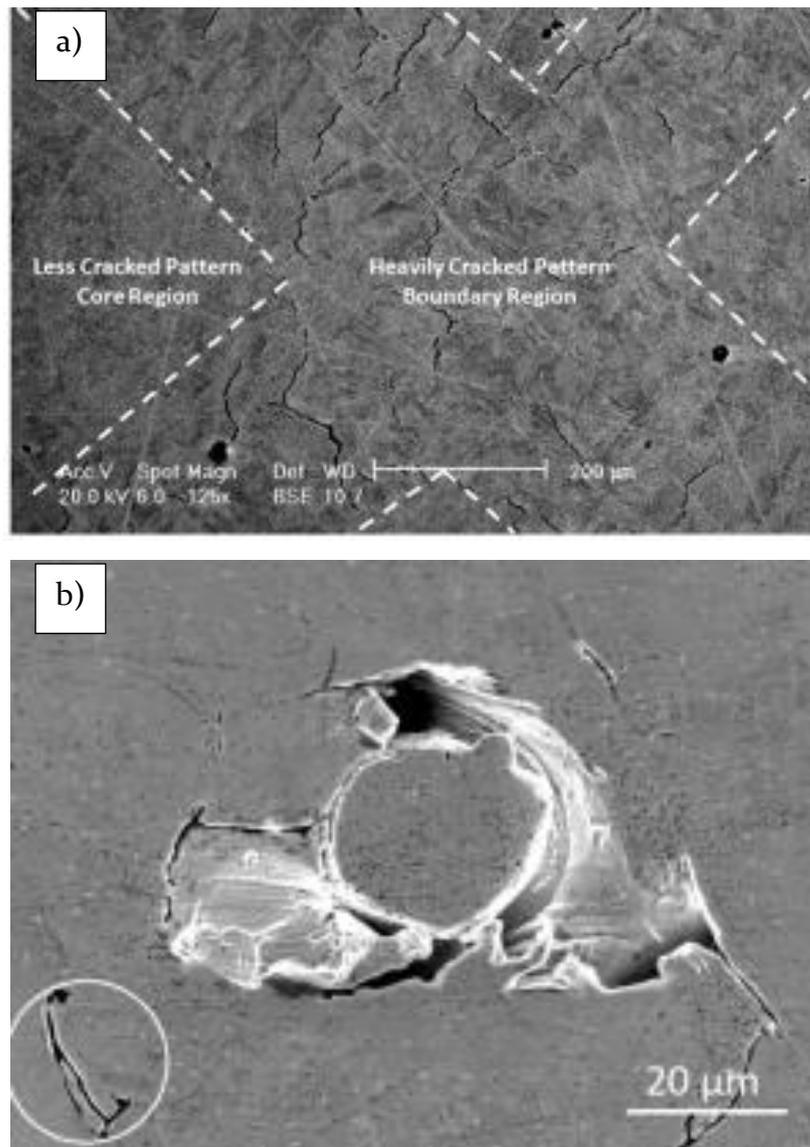
Figure 2-19 – a) SEM micrograph of x-y plane showing micro-cracking in a CM247LC sample at high-angle grain boundary [75] and b) thermally induced micro-cracking caused by processing under high thermal gradients with high laser power and scan speed [77].

Micro-cracks are not always detectable by conventional non-destructive testing methods, but can be detrimental to a components material properties, if present. As laser PBF processing and welding are inherently similar processes, common cracking mechanisms occurring in welding are also found in laser PBF samples. The term “weld cracking” is used to describe a number of mechanisms which occur during processing, such as solidification cracking, liquidation cracking, ductility-dip cracking (DDC) and also strain-age cracking (SAC), which can arise during post-process heat treatments [74]. At high laser powers, solidification cracking dominates and at low powers, liquidation or grain-boundary cracking dominates [74]. Alloys with a high gamma prime ( $\gamma'$ ) content are particularly susceptible to weld cracking and thus are also more difficult to process by laser PBF (Figure 2-19a) [75]. The material ductility reduces at intermediate temperatures and under residual stress, the ductility dip cracking mechanism forms grain boundary cracks [76].

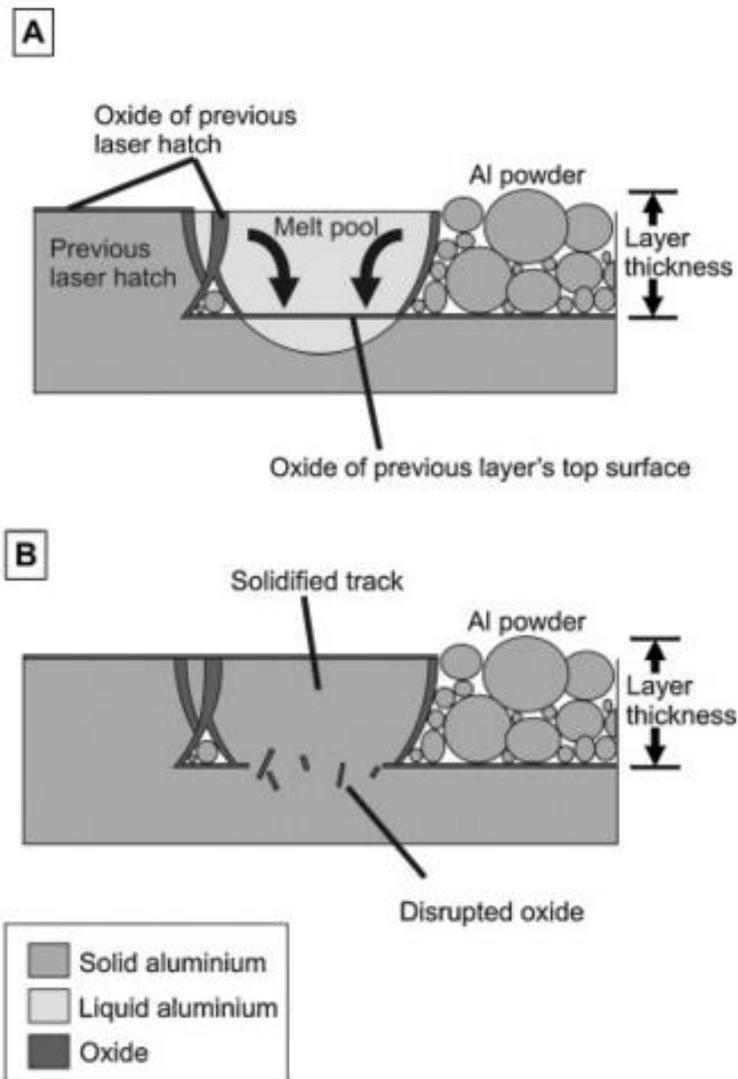
Figure 2-20 - Schematic showing oxide layer disruption at base and presence at side wall locations [80].

The power of the laser must be high enough to break through the oxide layer formed on the top surface of the solidified melt pool. The oxide layer at the “side” of each track remains undisturbed and is present within the final component, impacting component quality. It is also worth noting that this mechanism can trap unmelted powder particles between tracks (Figure 2-20).

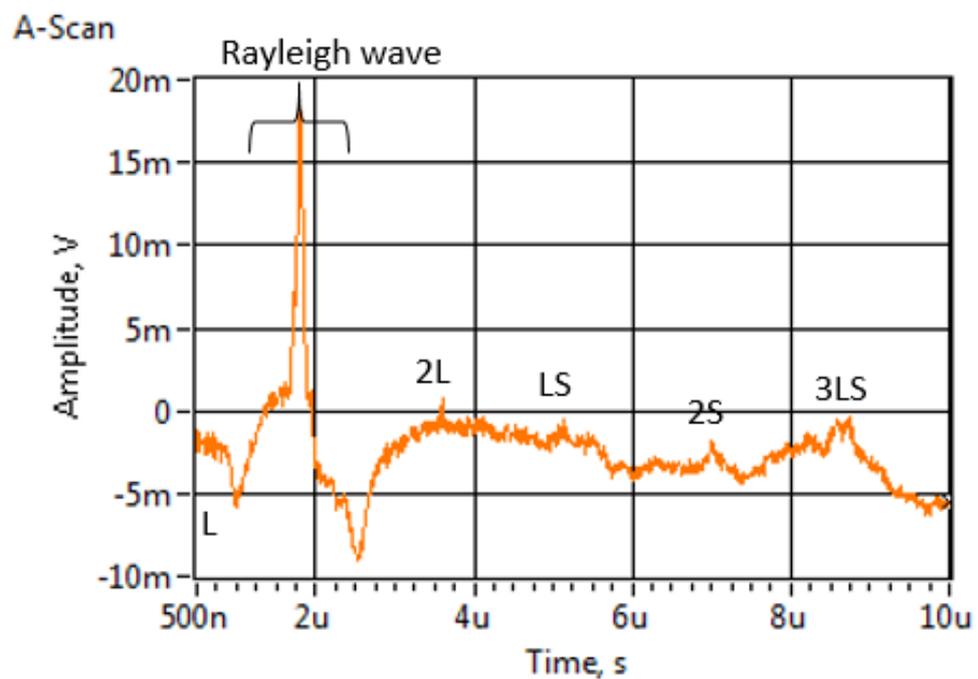
Figure 3-6 - Example A-scan indicating arrival of direct, reflected and mode-converted waves.

If the amplitude response ( $y$ -axis) at the detector is recorded as a function of time ( $x$ -axis), then an A-scan is generated for that location. An example is shown in Figure 3-6; labelling indicates the different wave type arrivals. Any material discontinuities can be identified by comparing the signal amplitude with a scan from an area with no known “defects”. The position of a material discontinuity can be estimated using the diffracted and reflected signals from the initial pulse and the reflections.

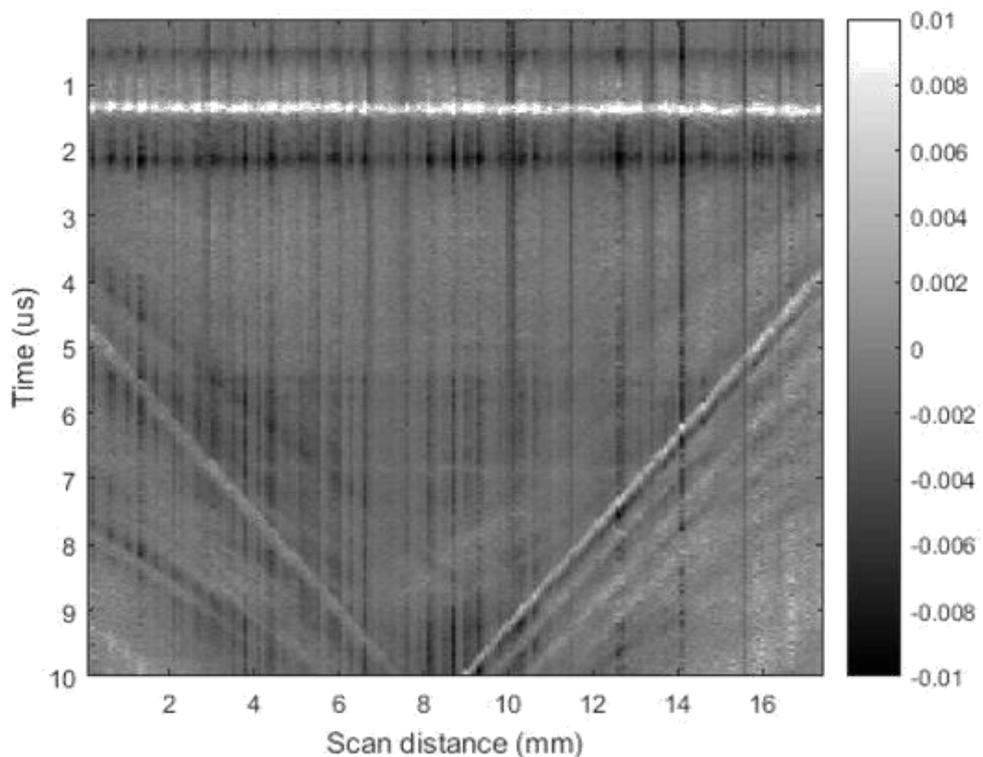
Figure 3-7 - Example B-scan.

A B-scan is a collection of A-scans which have been effectively stacked up; the x-axis of the A-scan becomes the y-axis on the B-scan and the y-axis of the A-scan then becomes the z-axis on the B-scan. It displays a profile view of the test specimen typically utilising travel time (x- axis) vs. linear position of the receiver (y- axis) [120]. A colour represents the amplitude of the returned signal, equivalent to the y-axis on an A-scan. An example B-scan is shown in Figure 3-7. The diagonal lines that can be seen are reflections from the end walls of the sample, as the laser unit moves farther from one end, the time for the wave to travel to the detection point increases. Similarly, the laser unit moves towards the other end of the sample and the wave travel time decreases.

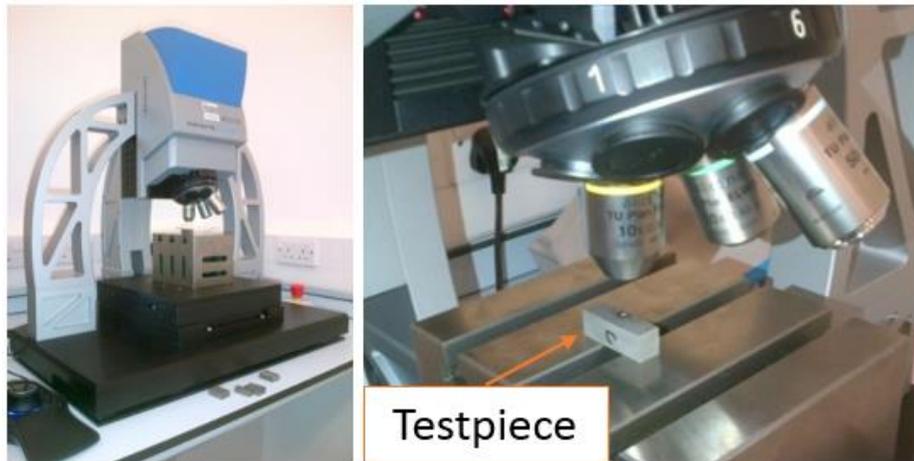
The EDM hole diameters and z-distances have been validated using an Alicona InfiniteFocus, optical 3D micro coordinate system shown in Figure 4-6. A 10x magnified scan was taken over the area of each hole and test piece edge.

Figure 4-6 – a) Alicona InfiniteFocus and b) sample mounted under turret.

The in-built Alicona software suite was used to remove any form present due to the inspection surface not being parallel to the x-y plane. The 2D measurement tool within the software was then used to automatically fit a circle to the hole. The “N-point” option was selected meaning greater than three points around the circle circumference were selected before the circle was automatically placed. A number of lines were then drawn between the circle and sample edges. The minimum line length was used as the z-distance. Values were given in microns to four decimal places. An example image is shown in Figure 4-7.

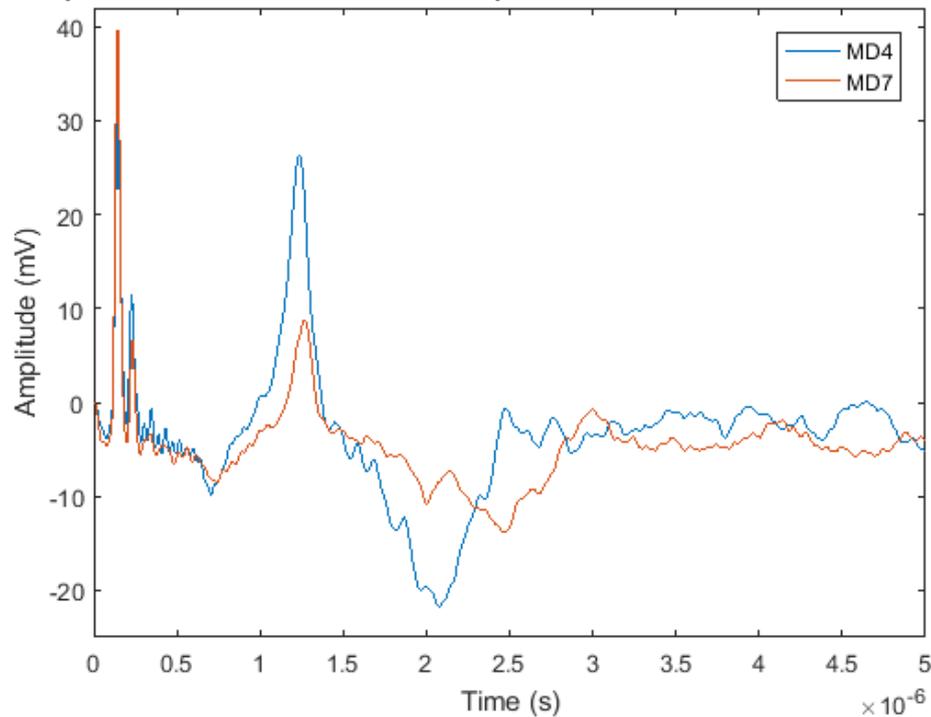
Figure 4-17 - Comparison of laser-PBF (M4) and EDM (M7) top surface A-scans at 1.0 mm translation, away from known “defect” locations.

As expected when using a photo-EMF detector, a higher magnitude response was detected when scanning the rougher surface (M4 – blue), shown in Figure 4-17.

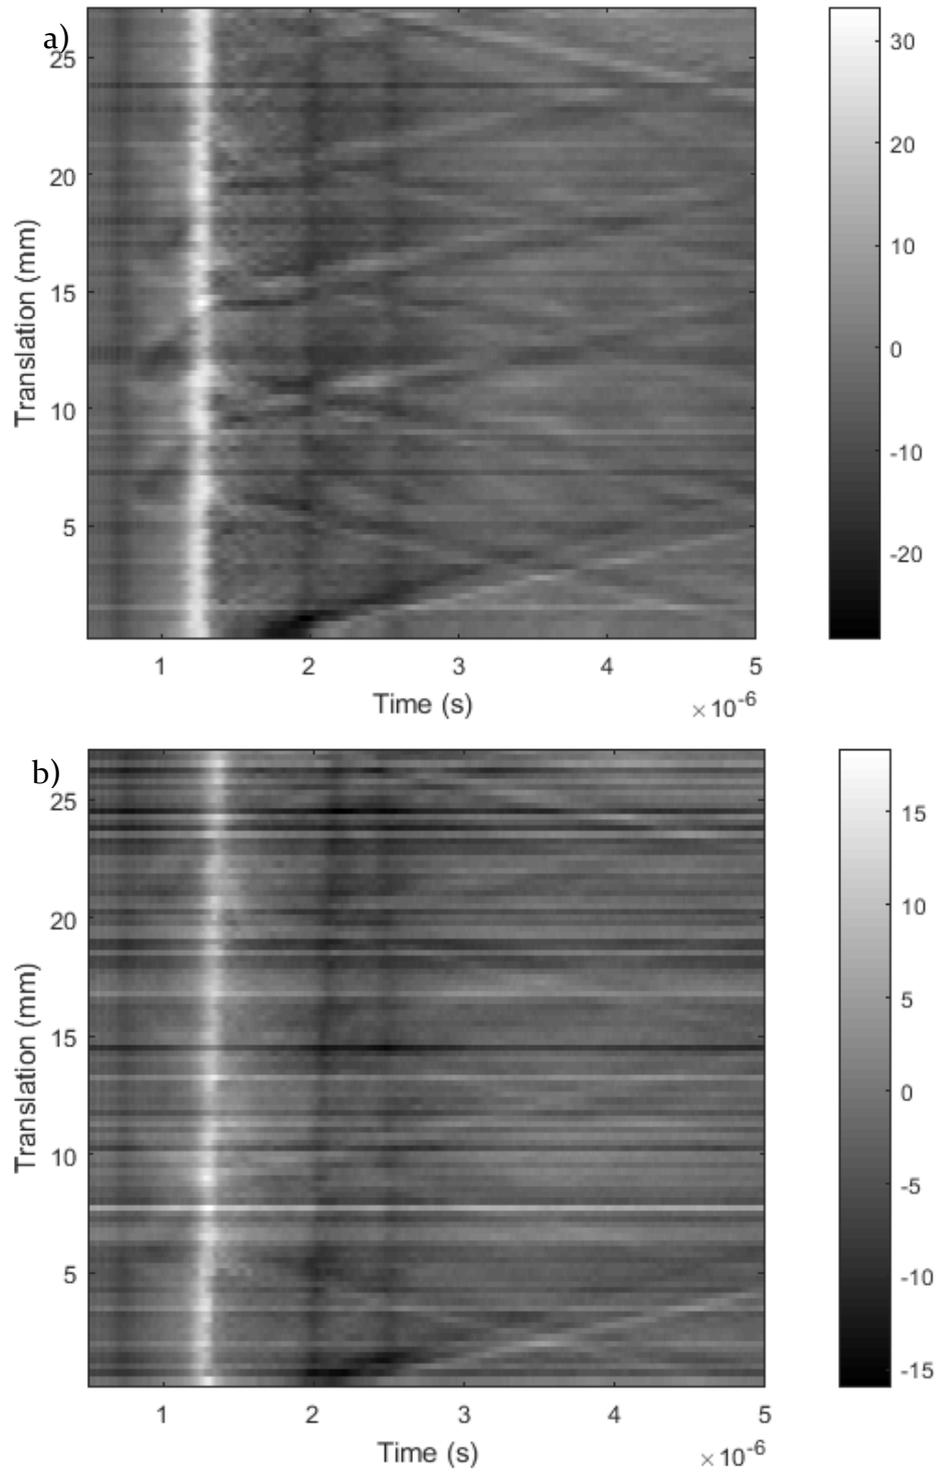
Figure 4-18 – a) M4 B-scan ( $13.2 \mu\text{m Sq}$ ) and b) M7 B-scan ( $4.6 \mu\text{m Sq}$ ) showing improved resolution, resulting from increased magnitude signal returned from laser-PBF surface.

The increased signal magnitude displayed in the A-scan for the laser-PBF surface of test piece M4 yields a B-scan with greater resolution. This can be seen in Figure 4-18a where many more full and partial parabolic indications of “defects” are visible. The B-scan for M7 shown in Figure 4-18b shows fewer indications and has a series of horizontal striations resulting from the fluctuations in DC signal received.

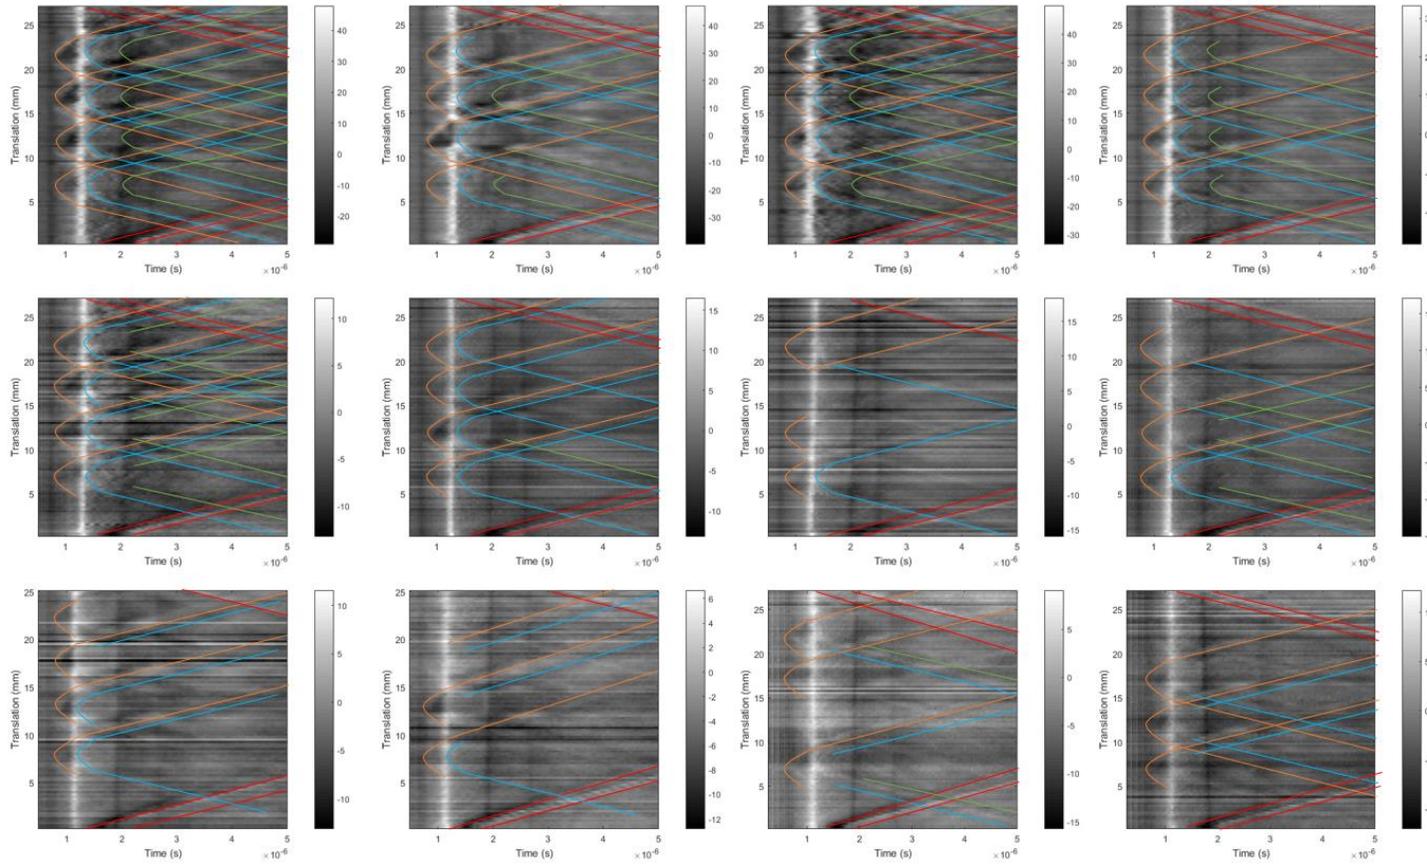
Figure 4-19 - Summary of B-scans for MI-12 with identified indications.

B-scans of each test piece (M1-12) have been assessed for indications of features such as those detailed in Figure 4-12. An overview of the B-scans with identified indications is shown in Figure 4-19, with the individual B-scans available in Appendix 10.1. A graph plotting the EDM hole diameter against z-distance is shown in Figure 4-20. Markers are used to distinguish between test piece surface finish; M1-4 have square markers, M5-8 have triangles and M9-12 have circles. Colours are used to designate whether a full or partial longitudinal and/or Rayleigh parabola is indicated.

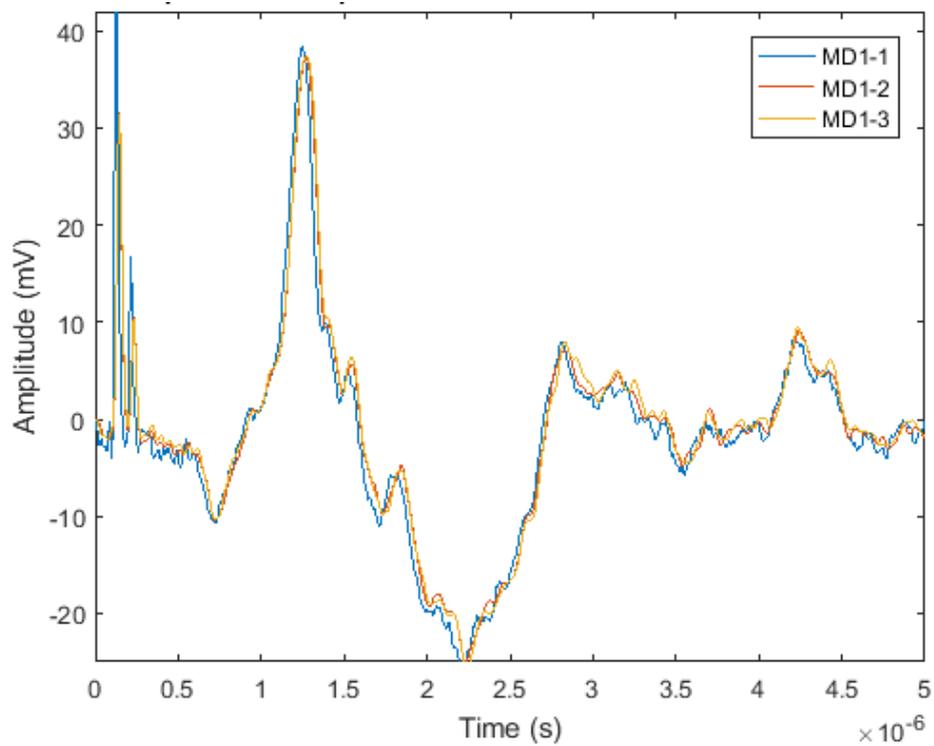
Figure 4-24 - A-scans at 1.0 mm translation for MI repeat scans 1-3.

Plotting A-scans for the three repeat scans of MI at 1.0 mm translation (Figure 4-24), it can be seen that there is generally good agreement between the signals; the second and third scans in particular rarely deviate. The first scan is generally at a lower magnitude than the second and third signals, suggesting that the initial scan in the ablative regime does perhaps alter the surface condition slightly, this was investigated further in section 6.3.8 .

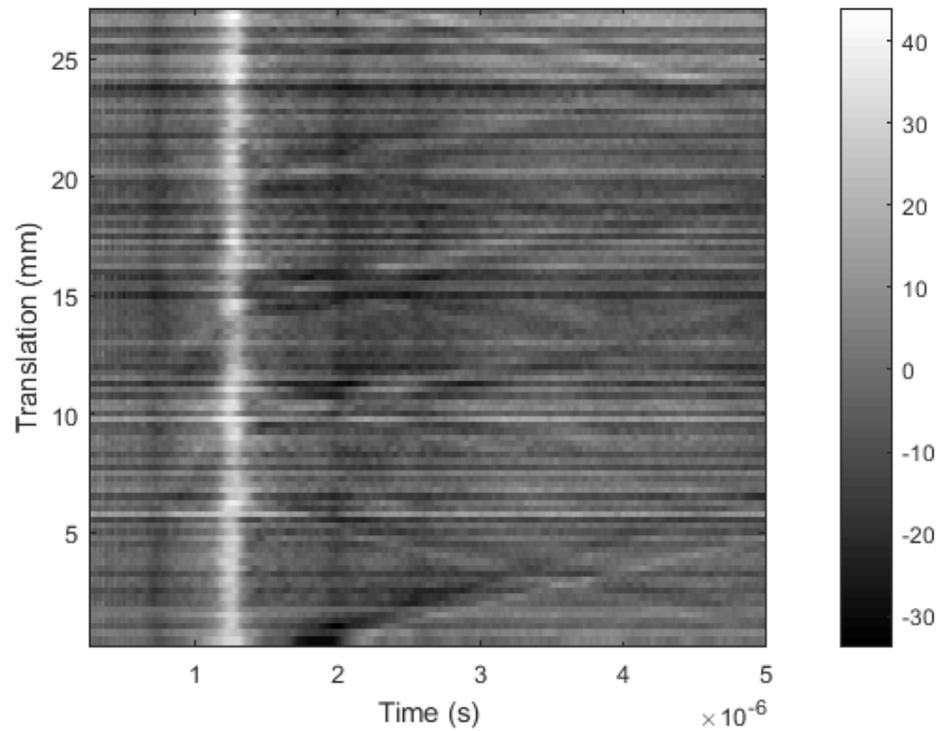
Figure 4-27 - B-scan of M4 with 2 averages.

A further reduction to 2 averages only reduced the scan time by a further 11 seconds and yielded a poor quality B-scan (Figure 4-27). The horizontal striations caused by the increased noise make it difficult to distinguish the previously identifiable features caused by the large material discontinuities.

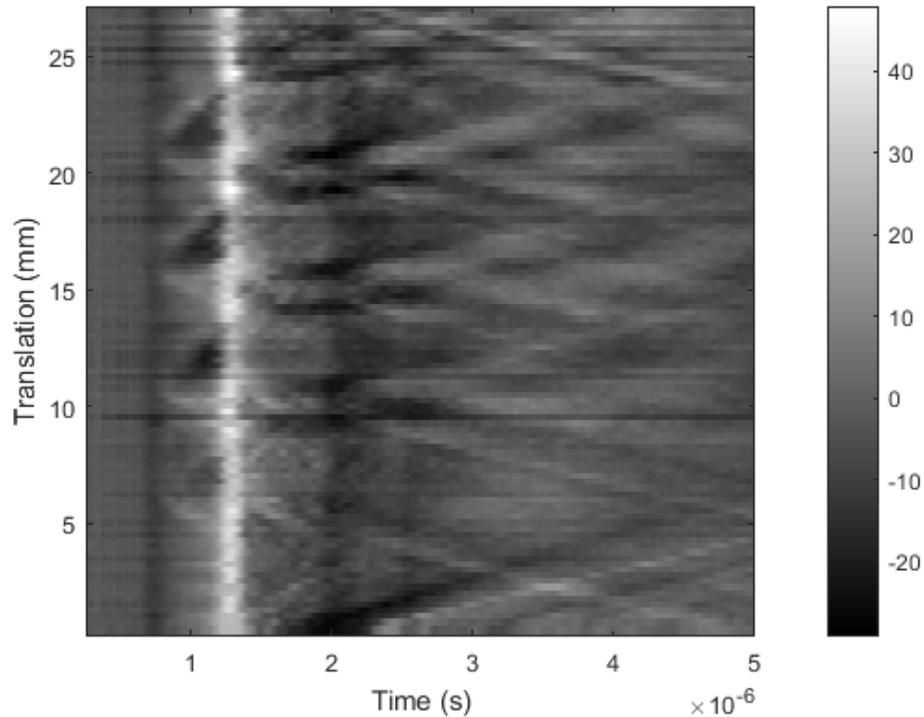
Figure 4-28 - B-scan of MI scanned at 0.25 mm intervals.

The B-scan resulting from the recommended settings is shown in Figure 4-28 and the four through-holes can be identified from the parabolic indications in the diffracted longitudinal wave returned from the bottom of the test piece, the diffracted Rayleigh wave and the diffracted longitudinal wave reflected off the sidewall.

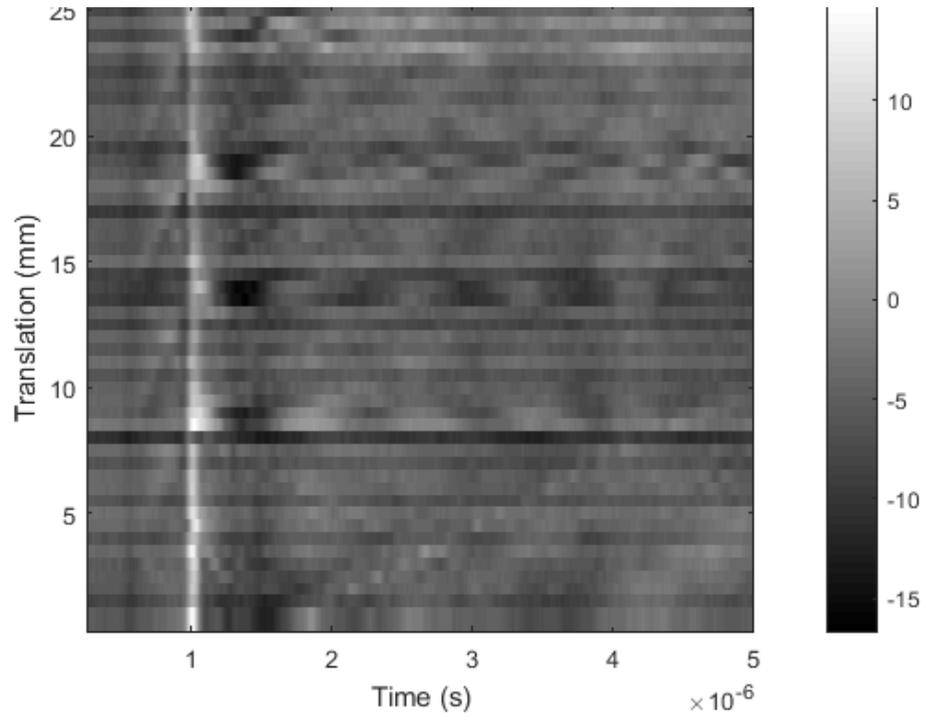
Figure 4-29 - B-scan of MI scanned at 0.5 mm intervals.

Figure 4-29 and Figure 4-30 show B-scans for the 0.5 mm and 1.0 mm step sizes. In both cases, the resolution has degraded to the point that the only identifiable indications are the top of the diffracted longitudinal wave returned from the bottom of the test piece. In the 1.0 mm case, even this is hard to distinguish from the noise.

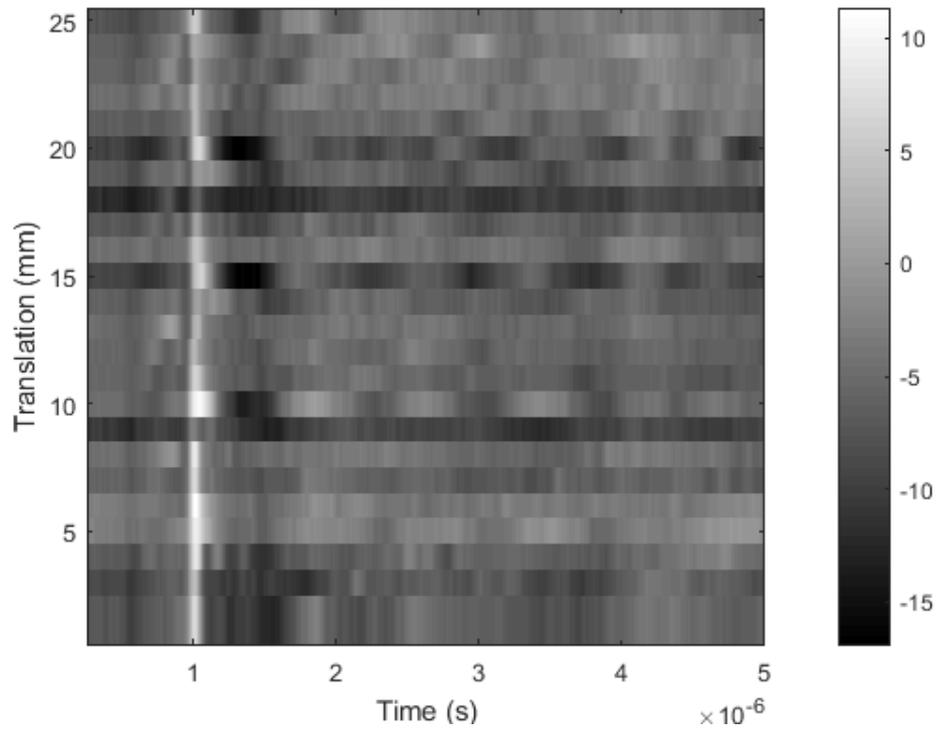
Figure 4-30 - B-scan of MI scanned at 1.0 mm intervals.

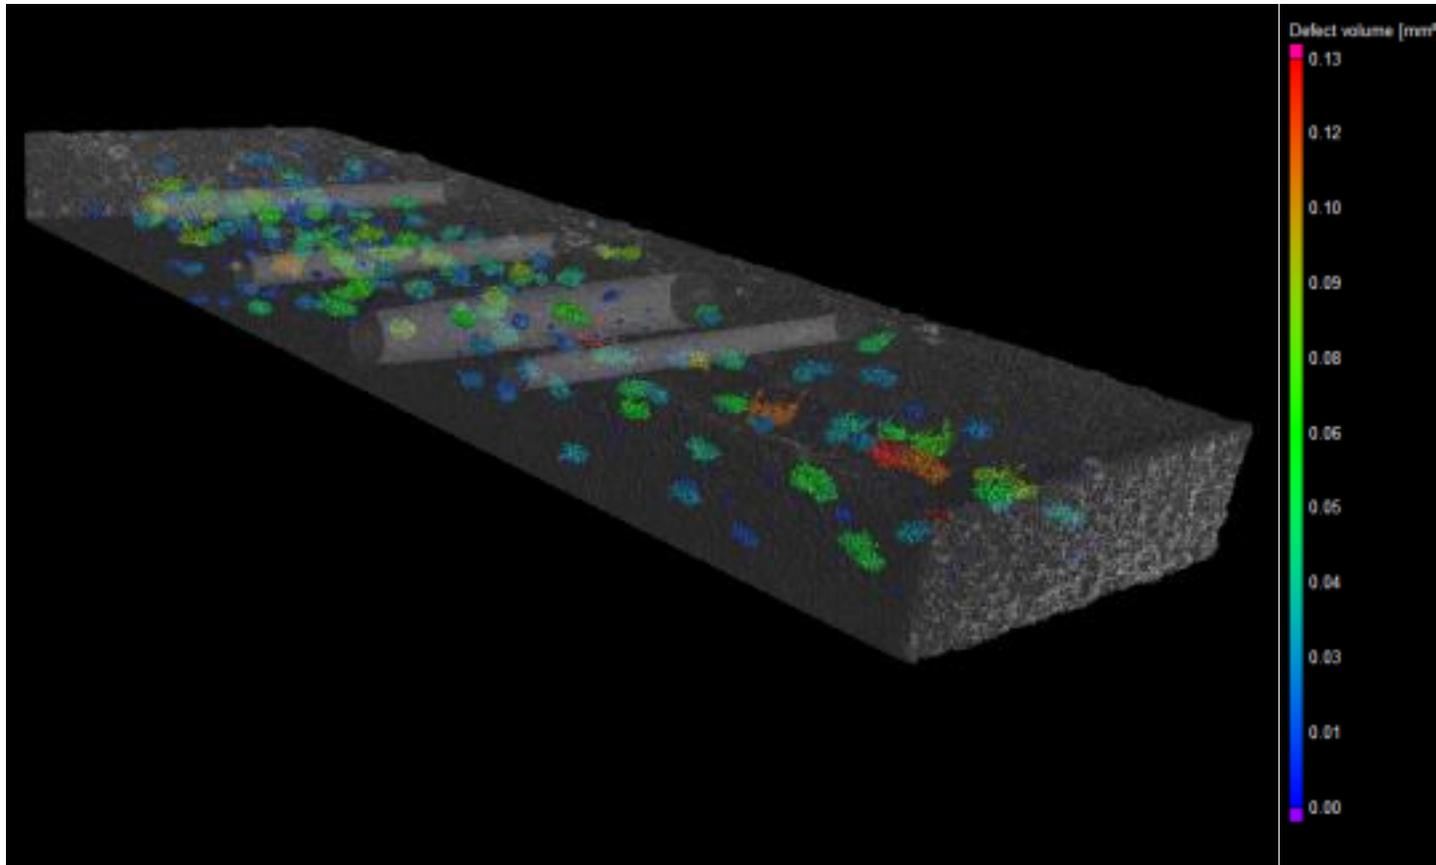
Figure 4-33 - Screenshot from Volume Graphics showing result of automatic defect recognition for M3.

Following manual alignment in the software, a region of interest was created for the top 3 mm of the test piece (in z-direction) and the automated defect recognition (ADR) algorithm run to identify any voids present. Thresholds were applied for void detection at a probability threshold of 0.5 and minimum size of 0.15 mm diameter. An example of the visual result returned is shown in Figure 4-33 for M3 (AM, as-built top surface).

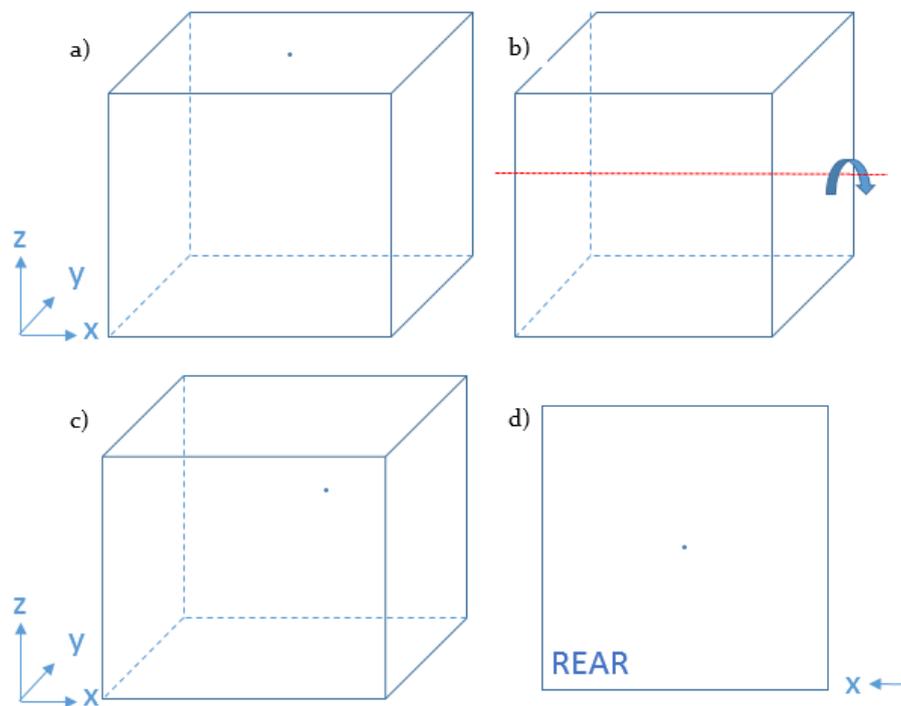
Figure 5-4 - Schematics showing a) intended location of void, beneath top surface, b) axis of rotation, c) manufactured position of void, centrally close to the rear face and d) rear face showing position of void in x-z.

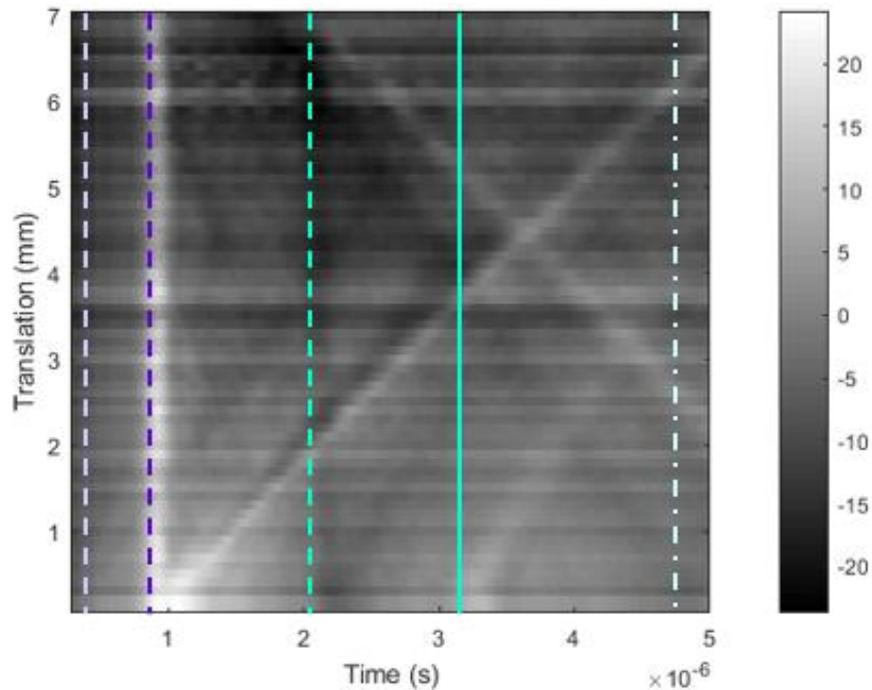
Figure 5-10 - B-scan for S3 overlaid with direct, reflected and mode converted waves from the base and side-walls.

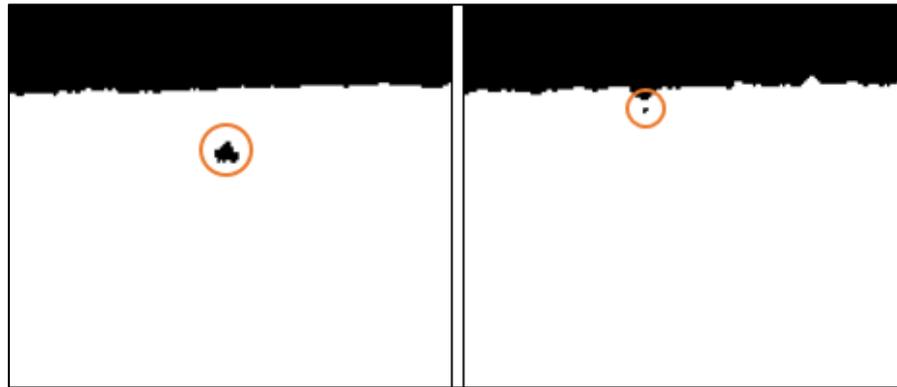
The two voids highlighted in Table 5-2 were found to correspond to translation positions of the two blue parabolas identified on the B-scan. The seeded “defect” at a translation of 3.6 mm had the largest diameter, but is also the furthest below the surface at 292  $\mu\text{m}$  z-distance. The picture in Figure 5-13 shows images generated in ImageJ for the two voids:

Figure 5-13 – Image generated through 'ImageJ' analysis of LU scan area showing a) the seeded void and b) unintended porosity (circled), at slice 491 equivalent to a translation of 5.7 mm.

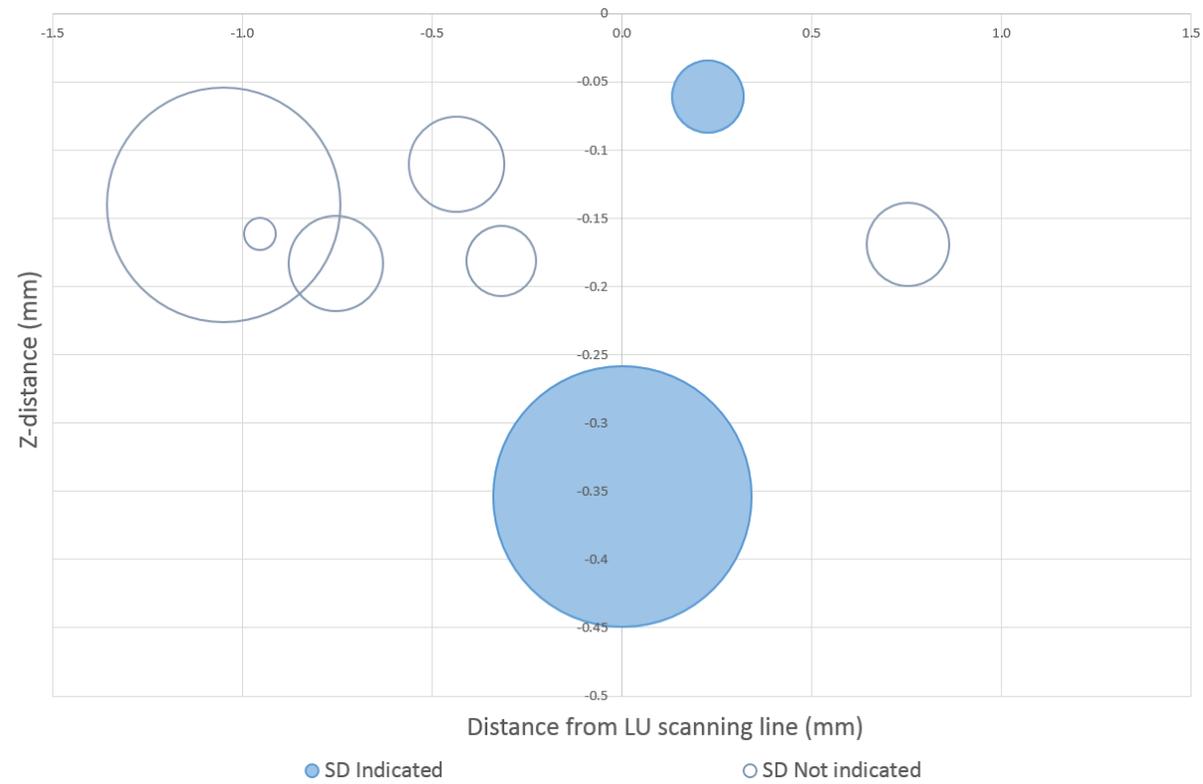
Figure 5-14- Graph showing void positions below the surface and distances from the scanning path, along with void area.

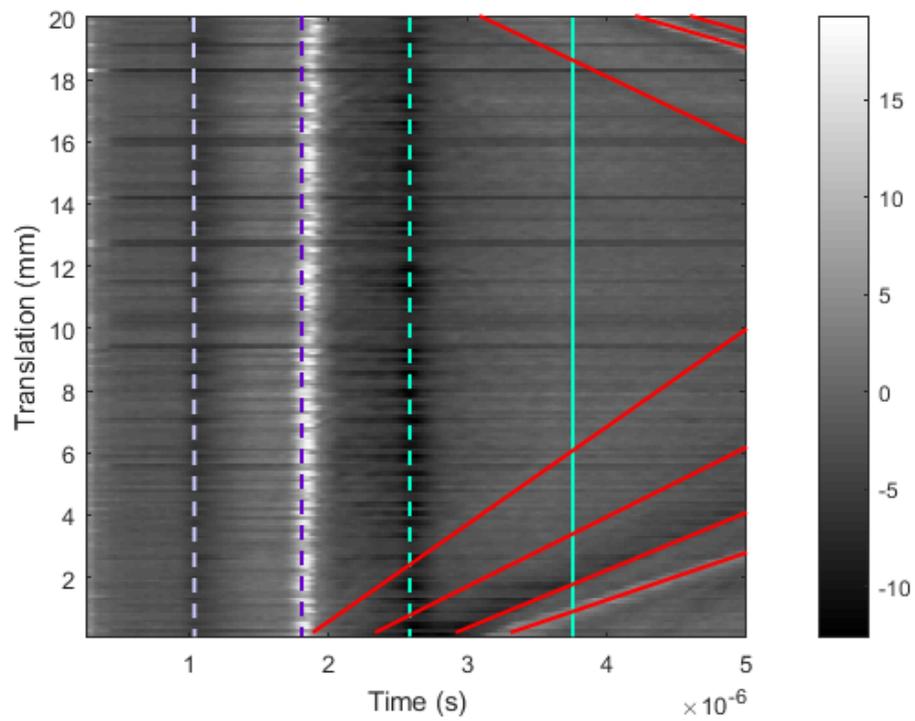
Figure 5-16 - B-scan of S2I overlaid with direct, reflected and mode converted waves from the base, side-walls and end walls.

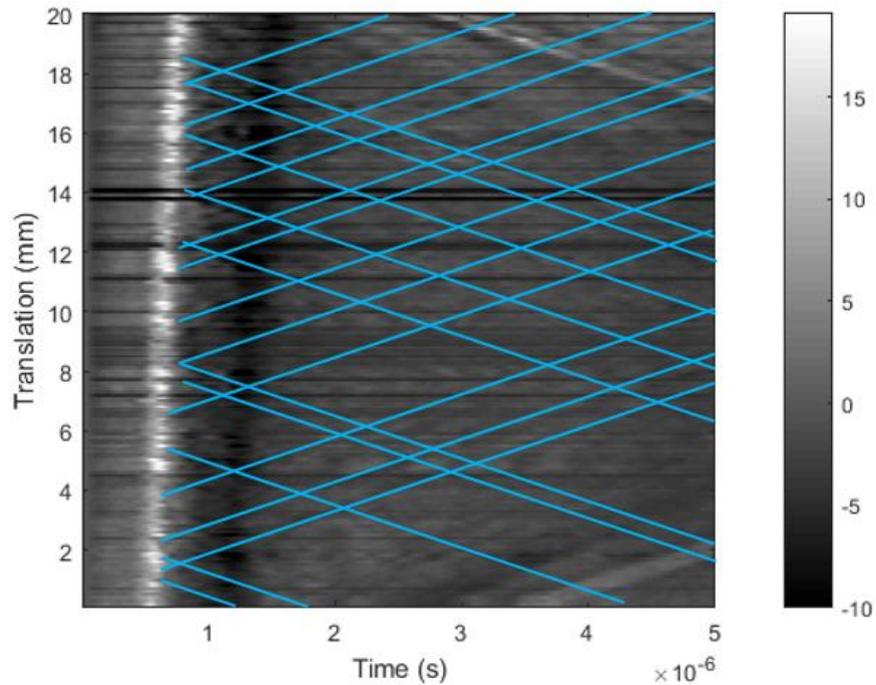
Figure 5-20 - B-scan for S22 overlaid with indications of material discontinuities.

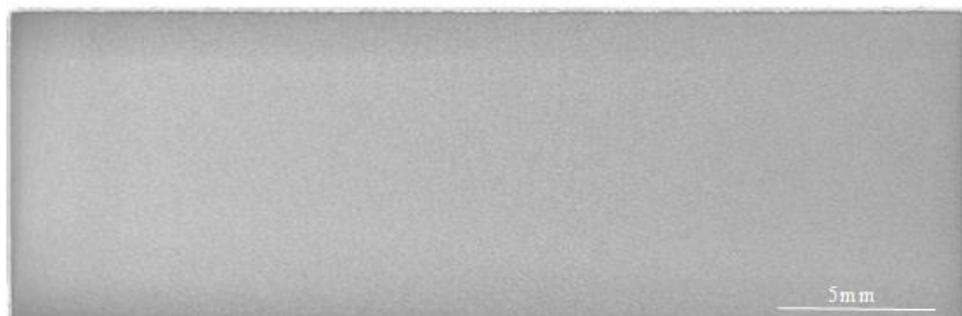
To discover whether the porosity indicated from the B-scans was in fact present, the Nikon XT H 225 XCT system was used to image S21 and S22, with  $27 \mu\text{m}$  voxel size. An example slice of the XCT reconstruction of reference sample (S21) is shown in Figure 5-21.

Figure 5-21 - XCT image of AM solid block sample (x-y plane at  $250 \mu\text{m}$  from top surface) – no indications have been identified.

Analysis of the XCT reconstruction for S21 did not reveal any indicated material discontinuities, this is in agreement with the LU B-scan of the test piece (Figure 5-15).

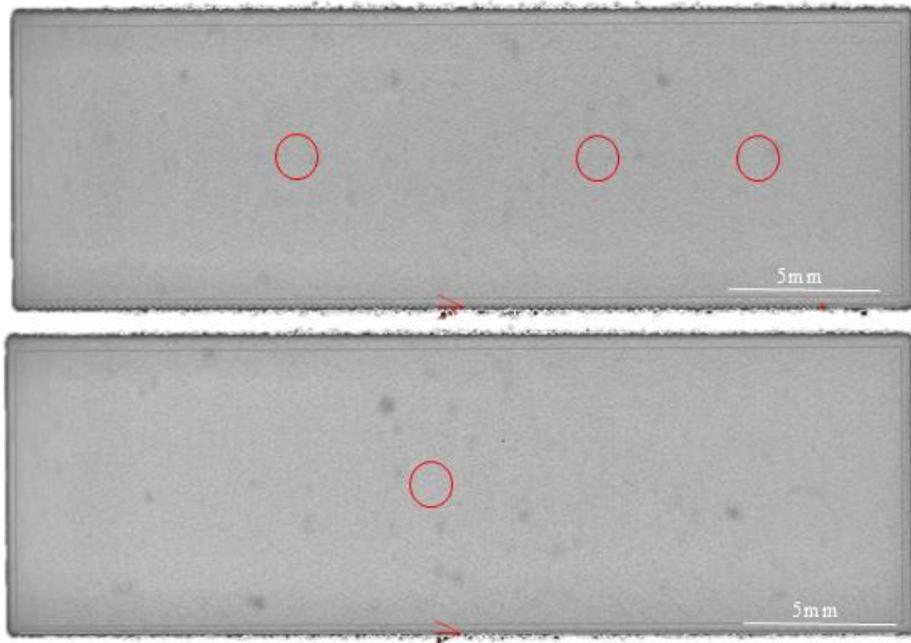
Figure 5-22 - XCT image of AM block showing intended locations of seeded “defects” - x-y plane at 250  $\mu\text{m}$  from top surface (left) and x-y plane at 500  $\mu\text{m}$  from top surface (right).

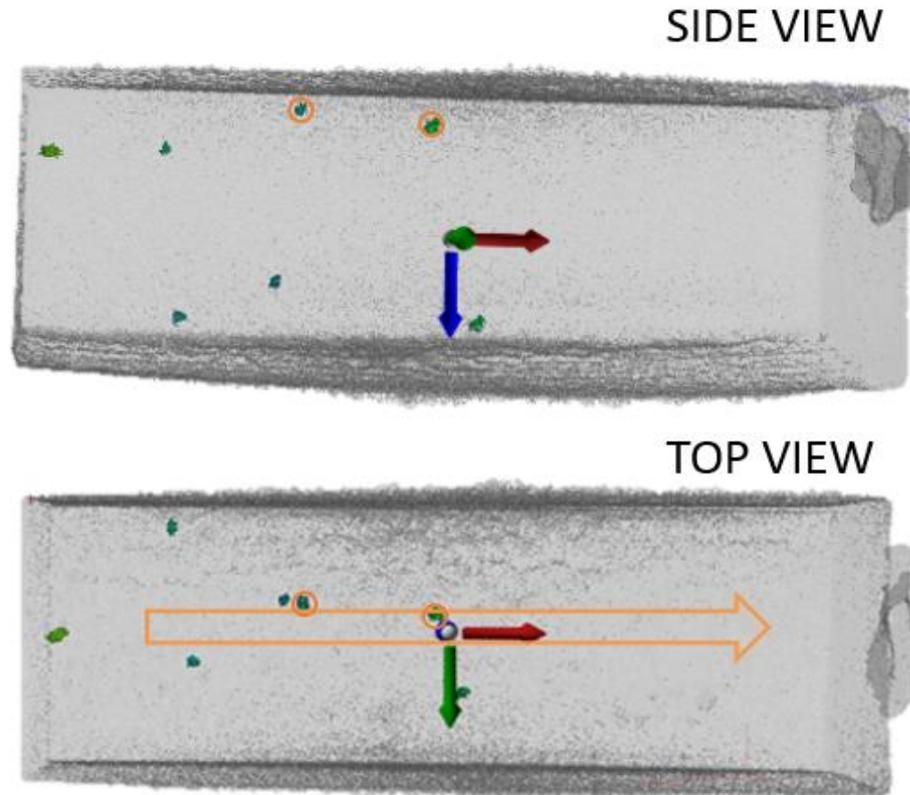
Figure 5-23 - ADR images showing locations of “defects” within the blocks from a) the side view and b) the top view. The circled “defects” are within the approximate LU scanning region, shown with an arrow.
