Ensuring the quality of components produced by  
metal additive manufacturing using laser  
generated ultrasound

Thesis submitted to University of Nottingham  
for the degree of Doctor of Engineering

October 2017

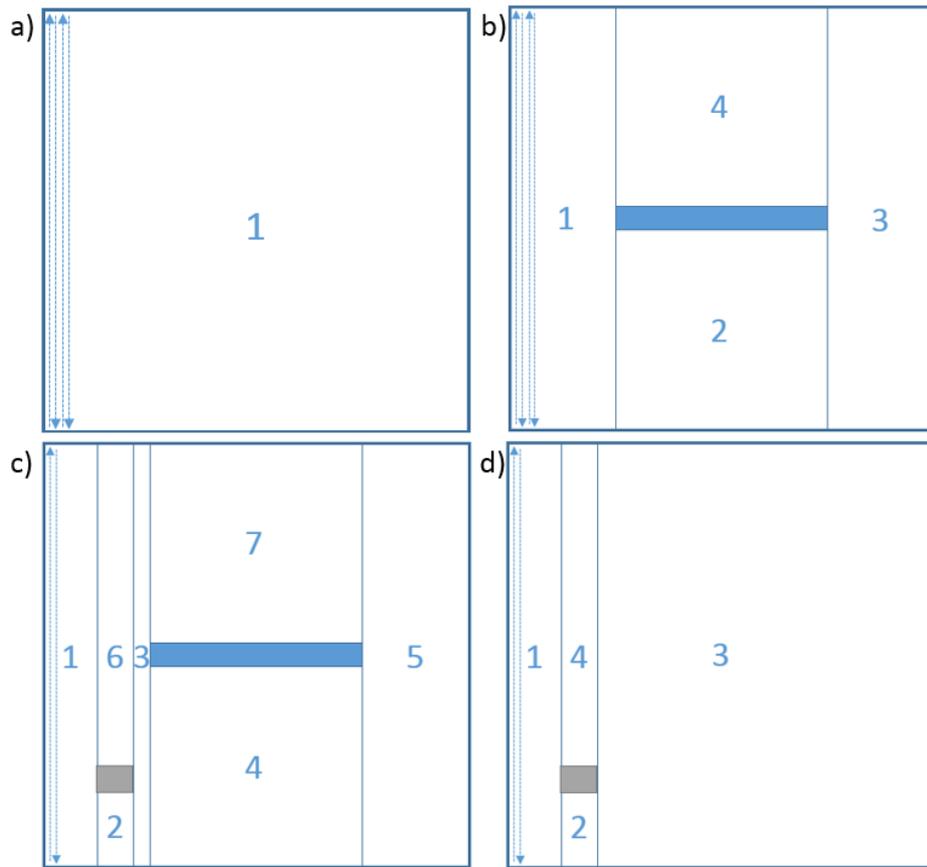
Figure 6-3 - Schematic showing scanning areas for a) bulk material, b) “defect zone” only layers, c) layers with “defect zone” and notch and d) notch only layers.

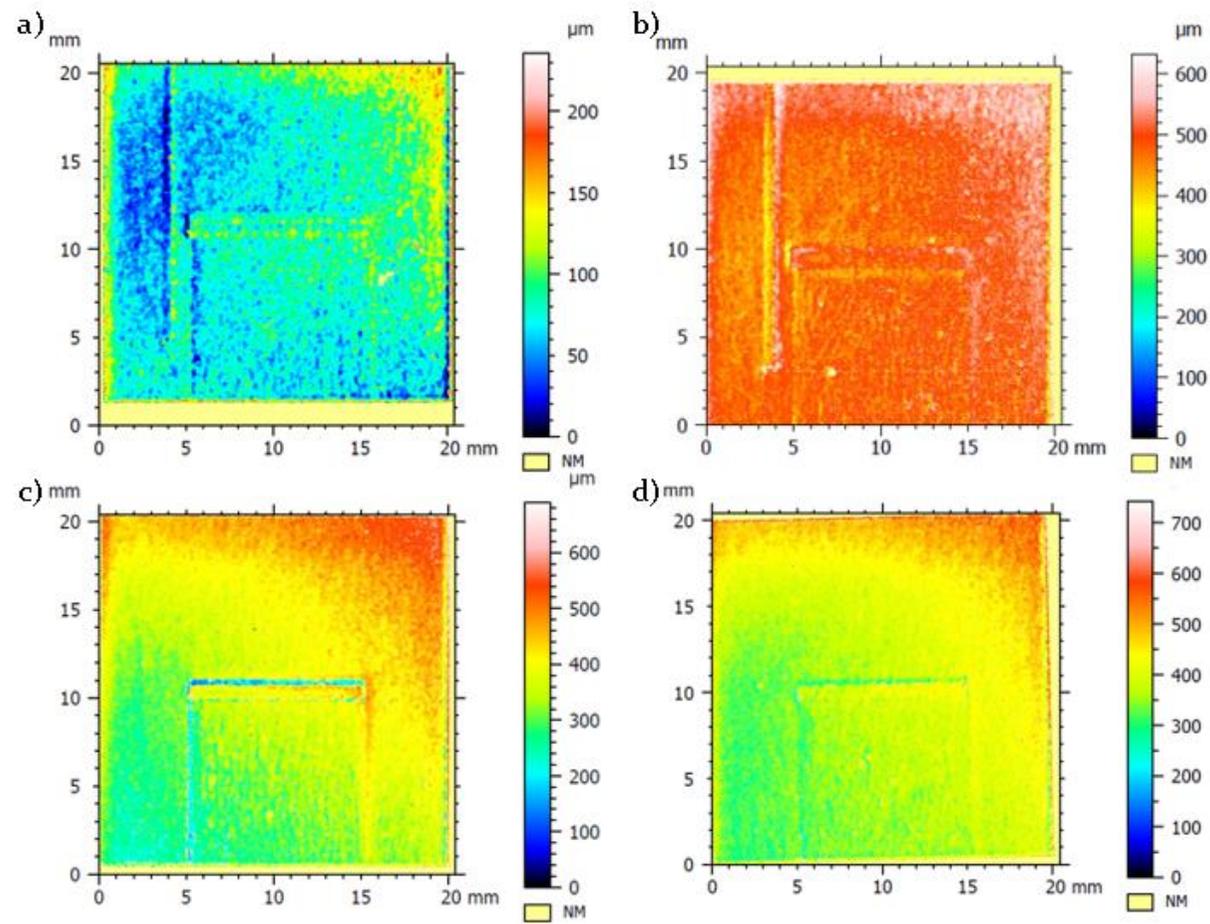
Figure 6-4 – FVM height maps showing a) P1, b) P3, c) P4 and d) P5 top surfaces, post-build.

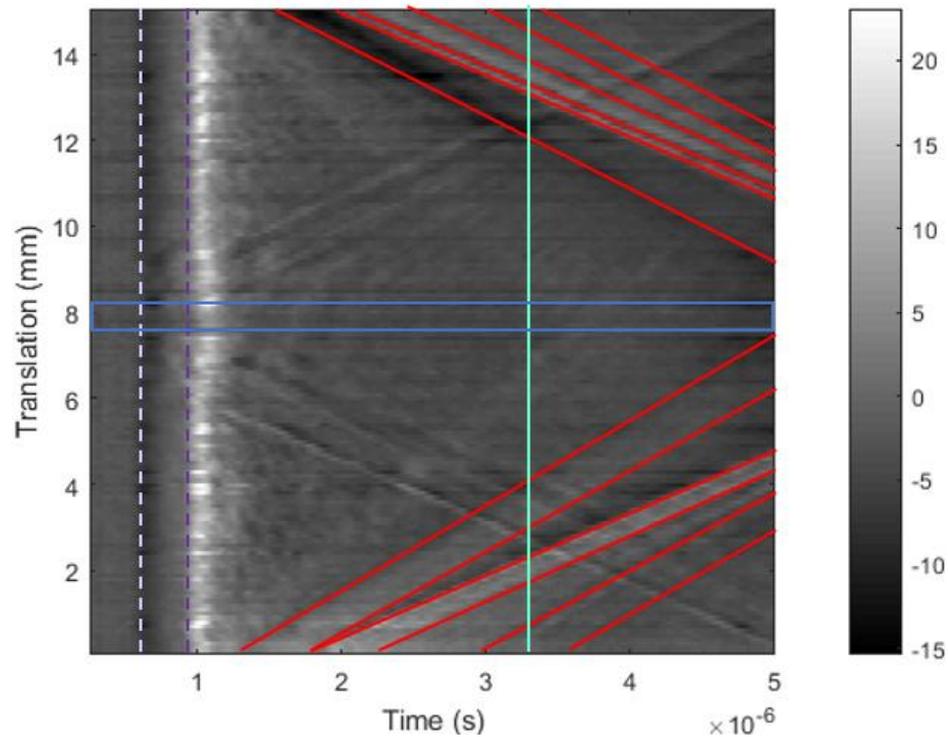
Figure 6-11 - B-scan of PI along scanning line I overlaid with direct, reflected and mode converted waves from the base and end walls and the “defect zone” highlighted.

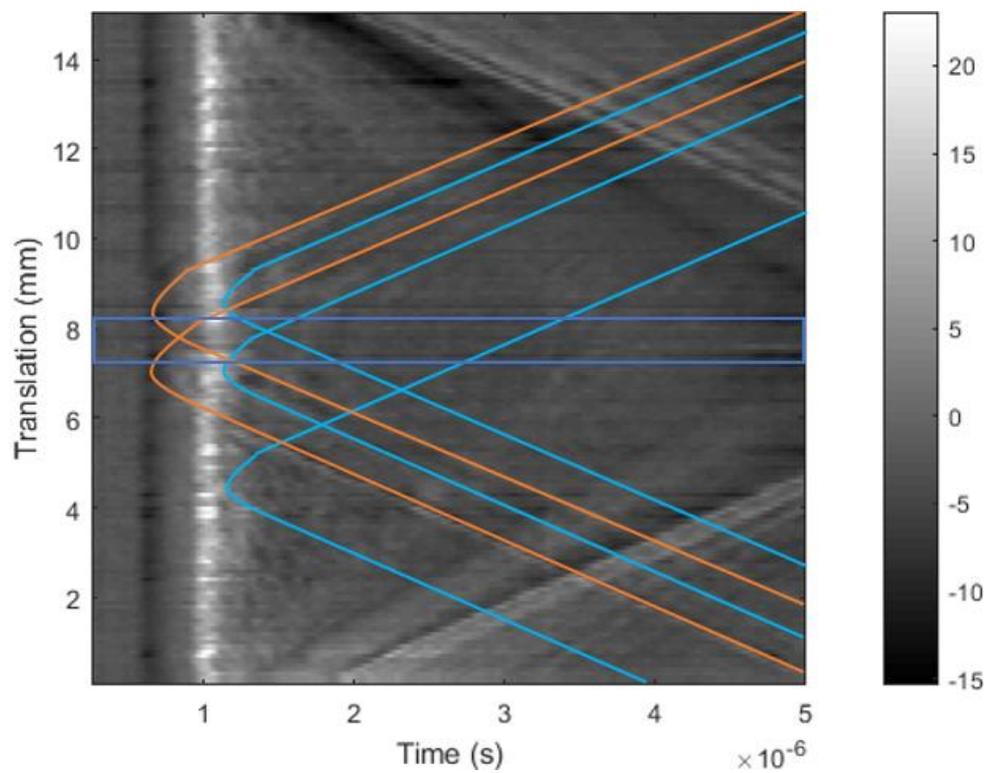
Figure 6-12 - B-scan of PI along scanning line 1 overlaid with indications of material discontinuities.

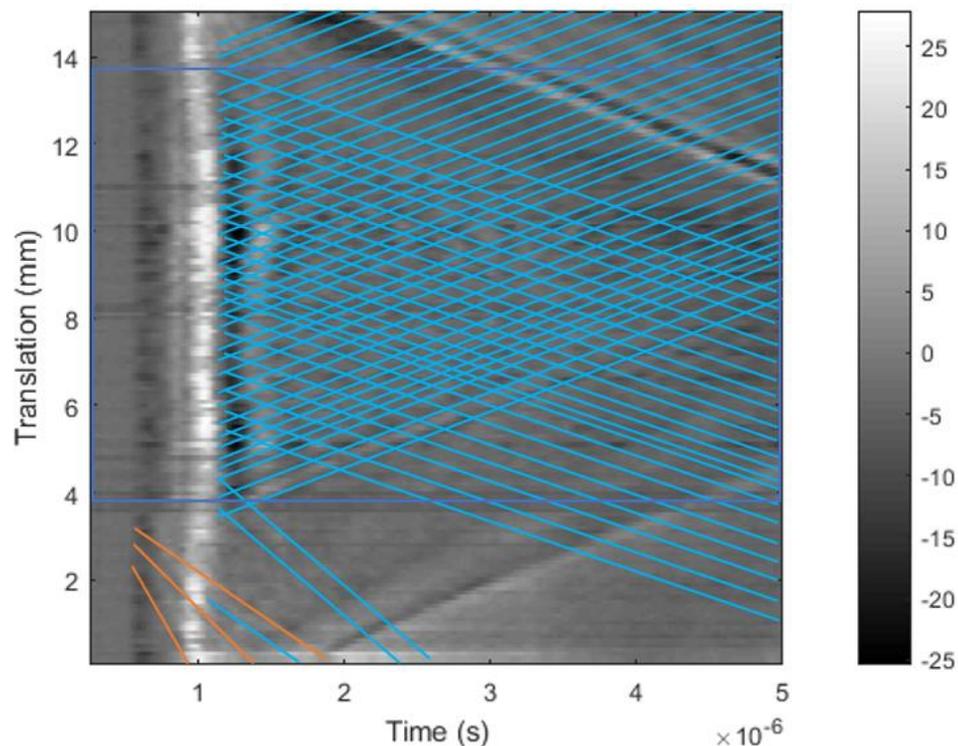
Figure 6-16 - B-scan of PI along scanning line 2 (reversed) overlaid with indications of material discontinuities and with the “defect zone” highlighted.

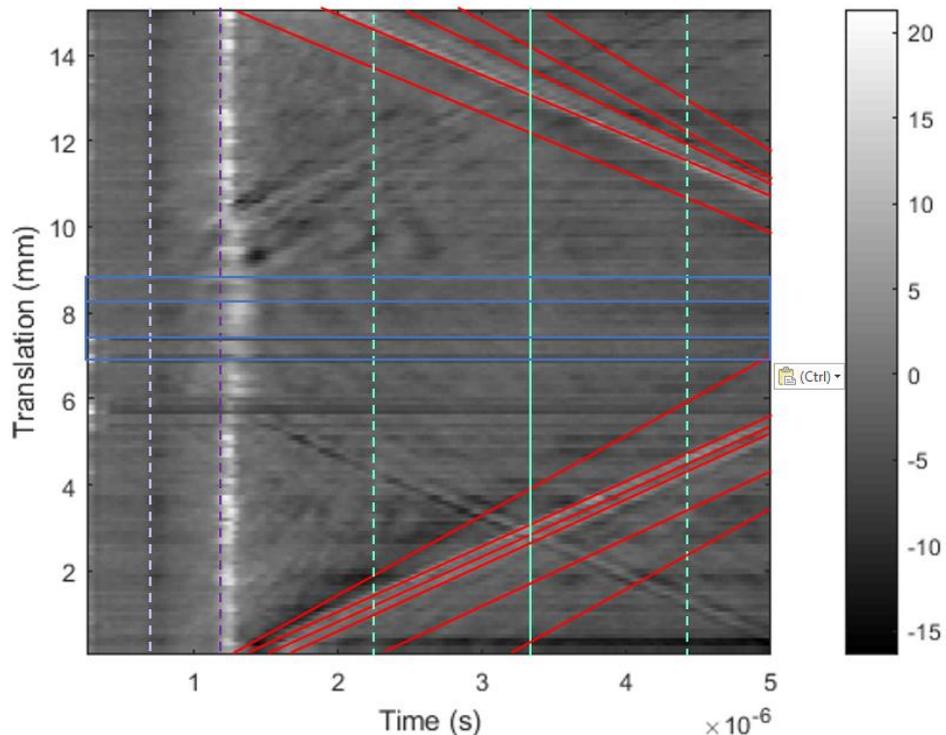
Figure 6-23 - B-scan of P2 along scanning line 1 overlaid with direct and reflected waves from the base, side-walls and end walls and areas of signal drop out highlighted.

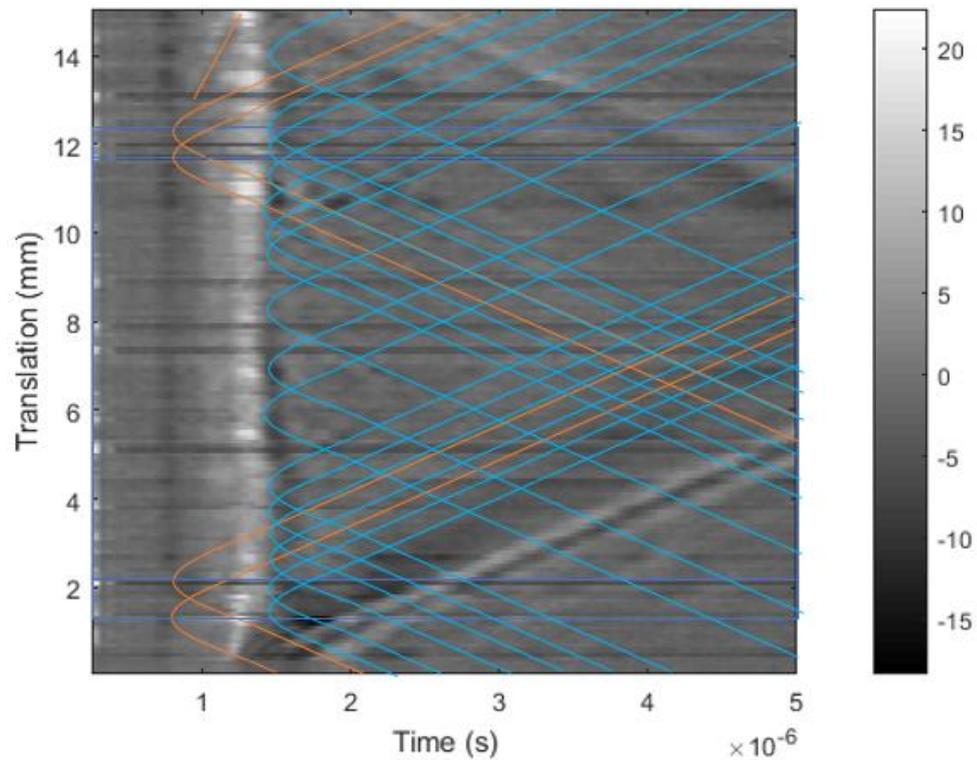
Figure 6-27 - B-scan of P2 along scanning line 2 overlaid with indications of material discontinuities and areas of signal drop out thought to be the “defect zone” and surrounding trough.

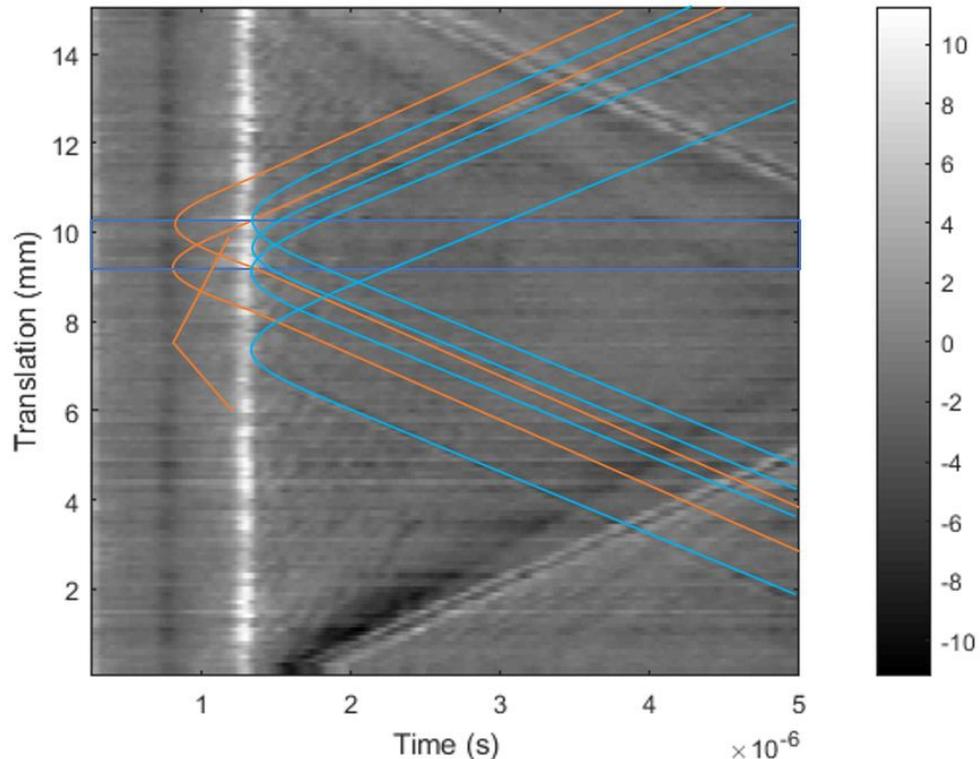
Figure 6-31 - B-scan of P3 along scanning line 1 overlaid with indications of material discontinuities and “defect zone”.

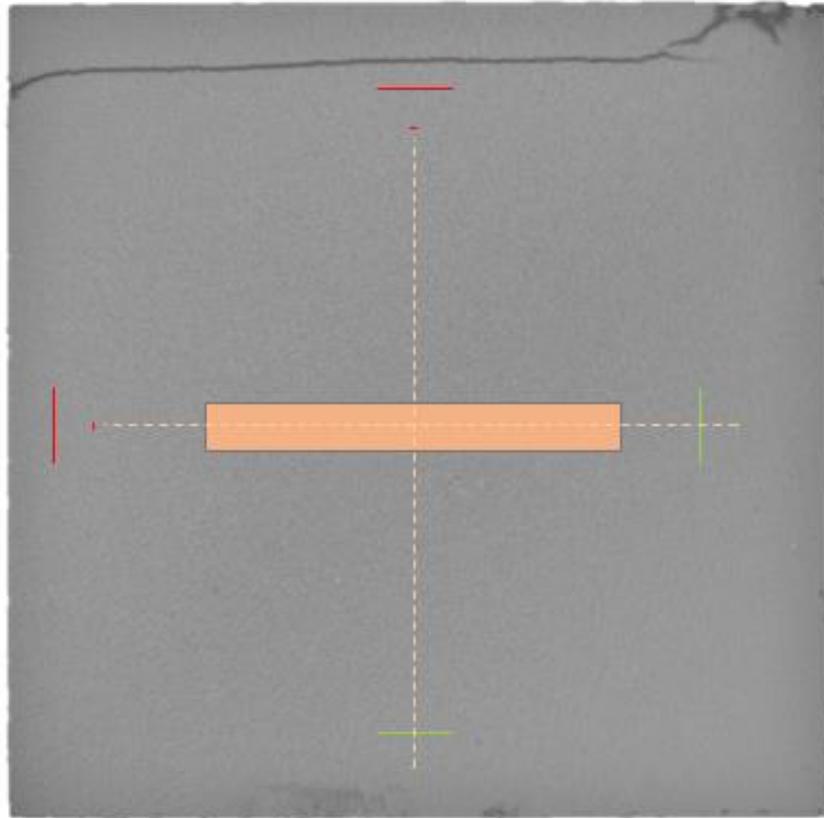
Figure 6-52 - XCT slice through x-y at -3.10 mm showing crack position.

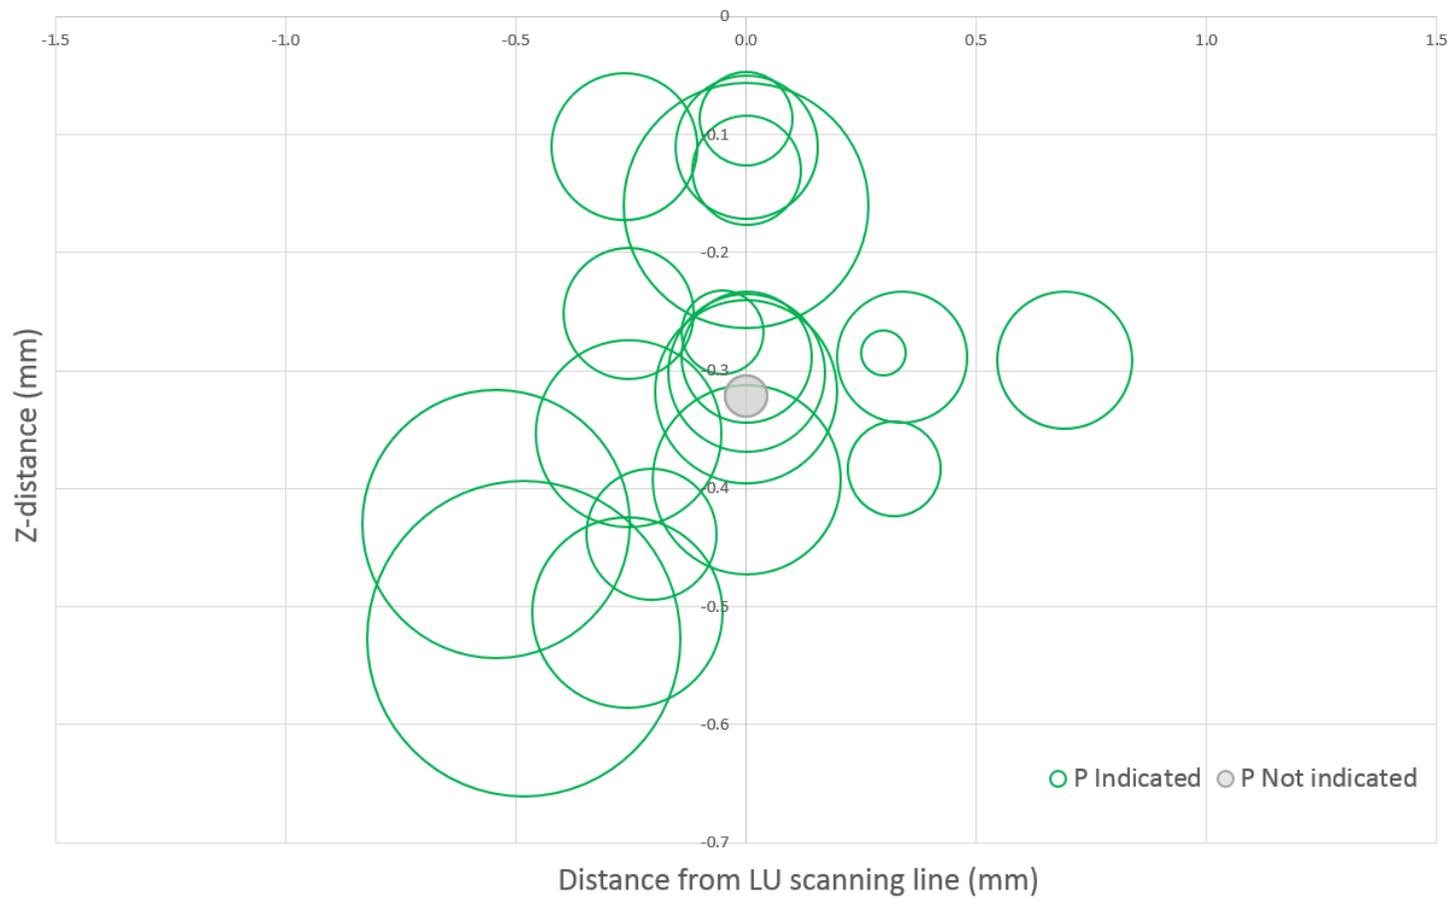
Figure 6-58 - Graph showing distance from LU scanning line vs. void centre z-distance, with markers scaled by void diameter

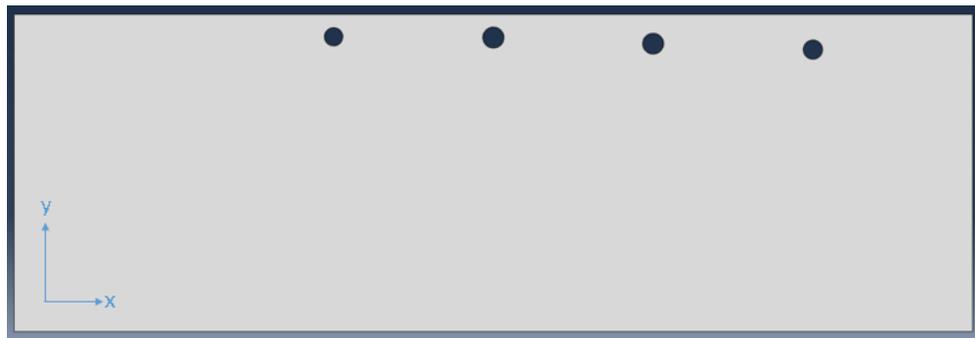
A 2D slice down the centre of M4, first discussed in Chapter 4, was replicated using the 'Section Sketch' tool within the 'Feature' menu. A 2D case was deemed sufficient in this case, as interrogation of the waves reflected from the side walls in the LU B-scans had not indicated the presence of any "defects". Additionally, only solving a 2D case reduces the associated computational cost and running time.

Figure 7-1 – 'Section Sketch' of cross section through M4 with four holes (left to right: 0.581, 0.669, 0.662 and 0.638 mm diameters at the following distances from the top surface: 0.417, 0.398, 0.593 and 0.807 mm respectively).

The term z-distance has been used throughout this thesis to mean the minimum distance of a void from the top edge of a sample, using the build co-ordinates of the AM machine. As a 2D model has been created in 'ABAQUS', please note the change in co-ordinate system orientation in the modelling, as shown in Figure 7-1.

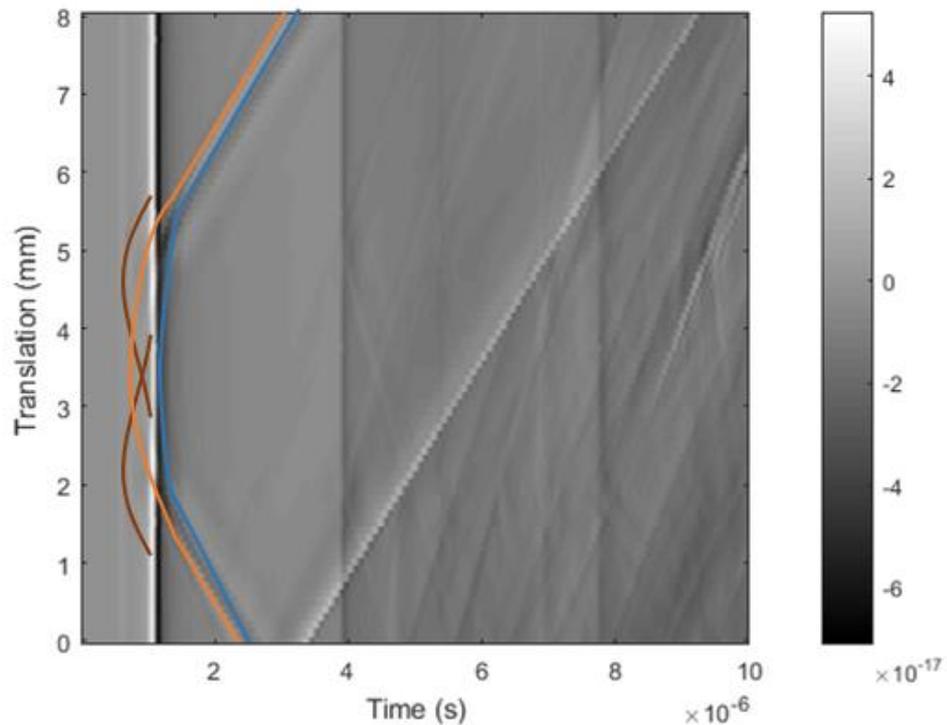
Figure 7-15 – B-scan of 2D modelled 300 µm diameter spherical pore at 300 µm z-distance, overlaid with unique wave arrivals.

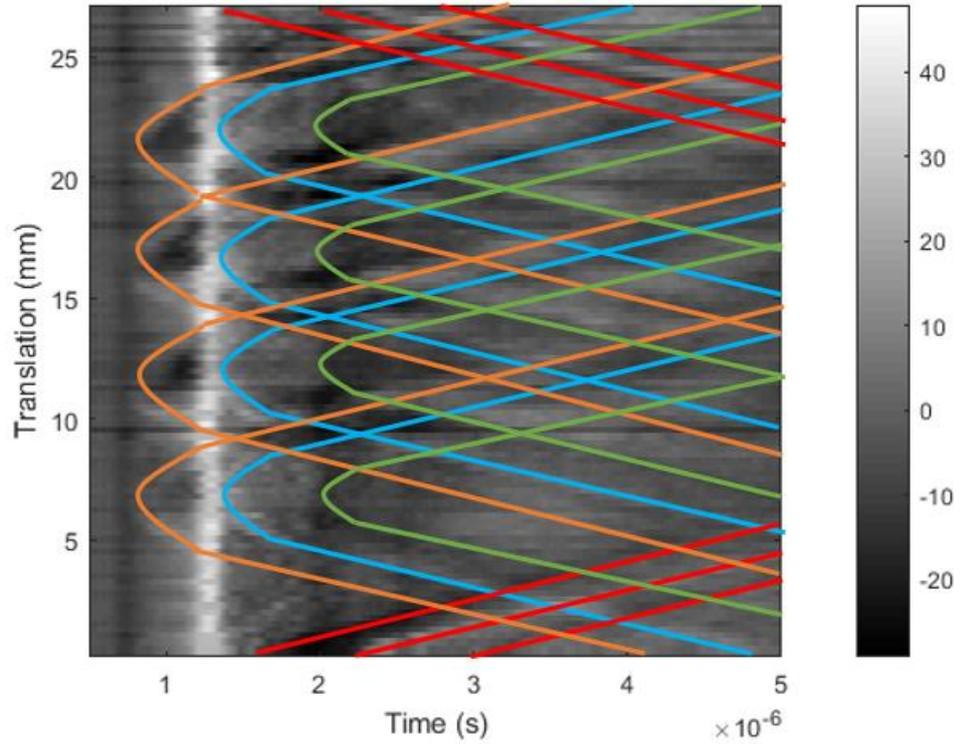
Figure 10-1 - B-scan of MI (AM, as-built top surface), overlaid with wave arrivals and indications.
