The Performance of Road Ironwork Installations

by C.J. Brown, MEng

Thesis submitted to the University of Nottingham
for the Degree of Doctor of Philosophy, February 1997

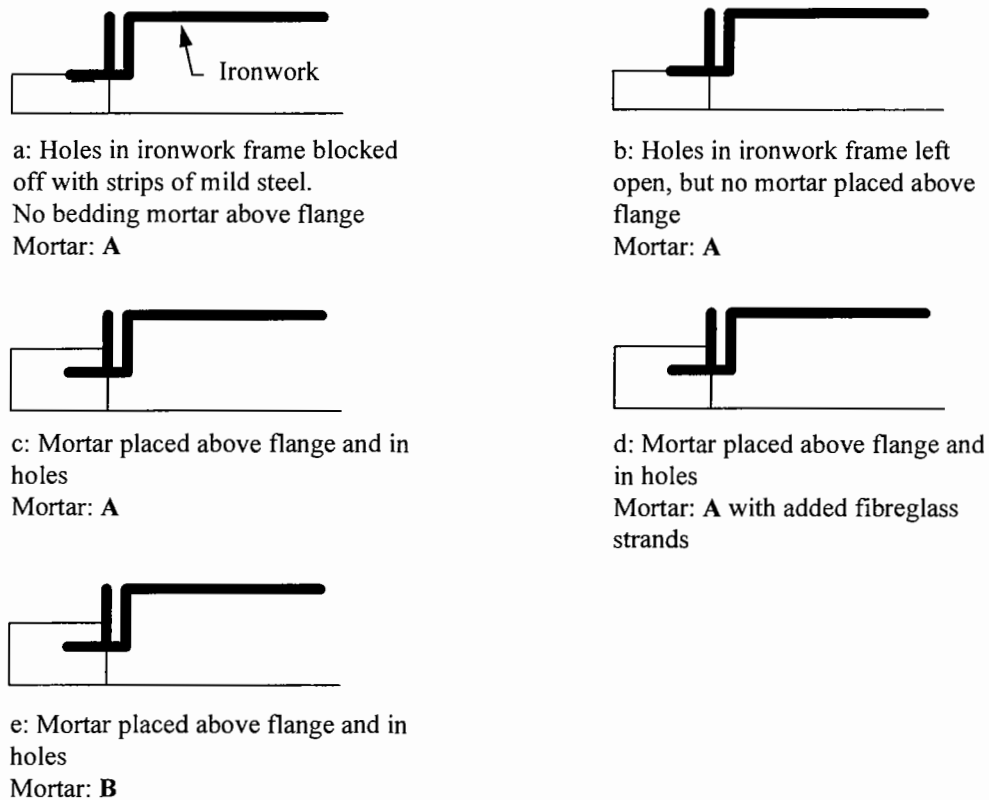
Figure 2.9: Sections through the bedding configurations used in the shrinkage test

Test Method: The test programme involved bedding four standard ironwork frames onto sheets of plywood with a 25mm thickness of mortar A. Each frame was bedded with a different configuration of the bedding material as shown in Figure 2.9. All ironwork frames have holes located in the flange. It was considered that placing bedding mortar in these holes and above the flange would restrain it from shrinkage and may induce cracking. The holes in the frame illustrated in Figure 2.9a were covered with strips of mild steel. This was to prevent mortar passing to the top of the flange when the frame was levelled to position. This allowed a comparison with the section shown in Figure 2.9b and 2.9c to study whether the restraint provided by the holes had any significant effect. Fibre glass strands were added to mortar A in the section shown in Figure 2.9d to see whether the reinforcement had any effect in reducing cracking. A total of 100g of fibre glass strands was gradually mixed with the mortar. A fifth frame was bedded with mortar B with the same configuration as shown in Figure 2.9e. This enabled a direct comparison of the performance of the two materials.

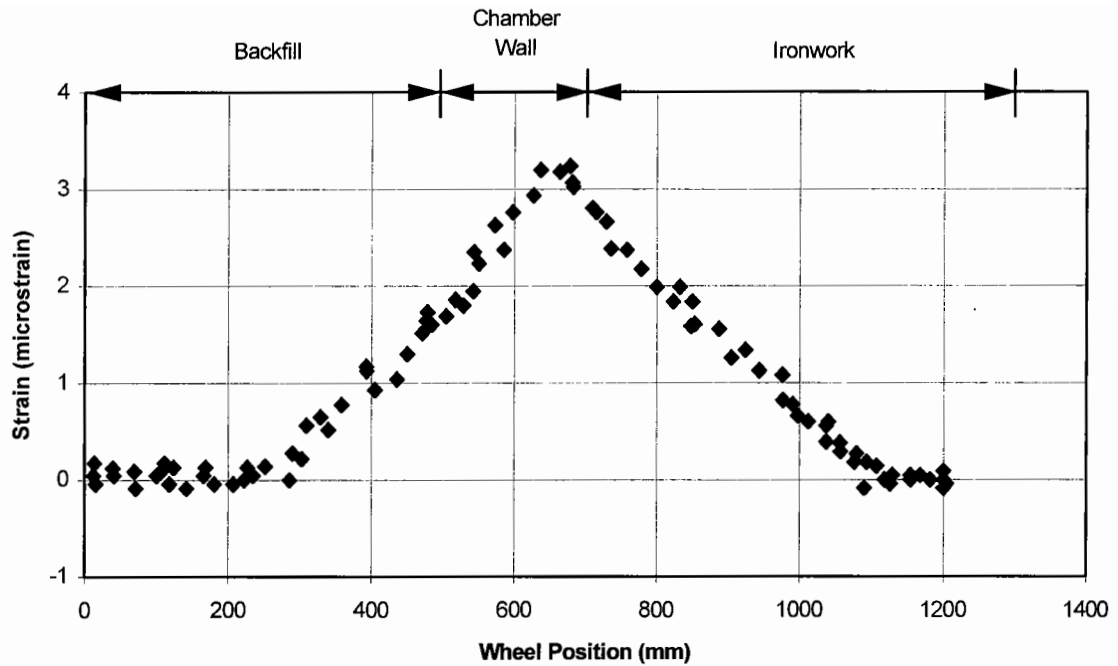
Figure 5.7: Horizontal strain measured by gauge T1-F in the installation with soft foundations (No. 2) when loaded in wheel Track 3

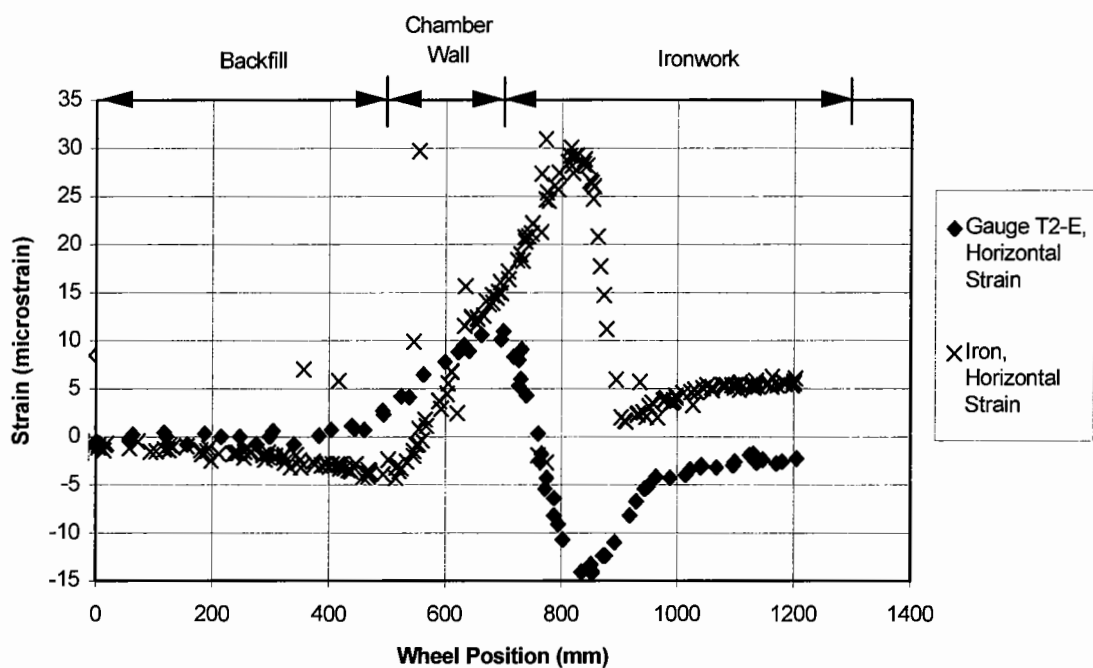
Figure 5.21: Horizontal strain measured by gauge T2-E and at the top of the ironwork frame in the installation with stiff foundations (No. 3) when loaded in wheel Track 3

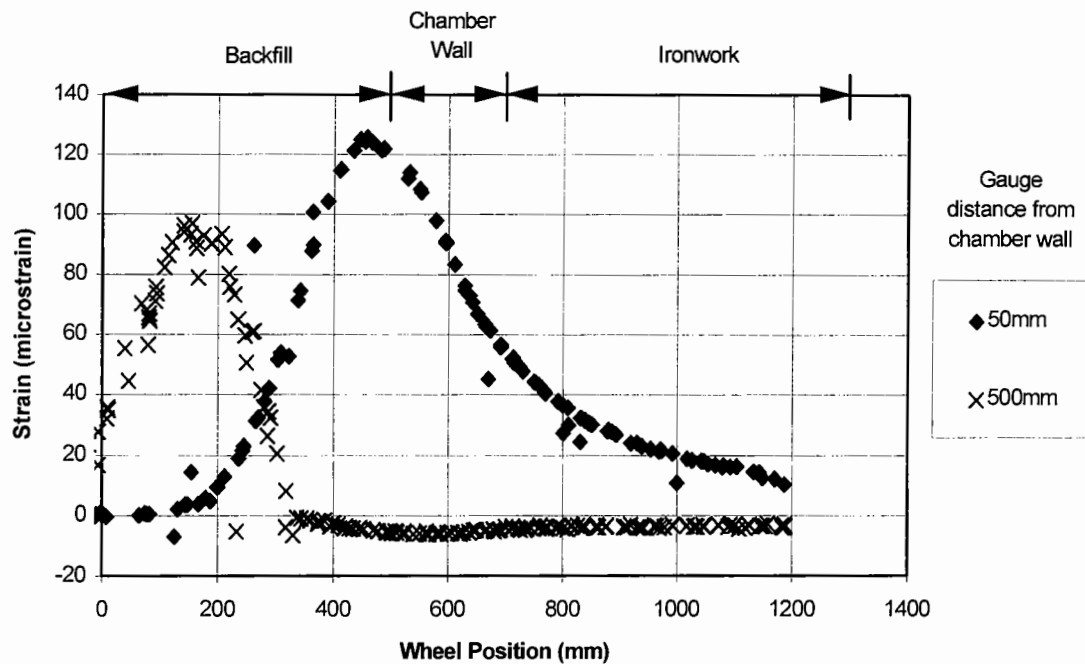
Figure 5.22: Horizontal strains measured by instruments positioned 25mm from the bottom of the DBM layer in the installation with soft foundations (No. 4)
