# Fireside Corrosion Behavior of HVOF and Plasma-Sprayed Coatings in Advanced Coal/Biomass Co-Fired Power Plants

T. Hussain, T. Dudziak, N.J. Simms, and J.R. Nicholls

This article presents a systematic evaluation of coatings for advanced fossil fuel plants and addresses fireside corrosion in coal/biomass-derived flue gases. A selection of four candidate coatings: alloy 625, NiCr, FeCrAl and NiCrAlY were deposited onto superheaters/reheaters alloy (T91) using high-velocity oxy-fuel (HVOF) and plasma spraying. A series of laboratory-based fireside corrosion exposures were carried out on these coated samples in furnaces under controlled atmosphere for 1000 h at 650 °C. The tests were carried out using the “deposit-recoat” test method to simulate the environment that was anticipated from air-firing 20 wt.% cereal co-product mixed with a UK coal. The exposures were carried out using a deposit containing Na<sub>2</sub>SO<sub>4</sub>, K<sub>2</sub>SO<sub>4</sub>, and Fe<sub>2</sub>O<sub>3</sub> to produce alkali-iron tri-sulfates, which had been identified as the principal cause of fireside corrosion on superheaters/reheaters in pulverized coal-fired power plants. The exposed samples we

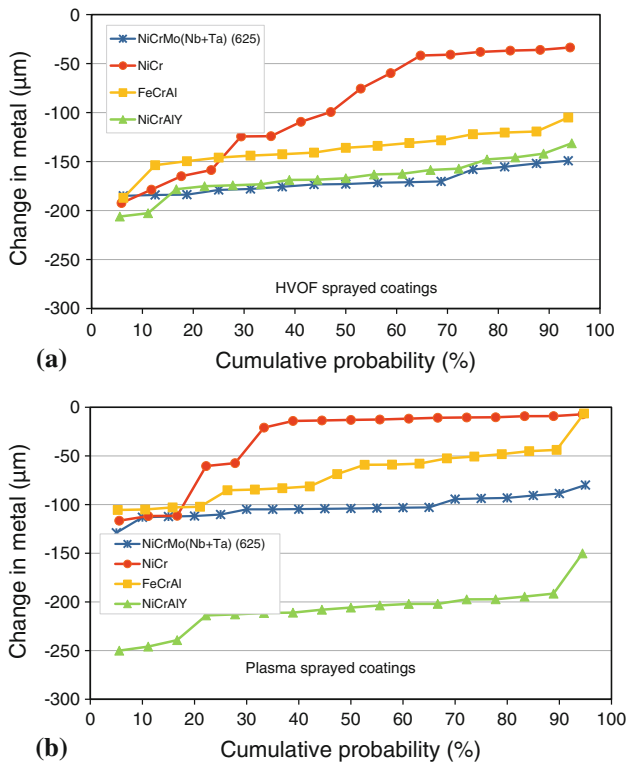
**Fig. 4** Changes in metal thickness vs. cumulative probability of HVOF- and plasma-sprayed alloy 625, NiCr, FeCrAl, and NiCrAlY coatings covered with deposits in simulated air-fired combustion gases after 1000 h at 650 °C

Figure 4(a) shows the change in metal distribution plotted against cumulative probability for HVOF-sprayed alloy 625, NiCr, FeCrAl, and NiCrAlY coatings exposed with a deposit (D1) to the simulated air-fired combustion gases at 650 °C for 1000 h. Cross section of each sample was measured using an image analysis system to provide ~17-20 metal loss measurements which were then ordered

to allow the extent of the attack to be determined. The data for HVOF-sprayed NiCr coating showed that the median metal loss (50% cumulative probability) was  $\sim 87 \mu\text{m}$ , which means that 50% of the sample surface had suffered a metal loss of more than  $87 \mu\text{m}$ . Similarly, 65% of the sample surface of the NiCr coating had suffered a metal loss of more than  $\sim 40 \mu\text{m}$ . FeCrAl coating suffered more corrosion damage than the NiCr coating. The plot illustrates that all the measured points on FeCrAl sample surface suffered a corrosion damage of  $100 \mu\text{m}$  or more over the duration of 1000 h in the test condition. The regions of the cumulative probability plots that are effectively flat correspond to an even metal loss, and a gradient indicates that the sample has suffered damage of various depths. It is interesting to notice that both alloy 625 and NiCrAlY coatings suffered a similar degree of corrosion damage.

Figure 4(b) shows the change in metal versus cumulative probability for plasma-sprayed alloy 625, NiCr, FeCrAl, and NiCrAlY coatings exposed with deposits in simulated combustion gases at 650 °C for 1000 h. Plasma-sprayed alloy 625, NiCr, and FeCrAl coatings showed much better corrosion performance compared to those of their HVOF counterparts. However, plasma-sprayed NiCrAlY coating suffered a corrosion damage of more than  $200 \mu\text{m}$  on 90% of the sample surface, and 18% of the sample surface suffered damage levels of more than  $250 \mu\text{m}$  (the initial coating thickness was  $\sim 250 \mu\text{m}$ ). The

crack present in the as-sprayed coating-substrate interface (Fig. 3d) could contribute to this loss. Plasma-sprayed NiCr coating had a median metal damage of  $13 \mu\text{m}$ , which is significantly lower than the HVOF-sprayed NiCr coating. Only 17% of the sample surface suffered from a corrosion damage of more than  $115 \mu\text{m}$ . Unlike the HVOF-sprayed alloy 625 and NiCrAlY coatings, there was a clear distinction between the performances of plasma-sprayed alloy 625 and NiCrAlY coatings; alloy 625 performed better than NiCrAlY. Median metal loss value of plasma-sprayed alloy 625 was  $110 \mu\text{m}$ , as opposed to  $170 \mu\text{m}$  for HVOF-sprayed alloy 625 coating.

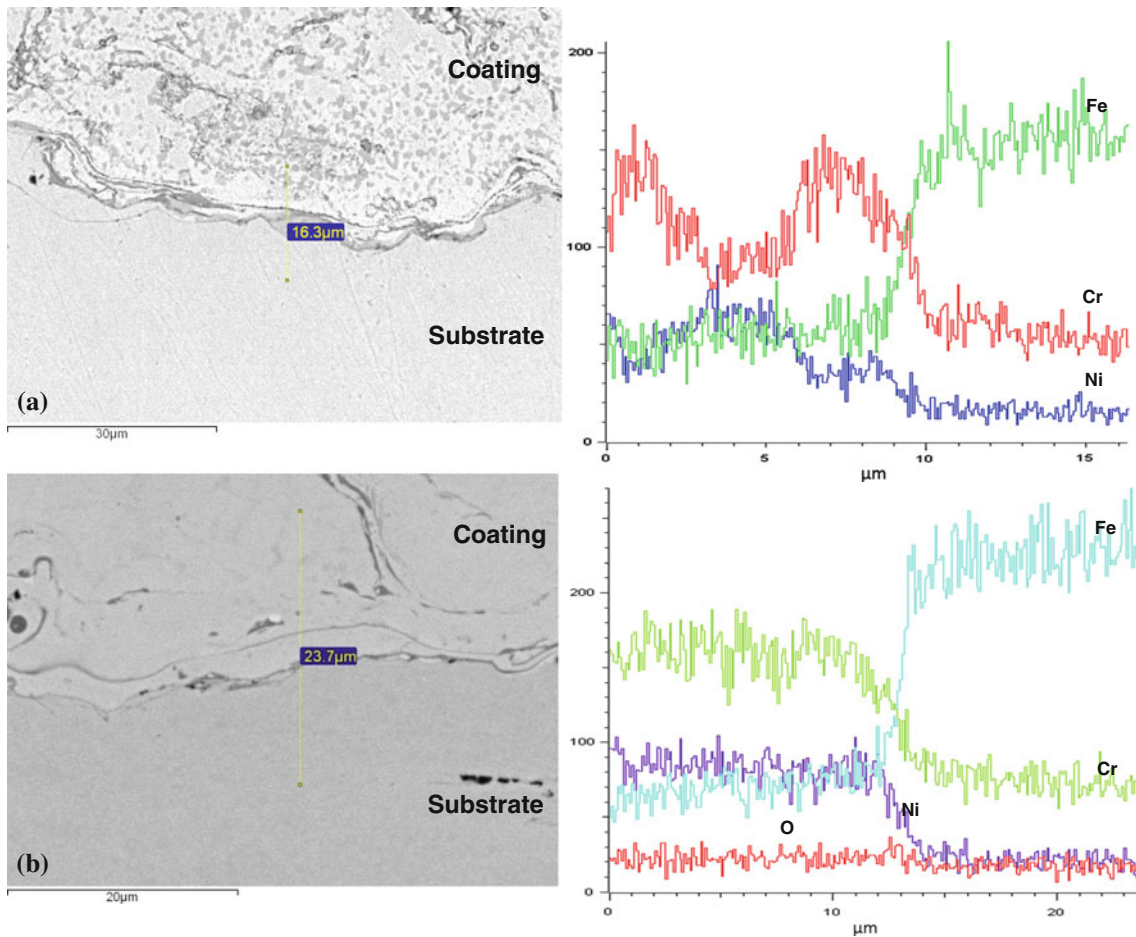
**Fig. 9** High magnification BSE images and their corresponding line scans of the coating-substrate interface of HVOF-sprayed (a) NiCr and (b) FeCrAl coatings after exposure in simulated air-fired combustion gases for 1000 h at 650 °C

An additional factor which can lead to enhanced degradation of coatings is the interdiffusion of elements at the coating-substrate interface. This can lead to depletion of important elements, such as Al and Cr from the coating, in addition to the formation of brittle intermetallic phases which can lead to premature coating delamination in service conditions (Ref 30). Figure 9 shows the cross sections of HVOF-sprayed NiCr and FeCrAl coatings on T91 substrates after exposure in the simulated air-fired combustion gases with deposits for 1000 h at 650 °C. The NiCr coating-T91 substrate interface showed a continuous thin band (a mild gray contrast in the BSE image, between the contrast of the coating and the substrate) at the coating side. The line scan showed the phase is rich in chromium. It was not possible to identify the phase reliability using the EDX spot analysis. However, a study by Sundararajan et al. (Ref 32) reported the formation of chromium carbide phase at the interface of Ni:Cr coating-T91 alloy substrate in a steam oxidation test. Figure 9(b) shows the HVOF-sprayed FeCrAl coating-T91 substrate interface following the test. No new phase was observed at the coating-substrate interface. An iron-based coating applied on an iron-based substrate avoided the formation of such a
