Fireside corrosion degradation of HVOF thermal sprayed FeCrAl coating at 700–800 °C

T. Hussain^{a,*}, N.J. Simms^b, J.R. Nicholls^b, J.E. Oakey^b

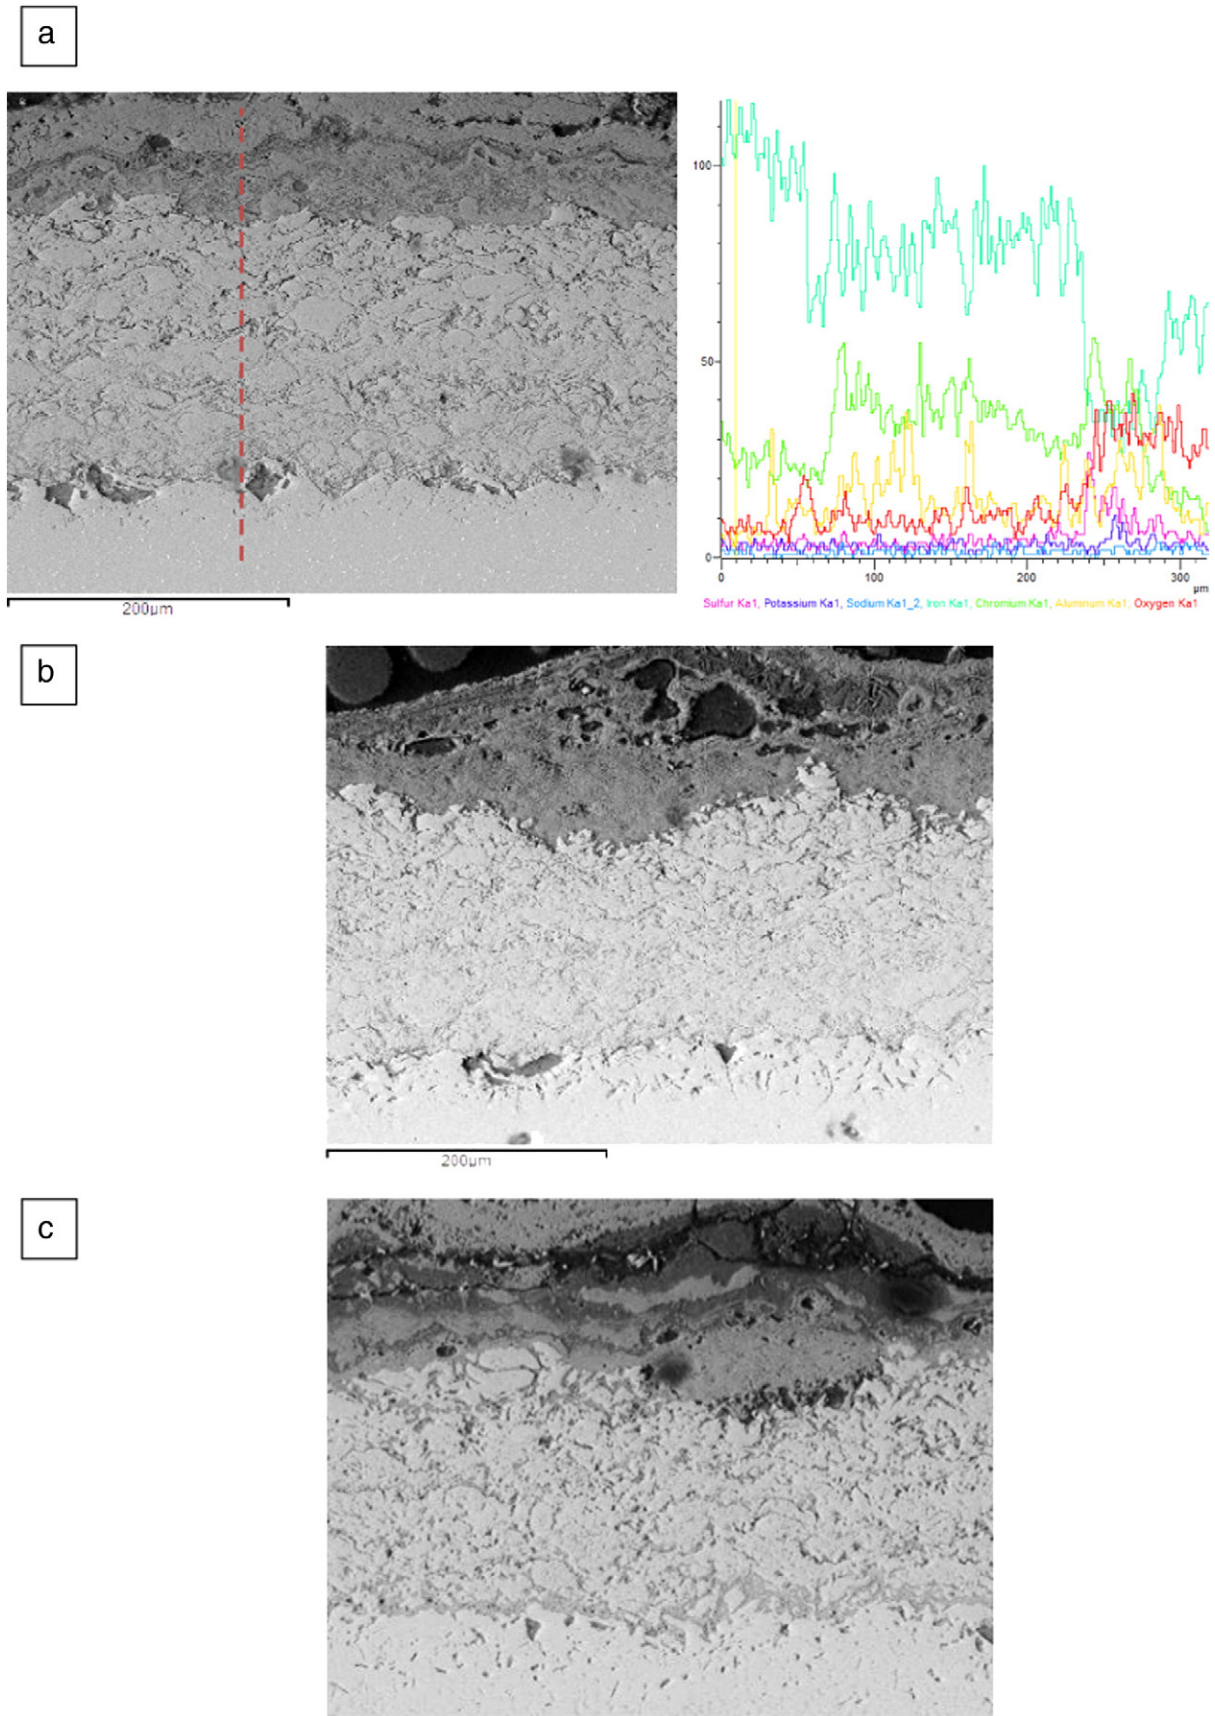
Fig. 3. BSE images of the FeCrAl coating following exposure in the simulated combustion gases with deposit at (a) 700 (with line scans showing elemental distribution), (b) 750 and (c) 800 °C.

Fig. 3 shows the post-exposure microstructure of FeCrAl coating following 1000 h exposure in simulated co-fired combustion gases at 700, 750 and 800 °C. The microstructure of the coating at 700 °C shows a mixed layer of scale and deposits at the top. A two-layered deposit/scale morphology can be identified looking at the contrast of the BSE image. The particle–particle boundaries in the coating are clearly identifiable following the fireside corrosion tests. A line scan across the coating scale was performed to detect the levels of aluminium, chromium and oxygen in the coating exposed at 700 °C. The level of oxygen in the coating was low with spikes associated with oxidation at the inter-splat regions. It is interesting to note that the levels of iron in the coating varied to some extent, which corresponds to the levels of aluminium and chromium present in the coating. The regions, which are rich in aluminium showed a drop in the concentrations of iron in the line scan. The concentration of chromium increased towards the coating-scale and coating-substrate interface. Looking at the

coating-scale interface, the inner region is rich in sulphur, which indicates sulphidation attack mechanism. The scale closer to the substrate (inner scale) has a higher concentration of chromium with small amount of aluminium, and the outer scale is rich in aluminium with small amount of chromium. Detailed EDX elemental maps of the oxides are shown in Fig. 4. The post-exposure microstructure of the FeCrAl coating exposed at 750 °C is shown in Fig. 3b. The coating suffered from a broad pitting type attack as can be seen from a reduction in thickness at the centre. The scale/deposit layer consisted of various elements from the deposit and a mixed oxide phase consisting of aluminium and chromium oxides. The coating exposed at 800 °C showed significant oxidation of the splats (the darker phases at the particle-particle boundaries). A large pitting type attack of the coating can also be identified in Fig. 3c (similar to the sample from 750 °C).

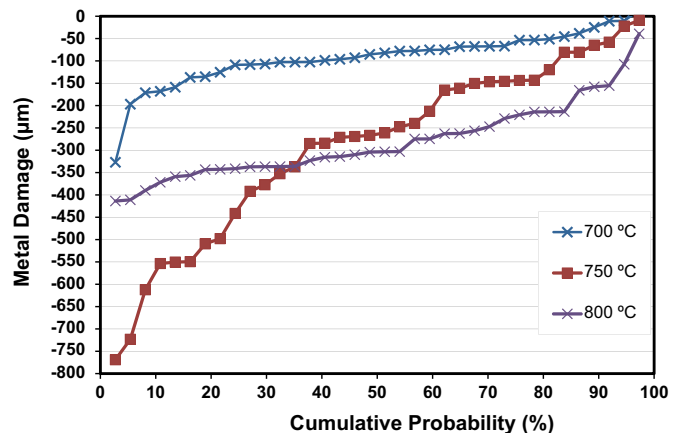
Fig. 8. Metal damage vs. cumulative probability of FeCrAl coating covered in deposits in simulated combustion gases after 1000 h at 700, 750 and 800 °C.

Dimensional metrology provides the most reliable measurement of corrosion damage to materials at high temperature, as it produces a distribution of metal damage data for each exposed samples [28,29]. The results are plotted as change in metal vs cumulative probability according to the draft standards for high-temperature corrosion measurements [17,18]. Fig. 8 shows the metal damage vs cumulative probability of FeCrAl coatings exposed in simulated co-fired combustion gases with screening deposits at 700, 750 and 800 °C for 1000 h. The
